# Roadway Stream Crossing Assessment

## Jennie Webber Creek at Cross Country Road

## Stella 2 Crossing – Jennie Webber Creek at Cross Country Road

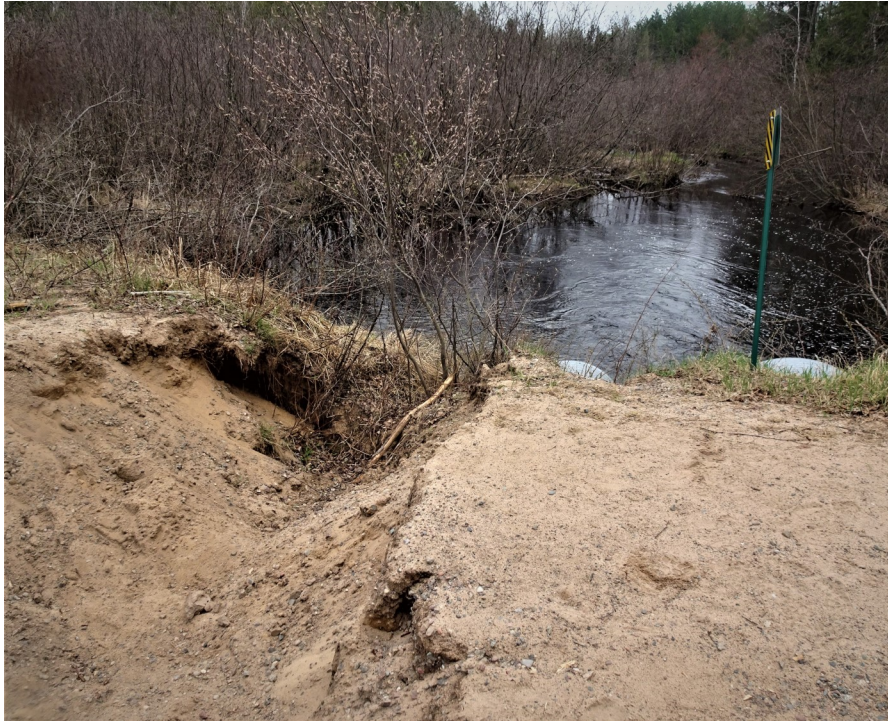
*Road surface looking downstream May 2022*

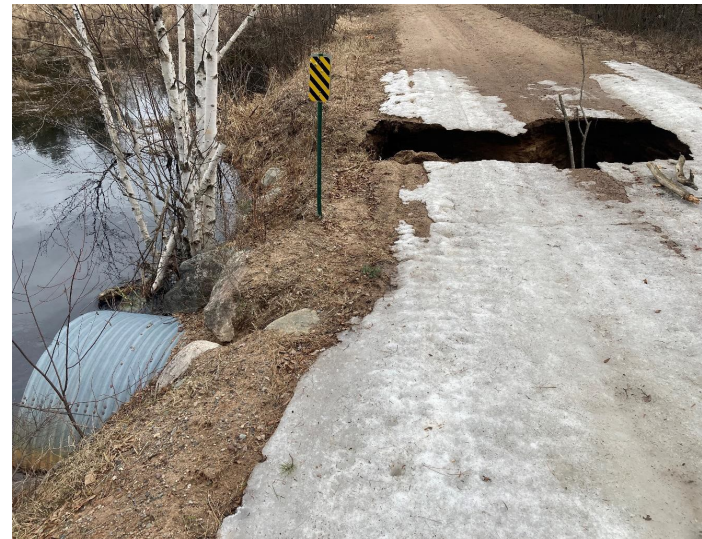
*Road condition spring 2021*

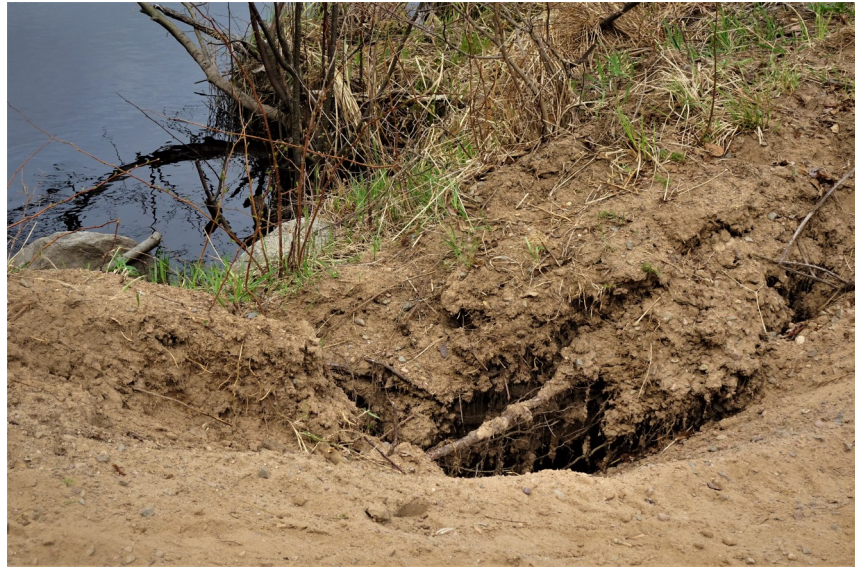
*Road surface over inlet May 2022*

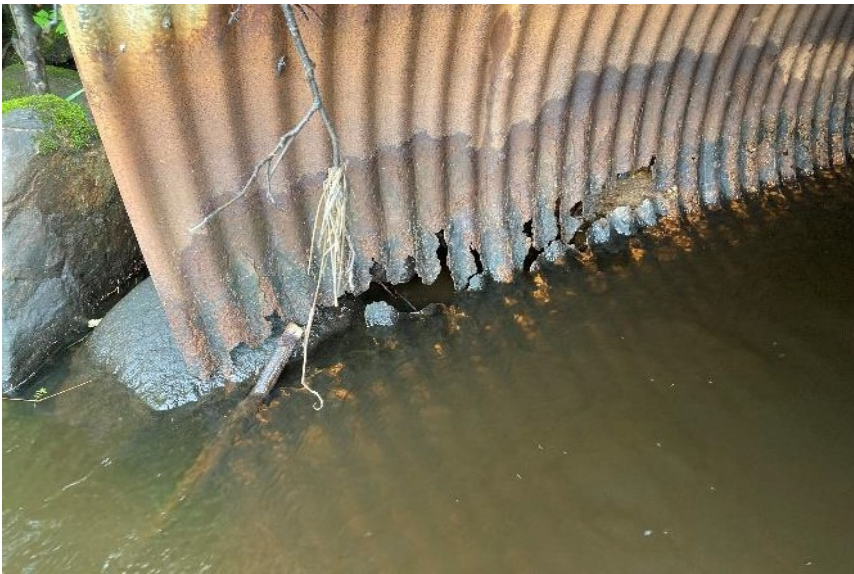
*Condition of 4 ft diameter culvert*

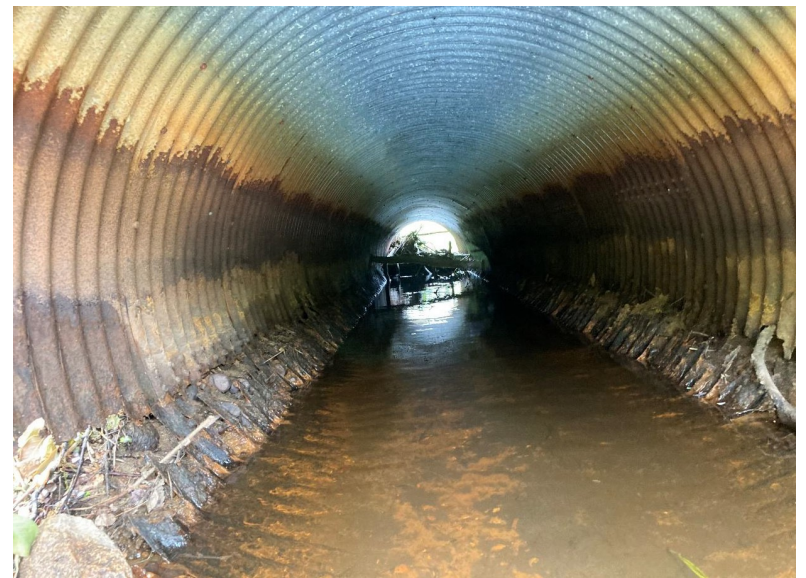
*Condition of 4 ft diameter culvert*
