Buffalo Lake Oneida County, Wisconsin Monitoring Reports

Buffalo Lake AIS Monitoring and Water Clarity Report

Field Date: August 20, 2021

Oneida County AIS Program: Buffalo Lake Monitoring Report

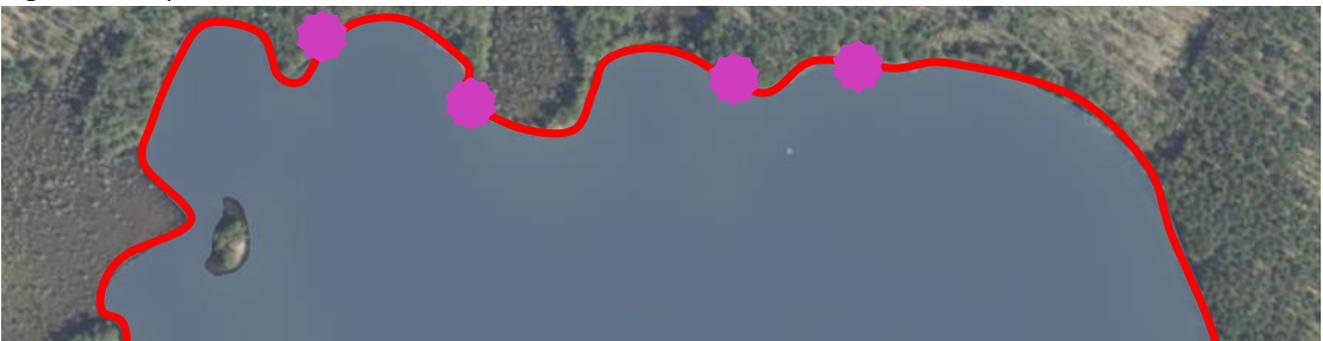
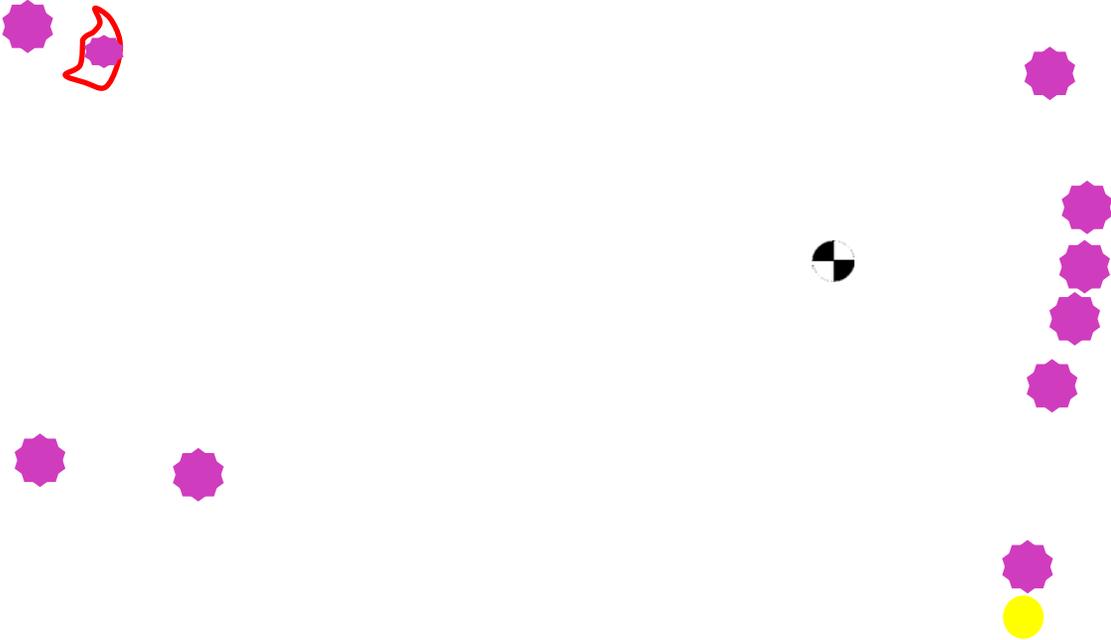
Figure 2. Map of Buffalo Lake.

Boat Landing
-

Area of shoreline that was monitored
-

Location of dissolved oxygen and Secchi disk reading
Latitude: 45.879226
Longitude: 89.56755
-

Purple Loosestrife plants observed and removed
