Townline Lake

Oneida County, Wisconsin

Townline Lake AIS Monitoring and Water Clarity Report

Field Date: June 16, 2022
WBIC: 1023100
Previous AIS Findings: Chinese Mystery Snails
New AIS Findings: No new AIS found.
Field Crew: Aubrey Nycz, AIS Lead Program Assistant, and Madeline Hetland, AIS
Project Assistant, Oneida County Land and Water Conservation
Department
Report By: Madeline Hetland

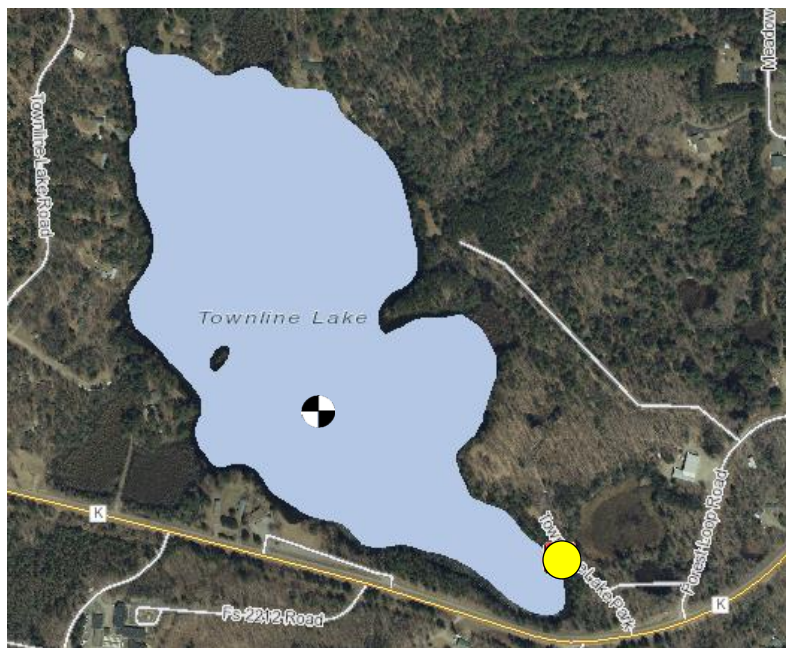
Figure 2. Map of Townline Lake.

Townline Lake Data: Townline Lake, located in the Town of Newbold, Oneida County, is a 61-acre seepage lake with a maximum depth of 25 feet (Figure 1.). There is one public boat landing on Townline Lake located near the Townline Lake Park on the southwestern shoreline of the lake (Figure 2). The substrate is 35% sand, 5% gravel, 15% rock, and 35% muck. Along with reporting

Location of dissolved oxygen and Secchi disk reading

Latitude: 45.645503

Longitude: -89.463707

Boat Landing

Field Notes (water quality monitoring): To observe the water clarity and quality on Townline Lake, we used a depth finder and maps indicating where data had been collected in the past to locate the deep hole. After locating the deep hole, we used a Secchi disk to measure water clarity and a dissolved oxygen meter to measure water quality. Oxygen is needed for a healthy fish population, and also for plants to respire at night. The measurements from the dissolved oxygen meter can tell us if the organisms in the lake are under stress. The dissolved oxygen measurements on Townline Lake looked healthy. The top 15 feet were well oxygenated. We were not able to obtain dissolved oxygen measurements past 15 feet due to strong winds. Our dissolved oxygen meter was moving around in the water, and our anchor was not holding our canoe steady. These measurements can be found in Table 2. The Secchi disk reading was at 10 feet out of a maximum depth of 25 feet.
