Big Carr Lake AIS Monitoring and Water Clarity Report

Field Date: August 17, 2022
WBIC: 971600
Previous AIS Findings: Chinese Mystery Snail, Purple Loosestrife, Rusty Crayfish
New AIS Findings: No new AIS found.
Field Crew: Aubrey Nycz, Lead AIS Project Assistant, and Madeline Hetland, AIS Project Assistant, Oneida County Land and Water Conservation Department
Report By: Madeline Hetland

Big Carr Lake AIS Boat Launch and Shoreline Surveillance Monitoring Report

Big Carr Lake Purple Loosestrife Control Report

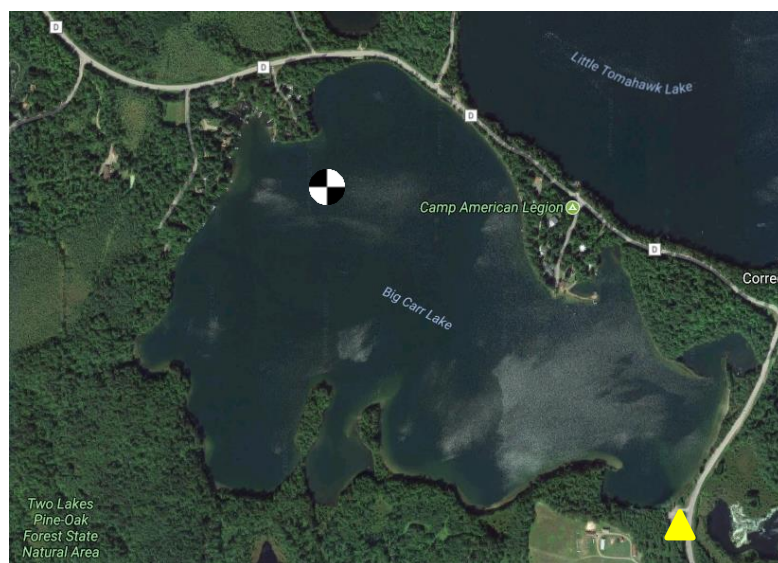
Figure 2. Map of Big Carr Lake with the location of the Secchi disk reading labeled.

Secchi: The Secchi reading on this lake was 8 feet out of a 75 foot maximum depth. The water color was a bluish color, and was clear when glancing across the lake.

Deep hole & location of Secchi disk reading

Public Boat Landing

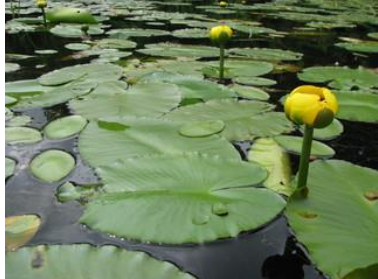
Common Name Scientific Plant Name	Description	Image
<p>Bullhead Pond Lily (Spatterdock)</p> <p><i>Nuphar variegata</i></p>	<p>An aquatic plant with heart-shaped leaves that can grow to be 15 inches long. This plant also has a yellow, cup-shaped flower. This plant is native.</p>

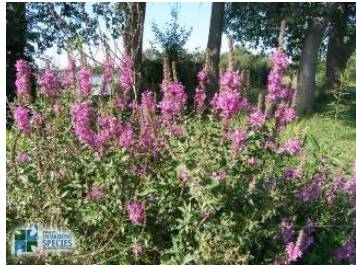
<p>Photo Credit: Jomegat's Weblog</p>
<p>Purple Loosestrife</p> <p><i>Lythrum salicaria</i></p>	<p>A flowering plant with a square or 6-sided stem and smooth leaves. Flowers tend to be a pinkish purple with 6 petals. This plant is invasive!</p>
