Gilmore Lake

Oneida County, Wisconsin

Page 1: August 3, 2021 Aquatic Invasive Species Monitoring and Water Quality Report

Gilmore Lake AIS Monitoring and Water Clarity Report

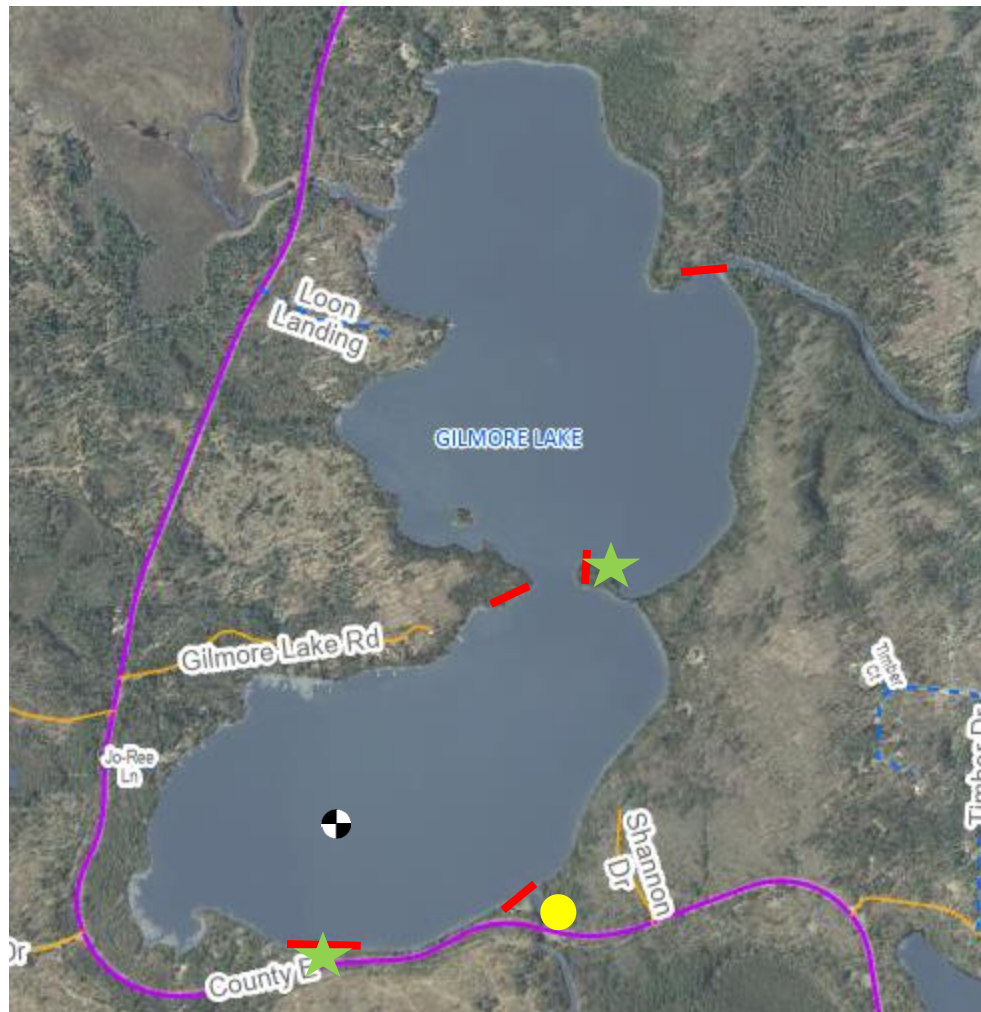
Figure 2. Map of Gilmore Lake.

Map Key

Boat Landing
-

Targeted monitoring locations
-

Banded Mystery Snail locations
-

Location of dissolved oxygen and Secchi disk reading
Latitude: 45.85069
Longitude: 089.56304

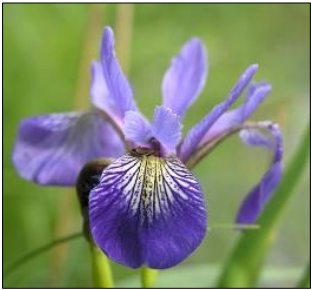
<p>Blue Flag Iris (<i>Iris versicolor</i>)</p> <p>Description: A semi-aquatic to emergent perennial. Flowers are deep blue to purple, 6 parted, 6-8 cm wide. Sepals may have greenish-yellow markings at the base surrounded by a white zone. Leaves are narrow, sword-like; arranged in flattened, fan-like clusters. Flowers stalks (20-80 cm high) are taller than the leaves.</p> <p>Status: Native</p> <p><i>Photo Credit: Wisconsin Department of Natural Resources</i></p>
