# Hemlock Lake

## Oneida County, Wisconsin

- Page 1: **July 21, 2022** Aquatic Invasive Species Monitoring and Water Quality Report
- Page 7: **June 11, 2020** Aquatic Invasive Species Monitoring and Water Quality Report
- Page 12: **June 21, 2017** Aquatic Invasive Species Monitoring and Water Quality Report
- Page 18: **September 8, 2014** Purple Loosestrife and Large Purple Bladderwort Monitoring
- Page 21: **August 13, 2014** Aquatic Invasive Species Monitoring and Water Quality Report

## **Hemlock Lake AIS Monitoring and Water Clarity Report**

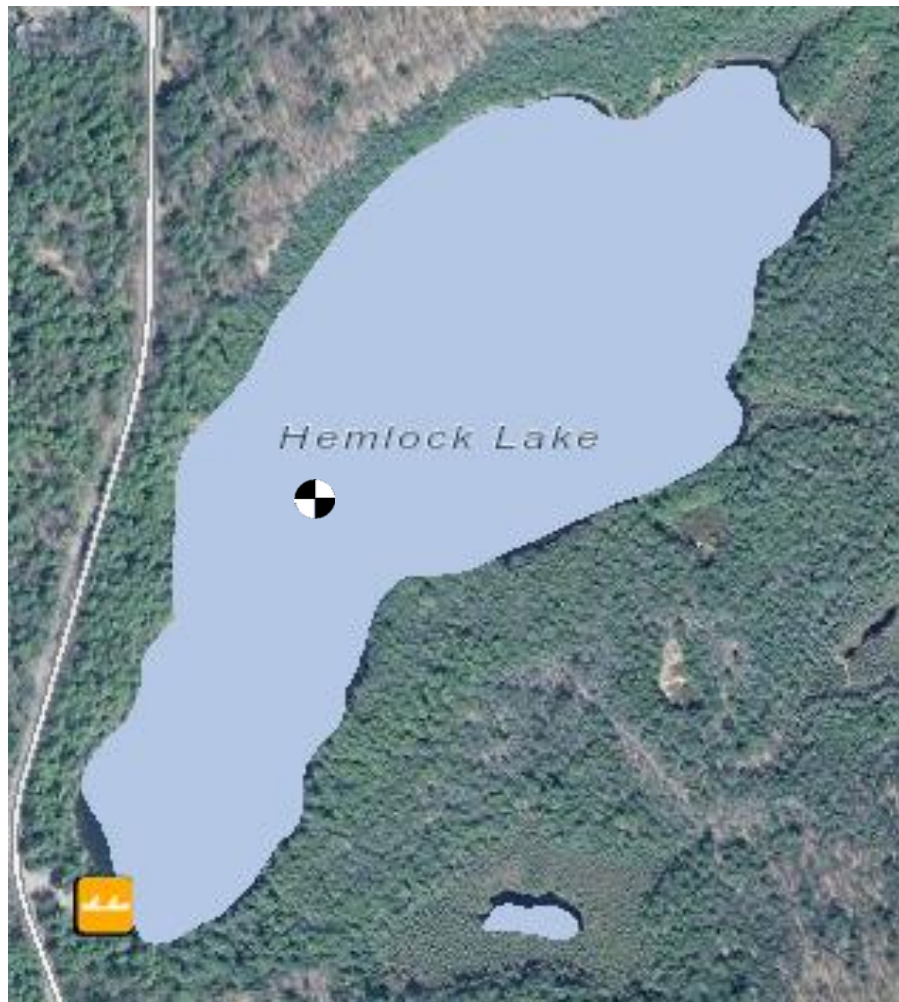
**Figure 2.** Map of Hemlock Lake.

**Map Key**

Boat Landing

Location of dissolved oxygen and Secchi disk reading

Latitude: 45.876386

Longitude: -89.652182
