Hodstradt Lake

Oneida County, Wisconsin

Hodstradt Lake AIS Monitoring and Water Clarity Report

Field Date: July 28, 2022
WBIC: 990700
Previous AIS Findings: Chinese Mystery Snails
New AIS Findings: Purple Loosestrife
Field Crew: Aubrey Nycz, AIS Lead Project Assistant, and Madeline Hetland, AIS
Project Assistant, Oneida County Land and Water Conservation
Department
Report By: Madeline Hetland

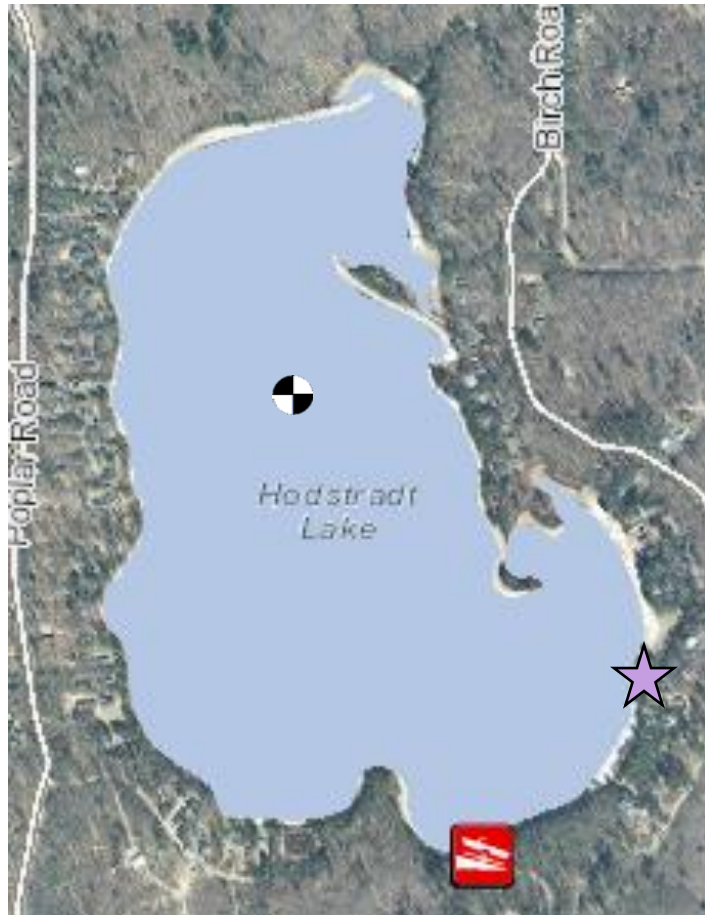
Figure 2. Map of Hodstradt Lake.

Hodstradt Lake Data: Hodstradt Lake, located in the Town of Lake Tomahawk, Oneida County, is a 119-acre seepage lake with a maximum depth of 36 feet (**Figure 1.**). There is one public boat landing on Hodstradt Lake located on Brush Road (**Figure 2**). The substrate is 60% sand, 10% gravel, 20% rock, and 10% muck. Along with reporting the depth and substrate, the Wisconsin Department of Natural Resources (WDNR) reports that the lake has panfish, largemouth bass, smallmouth bass, and walleye.

Field Notes (water quality monitoring): To observe the water clarity and quality on Hodstradt Lake, we used a depth finder and maps indicating where data had been collected in the past to locate the deep hole. After locating the deep hole, we used a Secchi disk to measure water clarity and a dissolved oxygen meter to measure water quality. Oxygen is needed for a healthy fish population, and also for plants to respire at night. The measurements from the dissolved oxygen meter can tell us if the organisms in the lake are under stress. The dissolved oxygen measurements on Hodstradt Lake looked healthy. Unfortunately, we were not able to obtain dissolved oxygen measurements past 32 feet due to an increasing amount of wind. The dissolved oxygen meter has difficulties getting readings when water is choppy. The measurements we did obtain can be found in **Table 2**. The Secchi disk reading was at 16 feet out of a maximum depth of 41 feet.

Location of dissolved oxygen and Secchi disk reading

Site of Purple Loosestrife Plant

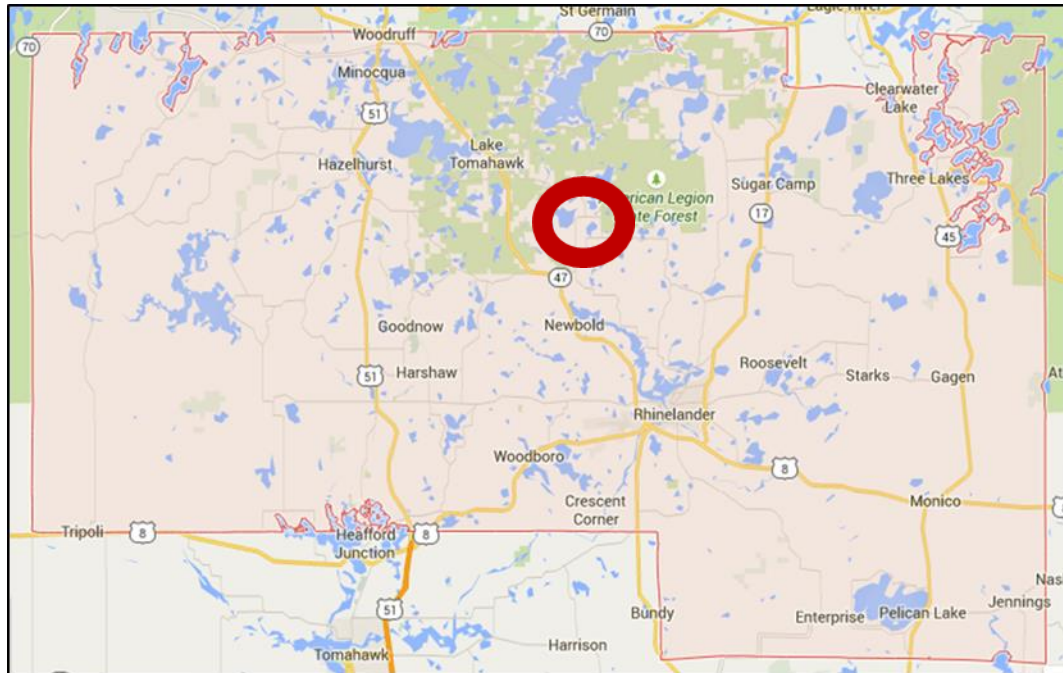
Figure 2. Map of Hodstradt Lake with the location of the boat landing and Secchi disk reading labeled.

They launched their canoe from the public boat landing, located on Brush Rd (Figure 2). The weather while on Hodstradt Lake was a sunny and approximately 80°F; however, there was quite a bit of wind while we were out on the water.

To measure water clarity and quality on Hodstradt Lake effectively, they used maps provided by the DNR to help us locate the deep hole (Figure 2). Once at the deep hole, a Secchi Disk was used to measure the water clarity, and a dissolved oxygen (DO) meter was used to measure the water quality. Oxygen is needed for a healthy fish population, and also for plants to respire at night. The measurements from the dissolved oxygen meter can tell us if the organisms in the lake would be under stress. The dissolved oxygen measurements on Hodstradt Lake appeared to be normal. Wind created a slight chop on the water which may have altered some of their DO readings; however, the readings they obtained were still in the normal range for the kind of lake that Hodstradt Lake is. The readings for the Secchi Disc showed 19 feet of visibility out of a maximum depth of 35 feet.
