# Indian Lake

## Indian Lake AIS Monitoring and Water Clarity Report

WBIC: 1598900  
Previous AIS Findings: Chinese Mystery Snails, Freshwater Jellyfish  
New AIS Findings: None  
Field Date: July 30, 2020  
Field Crew: Aubrey Nycz, AIS Project Leader, and Rachel Cook, AIS Project Assistant, Oneida County Land and Water Conservation Department  
Report by: Rachel Cook

WBIC: 1598900  
Previous AIS Findings: Chinese Mystery Snails, Freshwater Jellyfish  
New AIS Findings: None  
Field Date: July 23, 2014  
Field Crew: Stephanie Boismenu and Sara Mills, AIS Project Assistants, Oneida County Land and Water Conservation Department  
Report by: Sara Mills

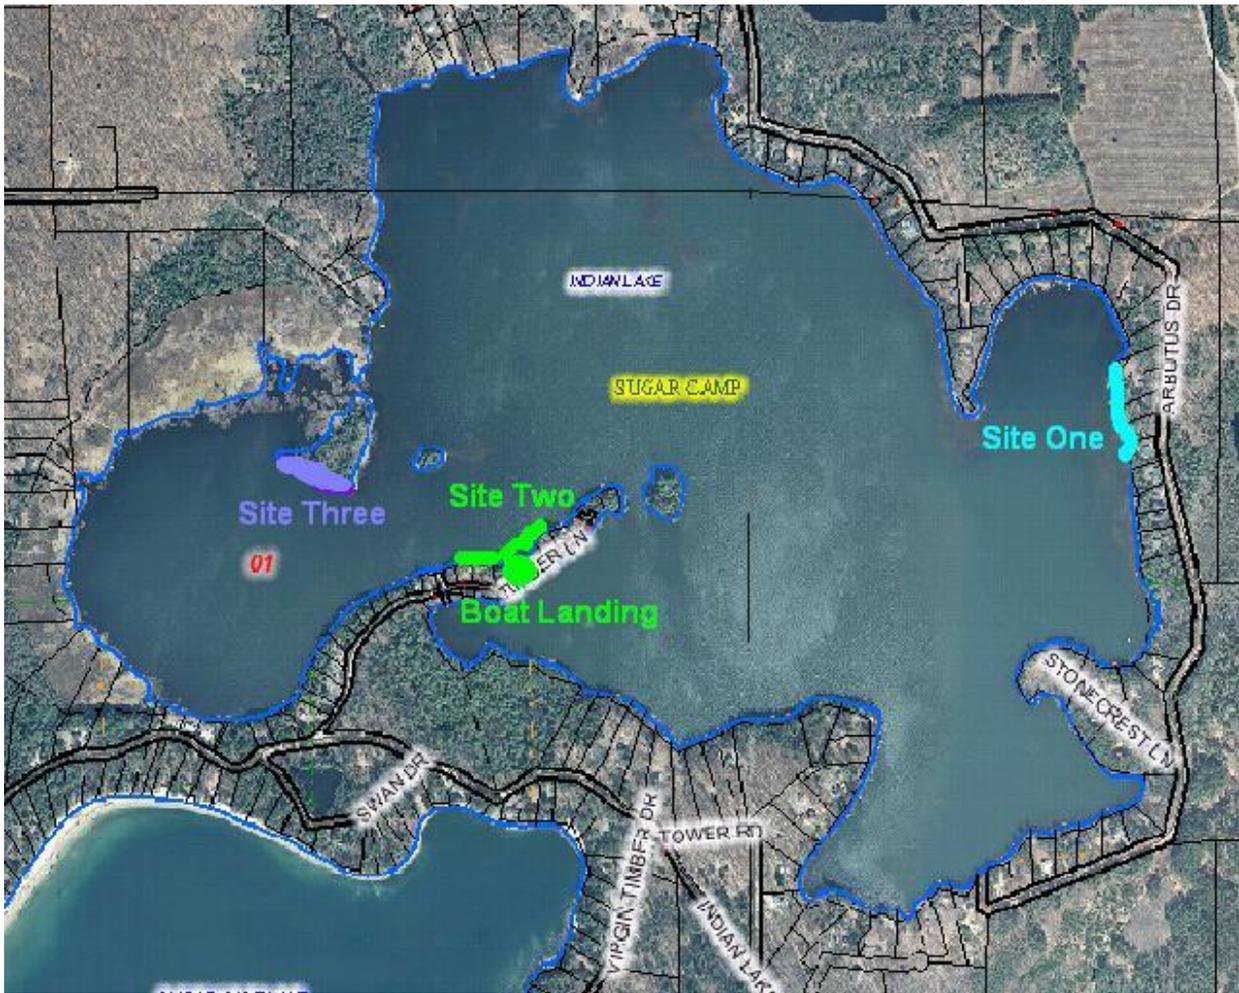
**Figure 1.** A map of Indian Lake with lines representing the approximate locations of our visual surveys and a pink dot representing the deep hole site.

The deep hole site where we measured water clarity and dissolved oxygen ranged between 27 and 28 feet in depth. Our secchi disk reading for water clarity was in between 2 and 3 meters or approximately 8.2 feet. Additionally we measured dissolved oxygen in the lake, starting at 1 foot below the water surface and continuing at 3 foot intervals. Table 1 presents the dissolved oxygen levels and temperature readings at the various depths measured in Indian Lake.

We visually inspected the lake's shoreline at three sites labeled one, two, and three on Figure 1. Indian Lake is listed only to have freshwater jellyfish and Chinese mystery snails. We did not find any indication of any other invasive species being in the lake. Our first location (site one on figure 1) was located on the northeast side of the lake near a bay. It was sandy with a lot of pickerel weed, Chinese mystery snails, and some native snails.

Our second site (site two on figure 1) was at the boat landing. The boat landing does not have a dock. It had more weeds there than our previous site with most of the weeds being pondweeds. There was no indication of Eurasian water-milfoil or curly leaf pondweed mixed in with the native weeds. There were less Chinese mystery snails at this site.

Our third site (site three on figure 1) was across from the boat landing at the entrance to an island that can be used for one night overnight camping. It was less sandy than the other sites and had more pondweed. There were Chinese mystery snails but no other indication of any other invasive species there. The vegetation seemed to be very healthy.
