Maple Lake

Oneida County, Wisconsin

Page 1: **July 13, 2022** Aquatic Invasive Species Monitoring and Water Quality Report

Maple Lake AIS Monitoring and Water Clarity Report

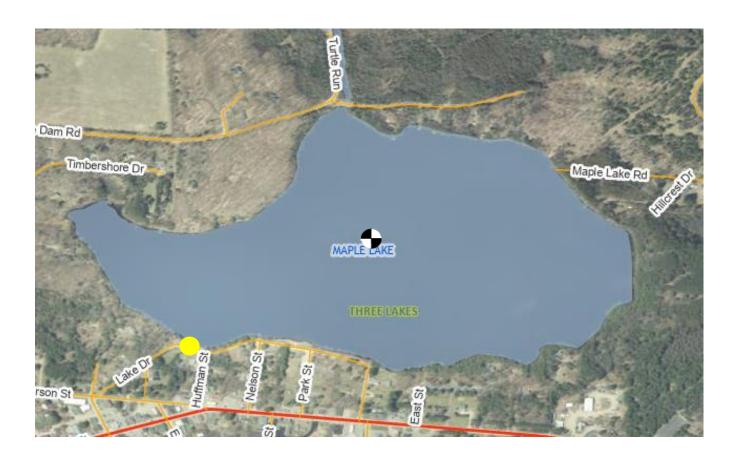
Figure 2. Map of Maple Lake.

Map Key

Boat Landing

Location of dissolved oxygen and Secchi disk reading

Latitude: 45.803469 Longitude: -89.162496

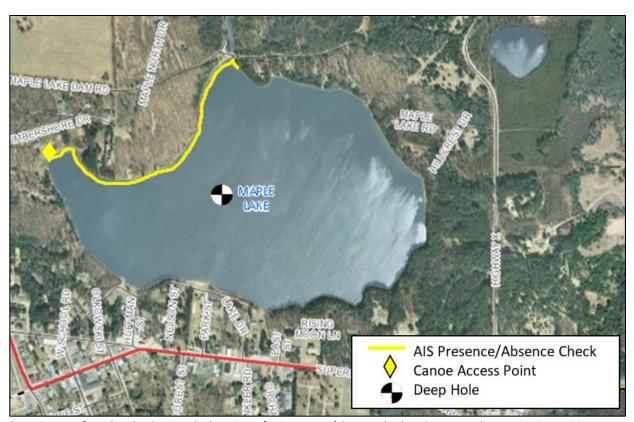
The main reason we visited Maple Lake was to follow-up on June's report of a potential purple loosestrife sighting. She had suspicions that there was purple loosestrife along the northwest shoreline, which is where we searched for a presence/absence check (Figure 3). While along this shoreline we also did a presence/absence check for other invasive species.

Aquatic Invasive Species: No new AIS were observed.

Secchi: The Secchi reading on this lake was 13 feet at a depth of 14 feet.

Figure 3. Map of Maple Lake showing the locations of AIS presence/absence check and water quality monitoring activites. Deep Hole GPS Coordinates: 45.80285148, -89.16418484

We entered with the canoes from Junes dock, on Timbershore Drive (Figure 3). Using a bathymetric map (Figure 2), the three of us canoed to the deep hole using a depth finder. After canoeing around the area of the deep hole, we used a point with a depth of 13 feet out of a possible depth of 15 feet. At this point Stephanie anchored so that we could do our water quality measurements. I used the dissolved oxygen meter to find the dissolved oxygen readings and temperature readings (Table 1), while Sara recorded. Sara then used the Secchi disk to measure water clarity while I recorded. During this time Stephanie used the GPS to record the exact location of our deep hole water quality measurements.
