# Pelican Lake

## **Pelican Lake AIS Monitoring and Eurasian Watermilfoil Removal Report**

## **Pelican Lake Landing Only AIS Monitoring & Signage Installation at Weaver's Resort and Campground Report**

**Pelican Lake Eurasian Watermilfoil Inspection Report**

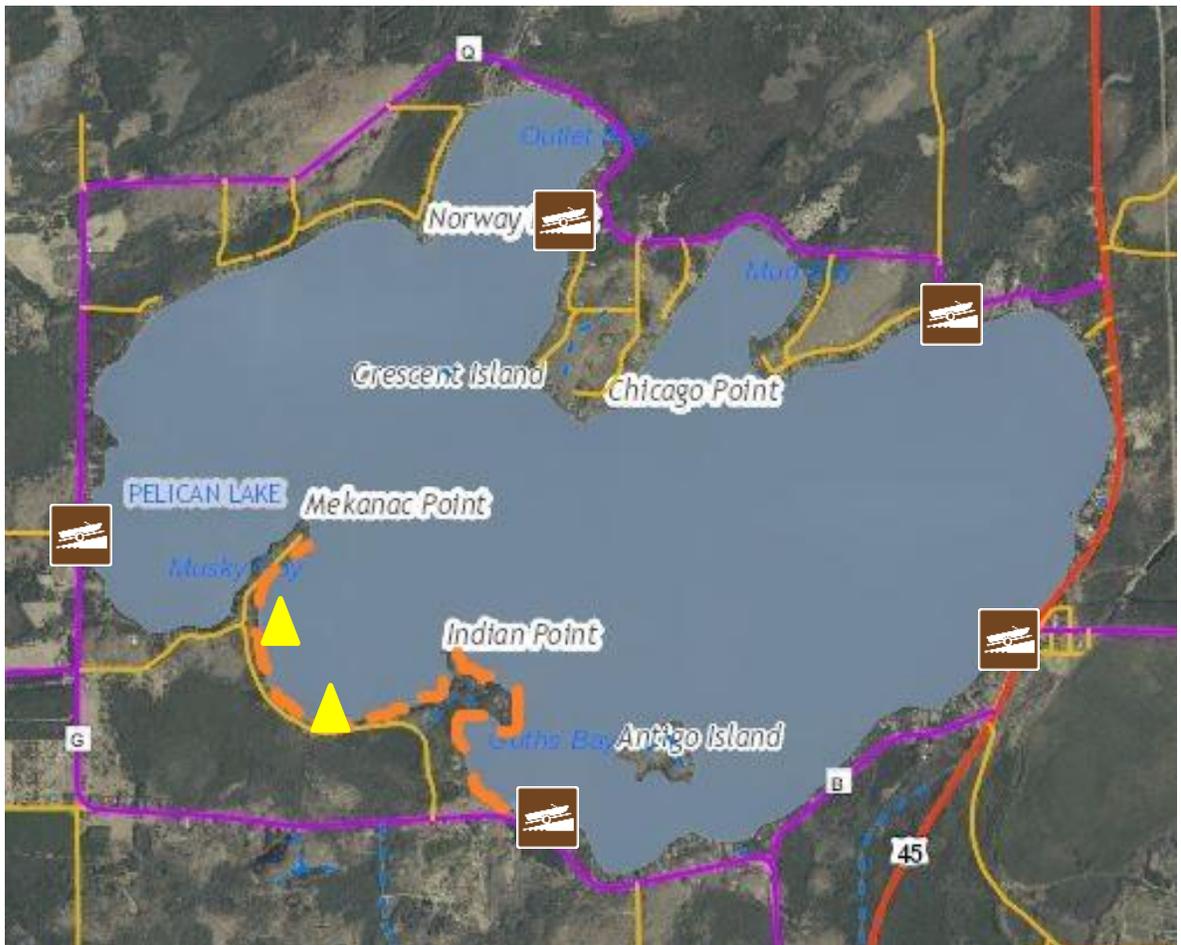
After checking the shoreline and talking with residents, Stephanie and I paddled further into Treacherous Bay, looking within areas of Bulrush and other vegetation for fragments of EWM. We did find many fragments on the south-western side of the lake, as well as a few rooted plants. We collected all the fragments and rooted plants that we could find and discarded them in a trash bag after leaving the lake. We worked until about 3:00 p.m. and then stopped for the day. This is a project that requires future monitoring sessions as EWM grows adventitiously, and since we were not able to monitor the entire lake or look on the sediment in deeper areas. Future hand removal or chemical treatments should be kept in consideration for Pelican Lake.

**Figure 2.** Map of Pelican lake with boat landings, monitored areas, and EWM locations marked.

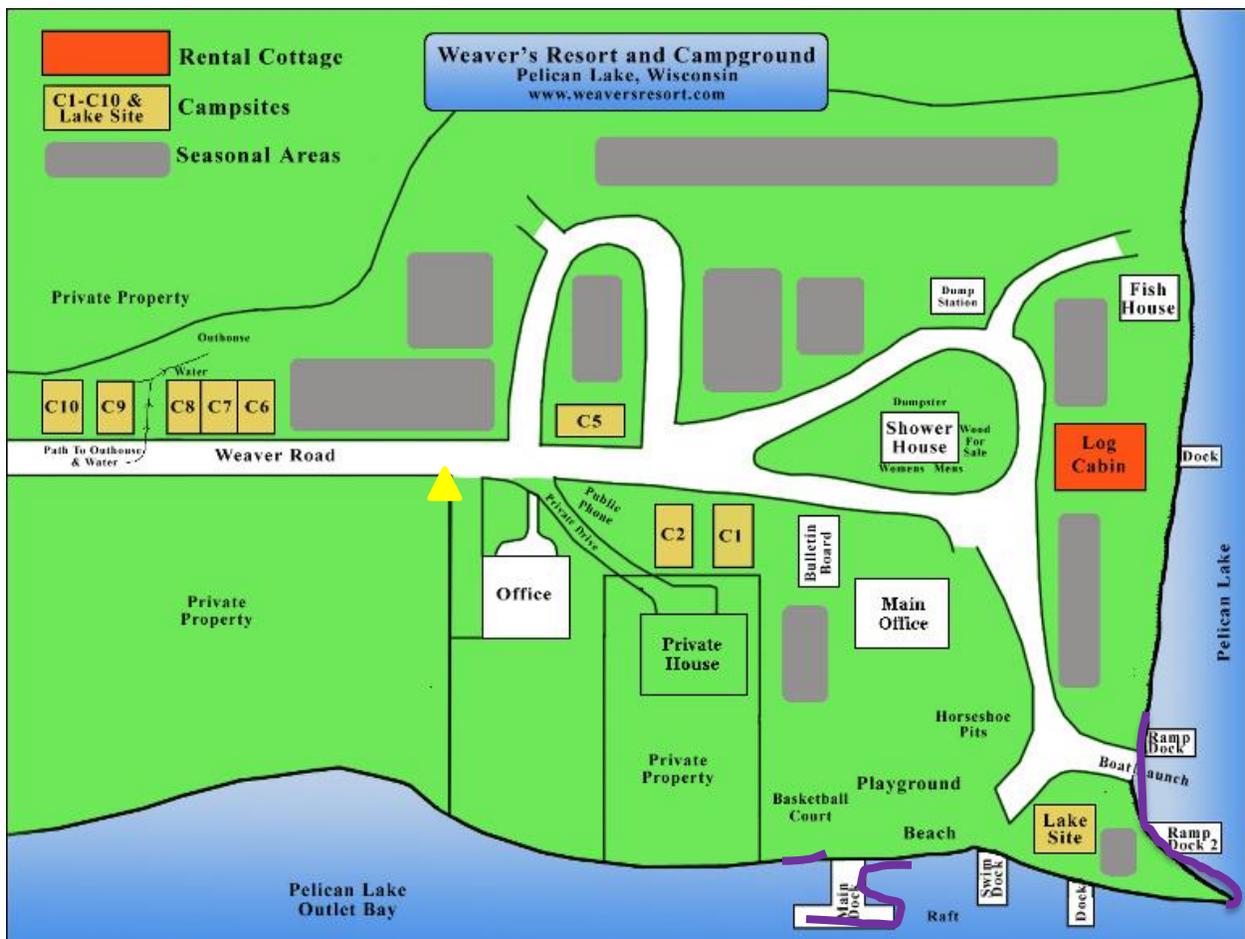
While at the boat landing, the team performed a shoreline inspection. We walked along the shoreline and raked the bottom of the lake to check for plant growth and animal activity. Through our observations, we found Chinese Mystery Snails (invasive), Wandering Pond Snails

(native), Great Pond Snails (native), Orb Snails (native), Clasp Leaf Pondweed (native), and Yellow Iris (invasive). It is recommended that any invasive snails and yellow iris plants be removed from the water/shoreline and disposed of, in order to prevent the spread of these invasives.

**Figure 1.** The purple lines indicate the parts of the shoreline where the Oneida County AIS team monitored (image taken from *weaversresort.com*)

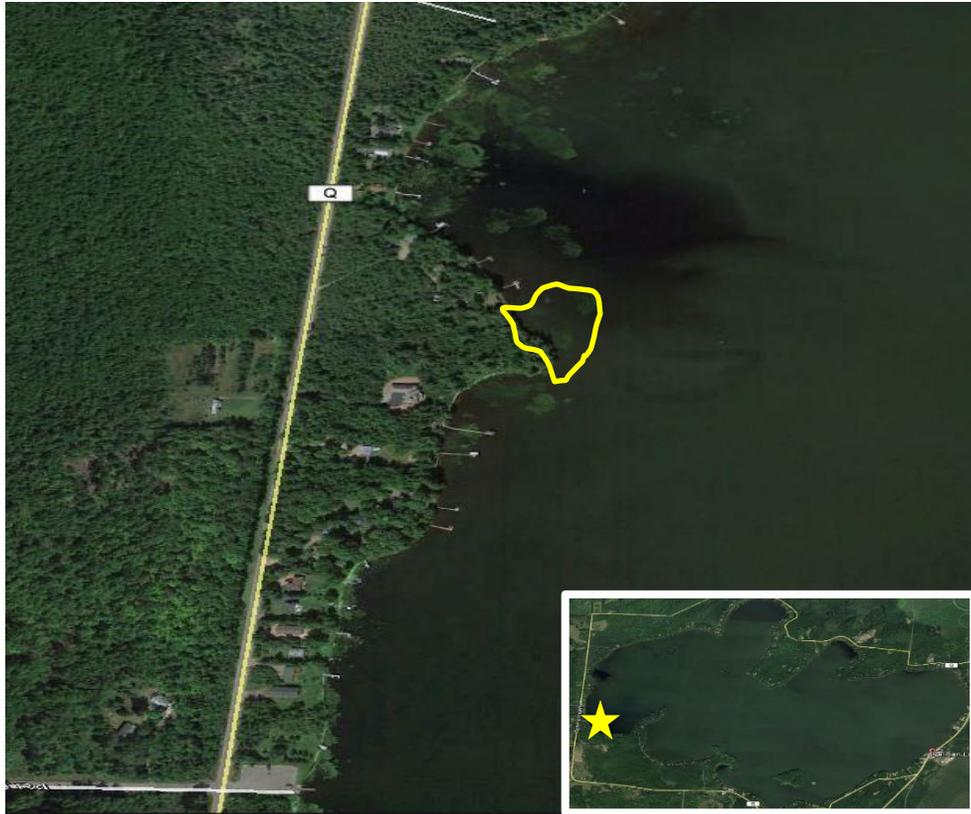
On both days, the area with EWM plants was searched intensely. Canoes and kayaks were used to scan the deeper areas, and aquascopes were used to help our team look at the lake's floor in greater detail. When searching the area, we made sure to use caution in order to not stir the sediment up. This was to ensure that if the EWM plants were in the area, they would not be broken into smaller pieces.

Figure 1: Yellow line/star represents area searched for EWM, and the inset is Pelican Lake as a whole.

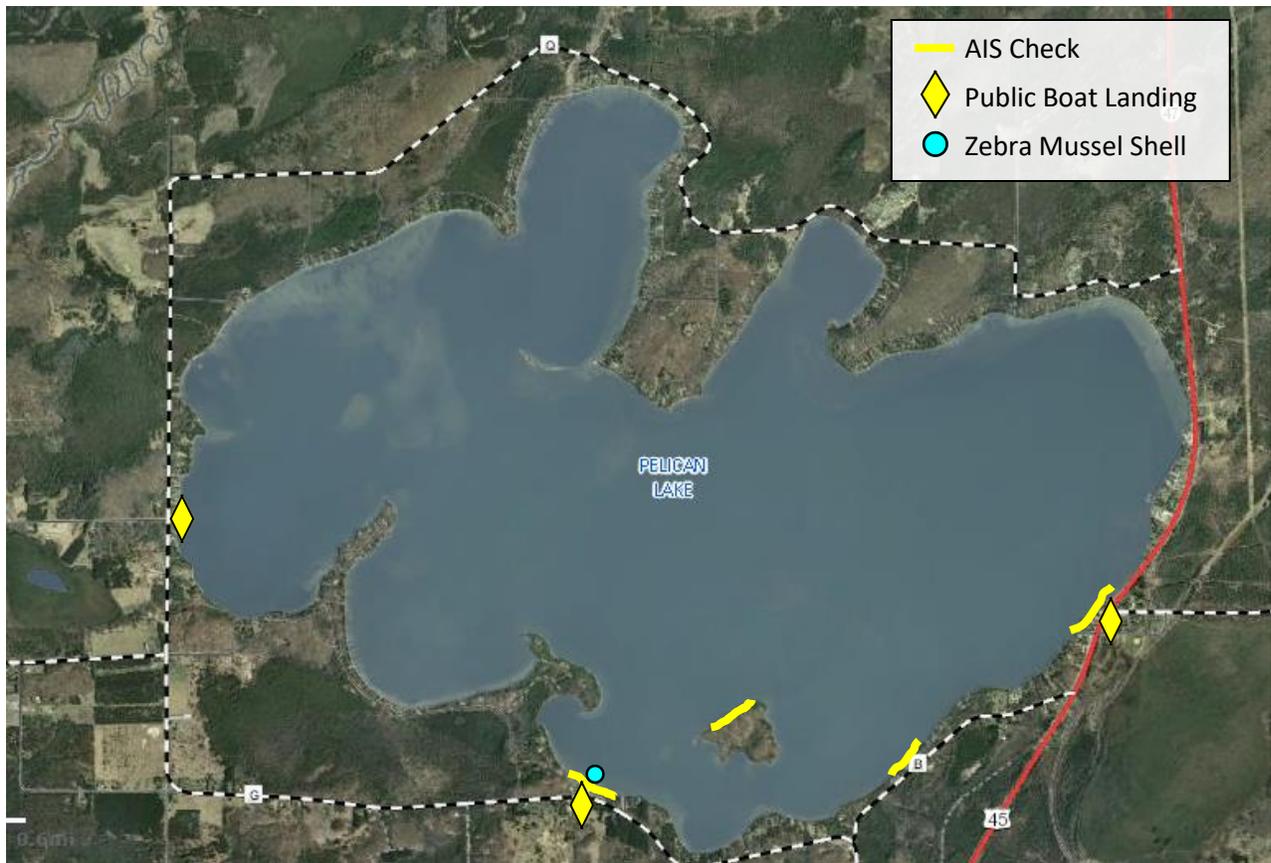
At the public boat landing on Highway G we found a dead half shell of a zebra mussel (Figure 2). We found the shell in between the pylons of the concrete ramp. A crew from the DNR had performed zebra mussel veliger tows on the lake prior to our visit. The results of their tow came back negative for zebra mussel veligers in the lake, however, there are outstanding tows that need to be tested. Due to the location that we found the shell and the condition of the shell, we believe that the dead shell was on a boat as they entered Pelican Lake and it fell off. Weeks later, a Clean Boats Clean Waters watercraft inspector at the same boat landing inspected a boat attempting to enter the lake that had two zebra mussels attached. Although we didn't find any live zebra mussels in the lake, boaters and property owners should remain vigilant in checking boats, piers, etc. for zebra mussels and report anything suspicious. In all the areas that we monitored, we found many banded mystery snails, Chinese mystery snails, and rusty crayfish.

**Figure 2.** Map of Pelican Lake with locations of AIS presence/absence checks chosen for potential zebra mussels, public boat landings, and zebra mussel shell labeled.
