Prairie Lake

Oneida County, Wisconsin

Page 1: **June 23, 2022** Aquatic Invasive Species Monitoring and Water Quality Report

Prairie Lake AIS Monitoring and Water Clarity Report

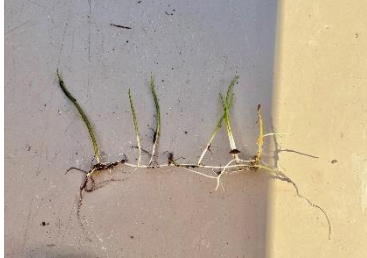
<p>Dwarf Watermilfoil (<i>Myriophyllum tenellum</i>)</p> <p>Description: An aquatic plant that grows in a dense cluster of thin, toothpick like, unbranched stems from buried rhizomes. Sometimes large mats of interwoven rhizomes and stems will become dislodged from the bottom and float up. Flowers may rise above the water surface in shallow water.</p> <p>Status: Native</p> <p><i>Photo Credit: Aubrey Nycz</i></p>

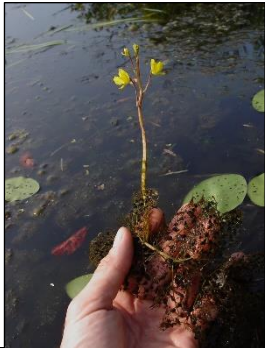
<p>Common Bladderwort (<i>Utricularia macrorhiza</i>)</p> <p>Description: Stems very leafy, floating just under the surface or occasionally upright from the sediment. Leaves are finely divided. Bladders are usually abundant on the leaflets, ranging from light green to black. Forms yellow-green winter buds at the tip of the plant in the fall.</p> <p>Status: Native</p> <p><i>Photo Credit: Donald Cameron</i></p>
