Site evaluation of completed County Cost Share Projects

Project Completed: 2014

Lake: Crescent Lake

Site Visit Follow Up: 07/27/2021 by Baerbel Ehrig, Oneida County Land & Water Conservation Department

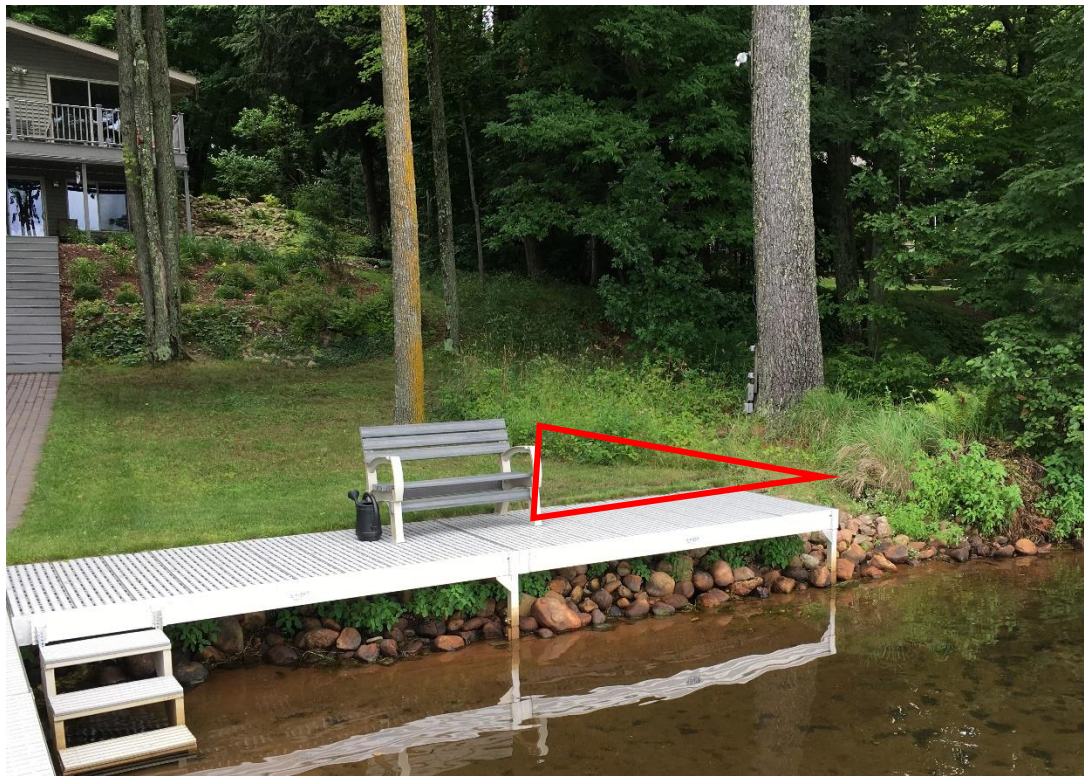
The native vegetation is well established. While I was at the site, the area of the red triangle on Figure 1 appeared to be initially part of the native planting project area, which is now being mowed, and shows signs of erosion due to the lawn mower and dumping of grass.

Revegetation of the area in the red triangle is needed to reconnect the native plantings area with the lakeshore; and therefore, will lead to more stability for the soil and the riprap. Great plants would be Blue flag iris, Joe Pye Weed, Swamp milkweed, and Blue Vervain.

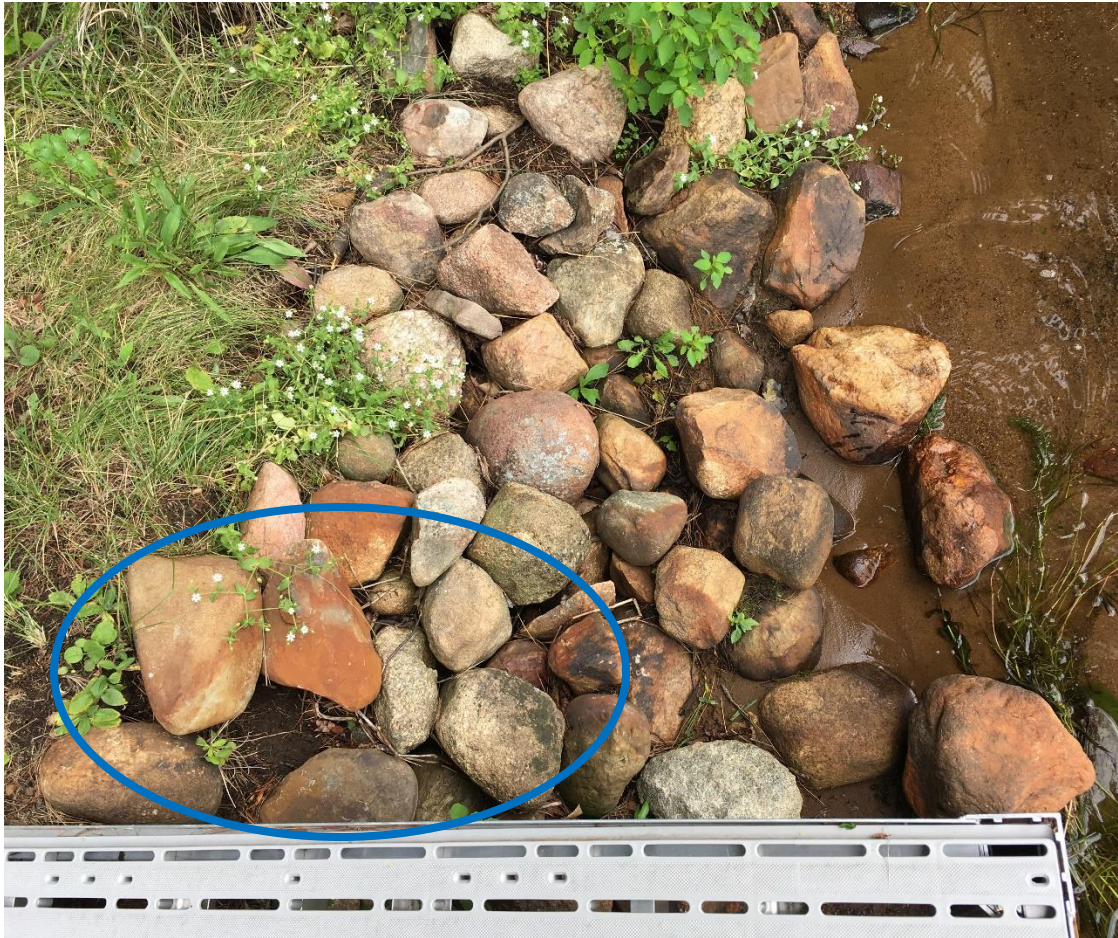
Figure 2

Right below the mowed area of the red triangle, the riprap has come loose and the rocks are slipping out of their place. See blue oval in Figure 2.

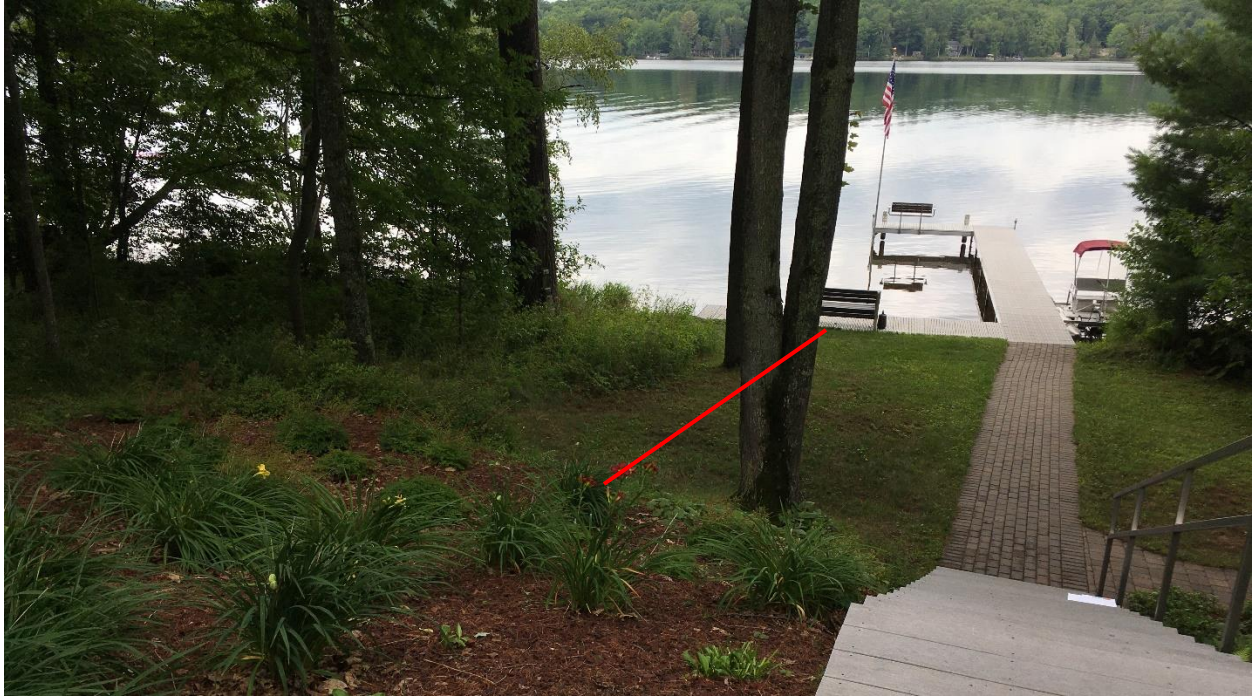
Figure 3

Upon further review of the plan in the office, it appeared that the view corridor line has been moved towards the “left”. According to the construction plan the view corridor line should be roughly where the red line is in Figure 3. Please see Figure 4 for more information. The native planting border according to the plan is also roughly where the red line is located.

The home owner signed a contract to maintain the project areas for 10 years. We therefore need to ask for the area to the left of the red line, which is now showing lawn, to be restored to a native planting area. We recommend a total of 40 plant plugs. Choose a mix of Black Eyed Susan, Beebalm, New England aster, Barren strawberry, Wild Columbine. For any questions or concerns please contact me at behrig@co.oneida.wi.us or call the office at 715 369 7835.
