Oneida County, Wisconsin

August 12, 2020 Sevenmile Lake AIS Early Detection and Water Clarity Report

Sevenmile Lake AIS Early Detection and Water Clarity Report

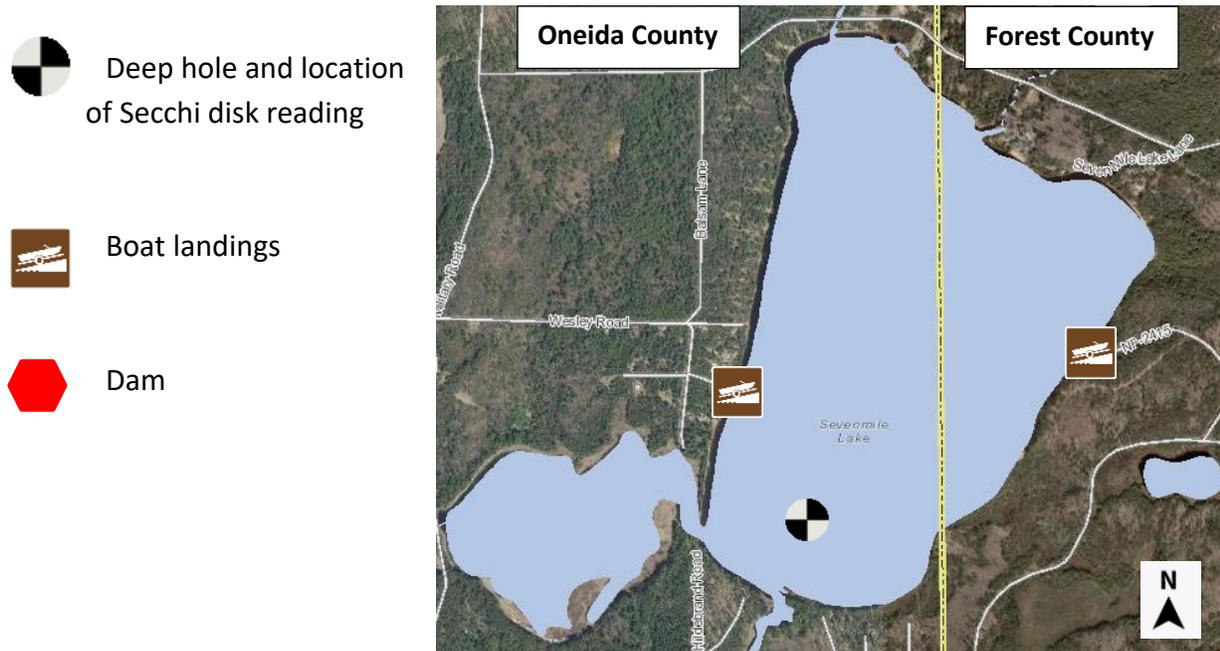
Figure 2. Map of Sevenmile Lake with boat landings, dam, and location of Secchi disk reading labeled. This lake is located in both Oneida and Forest Counties. The yellow line on the map separates the two counties. The western side of the lake is in Oneida County and the eastern side of the lake is in Forest County.
