Case Studies - Photos

Lakeshore Protection Options

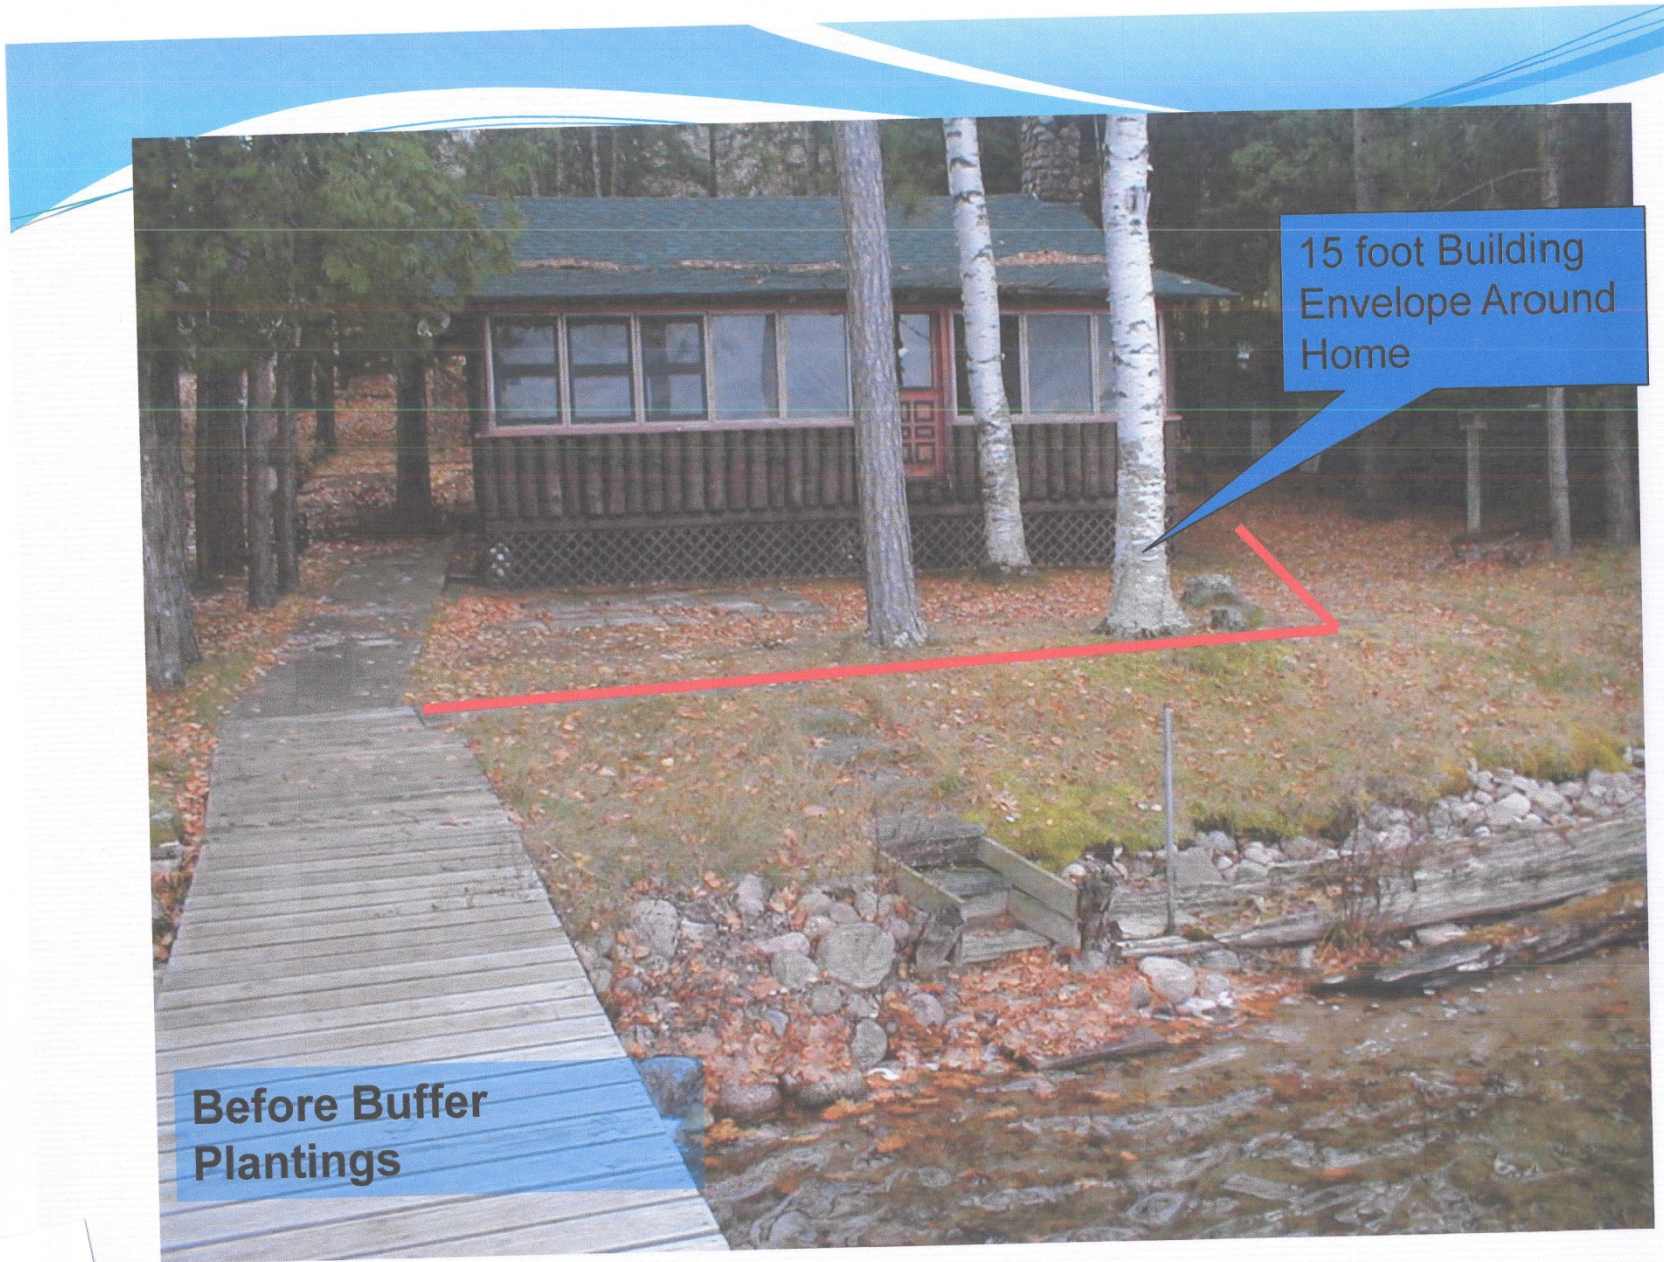
Native Plantings

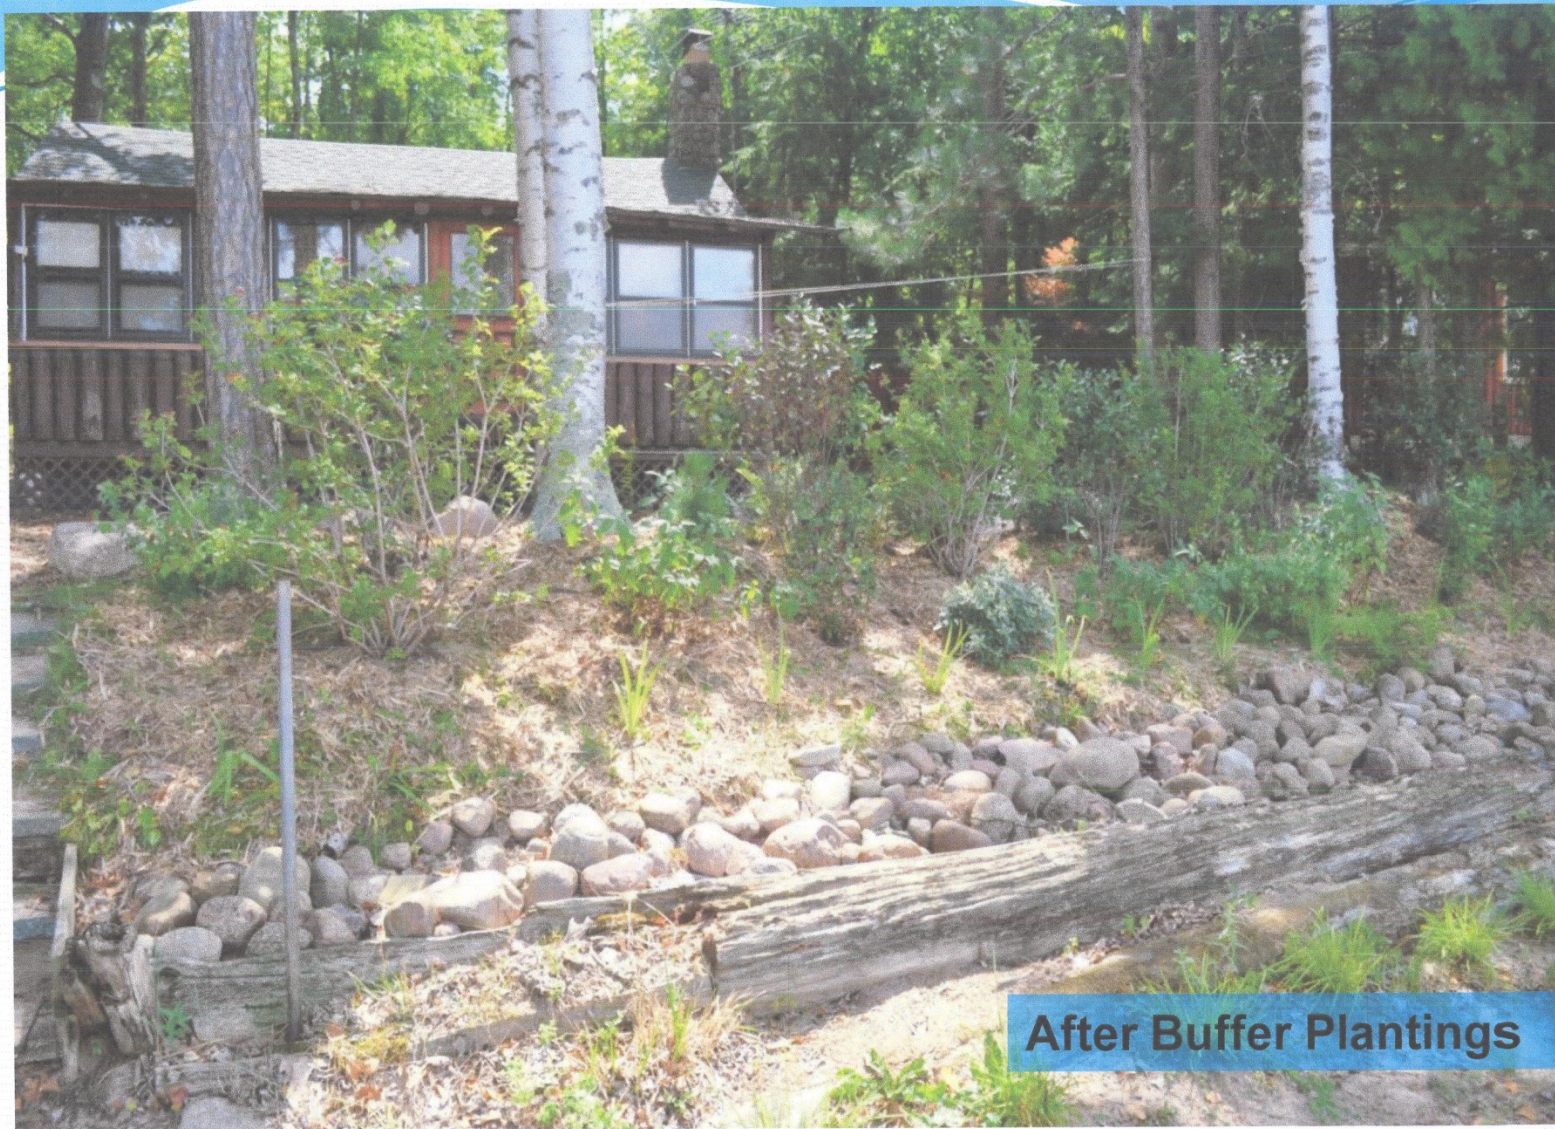
15 foot Building
Envelope Around
Home

Before Buffer
Plantings

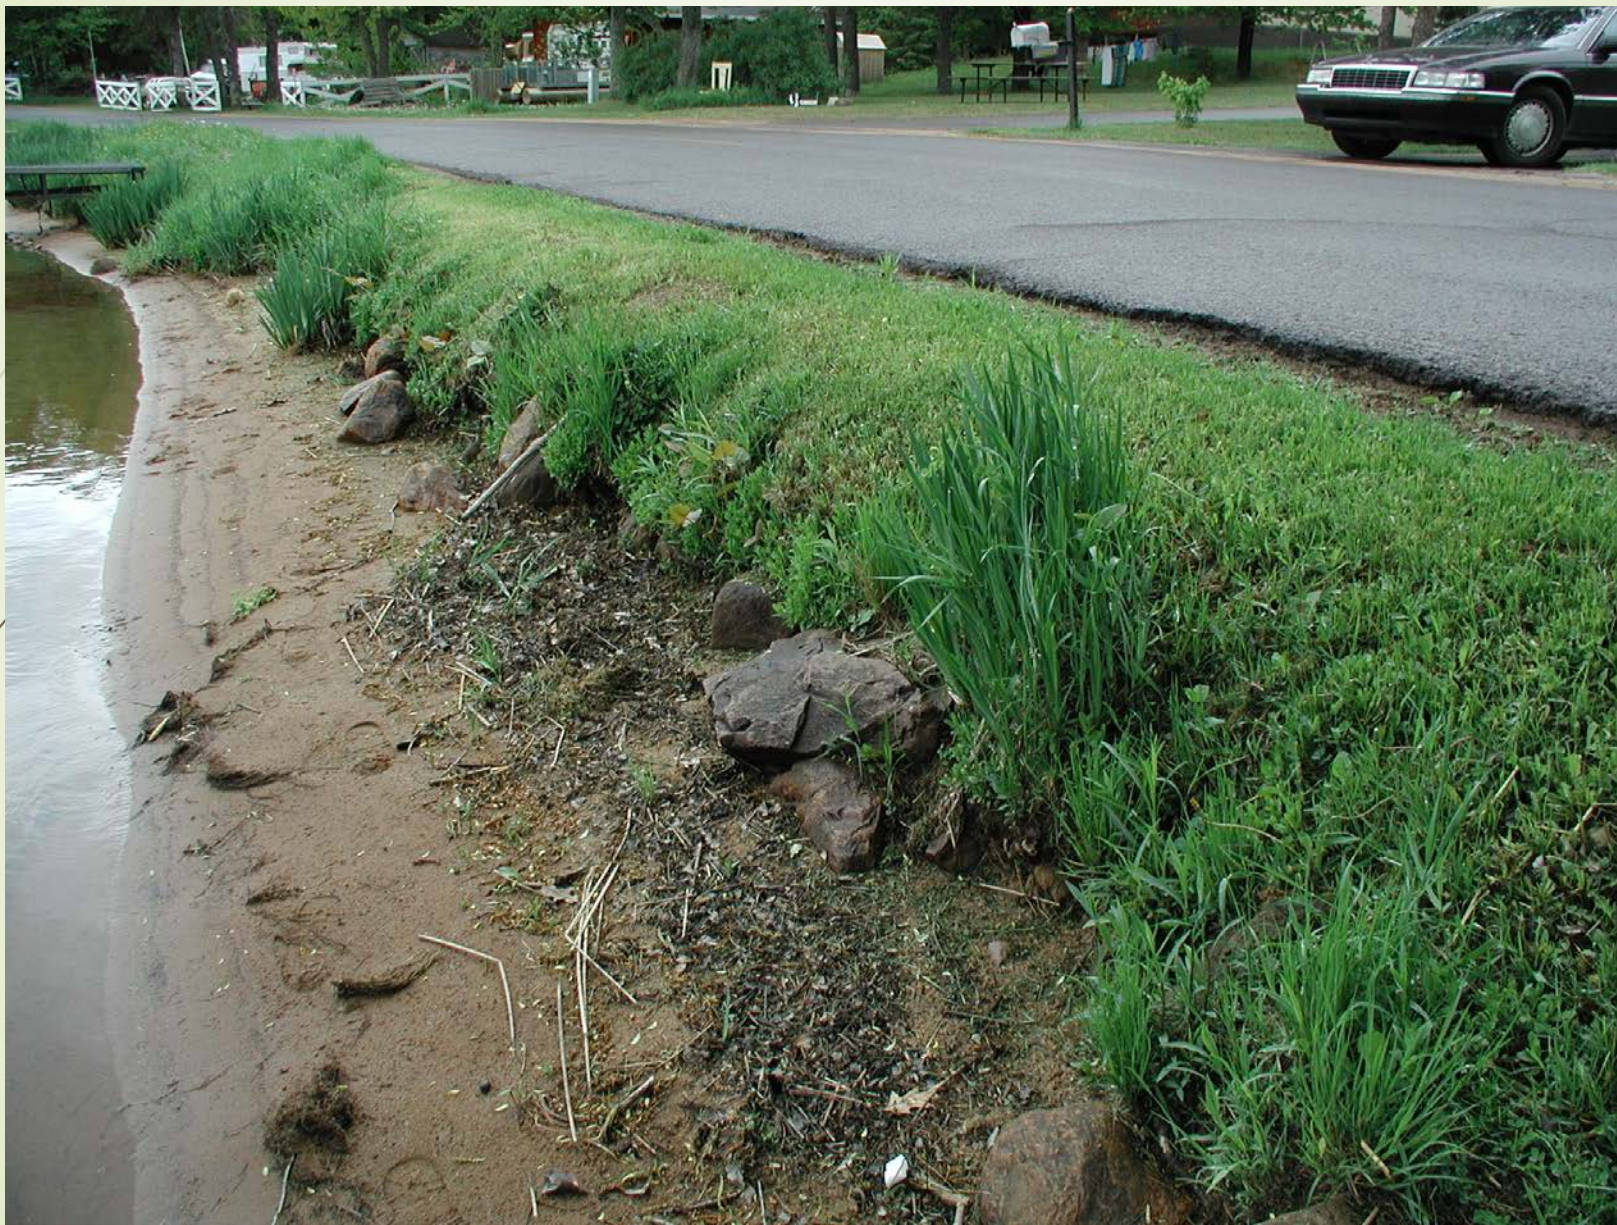
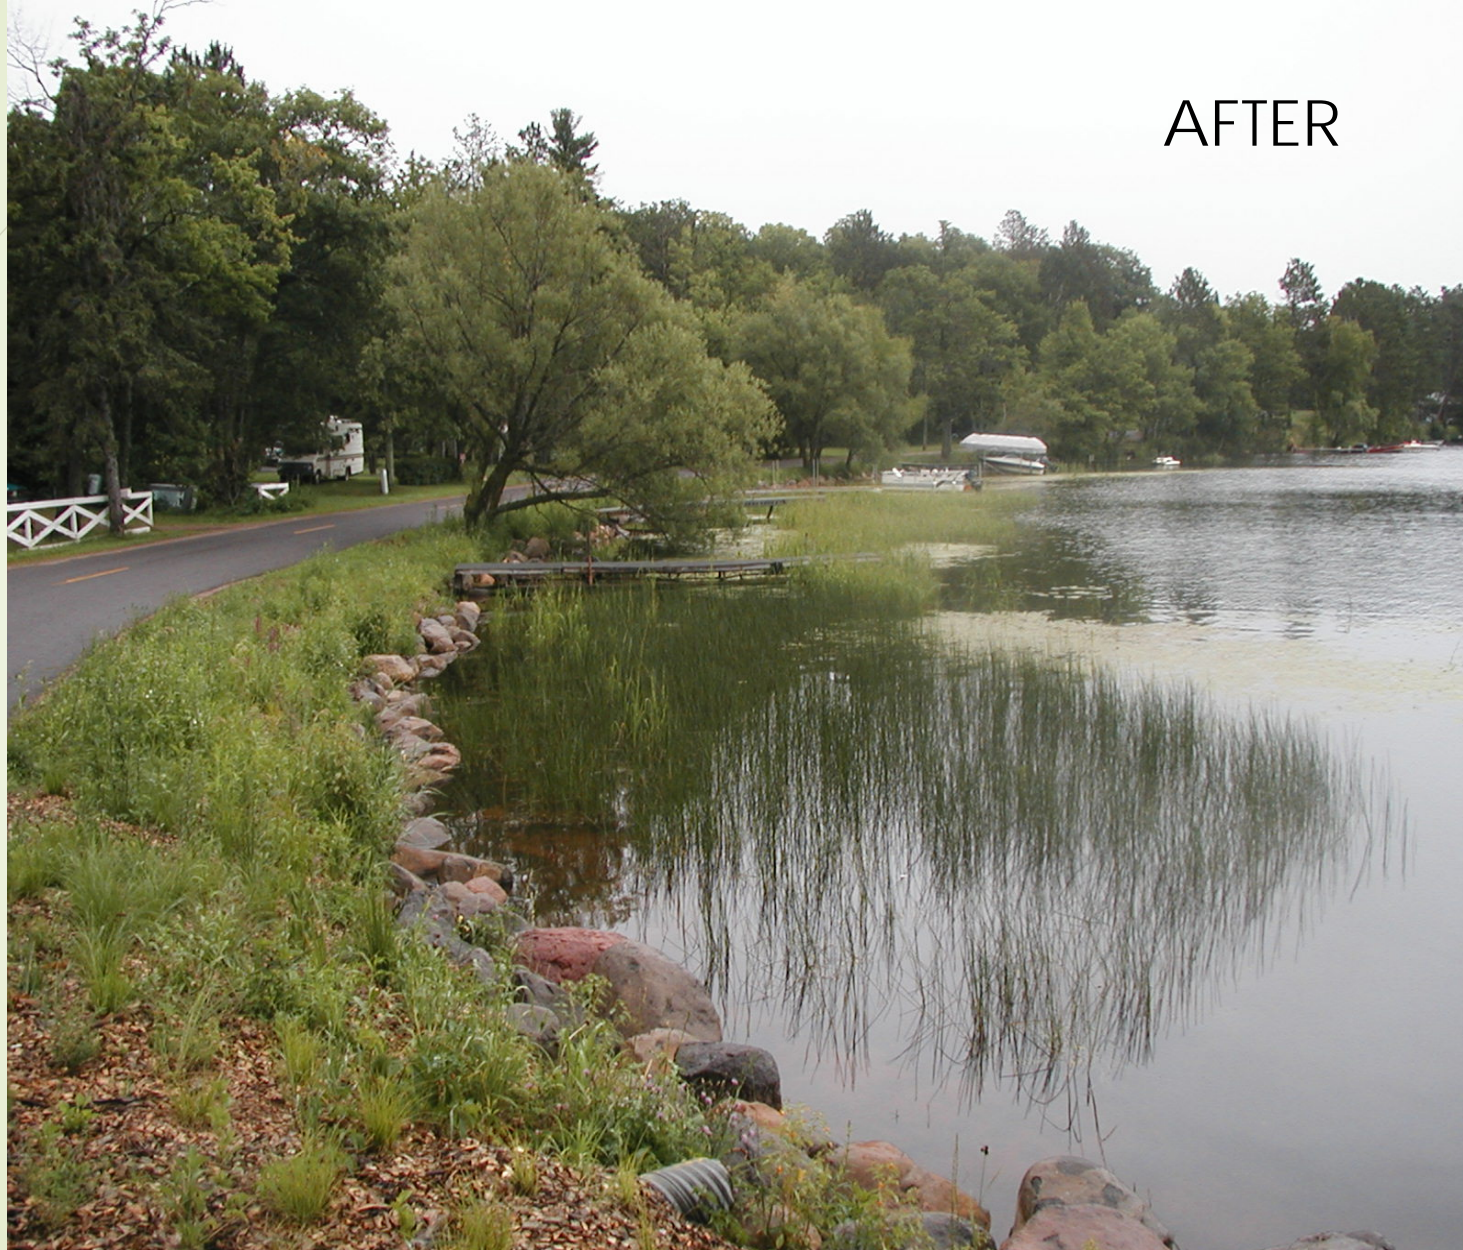
Road Limitation Riprap and Minimal Plantings

BEFORE

AFTER

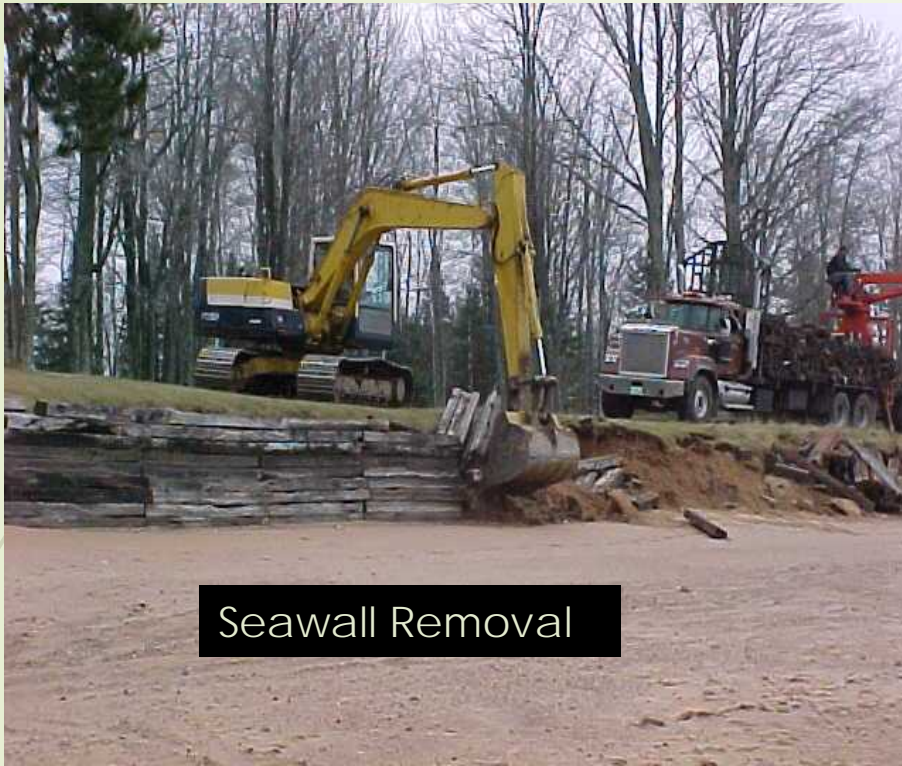
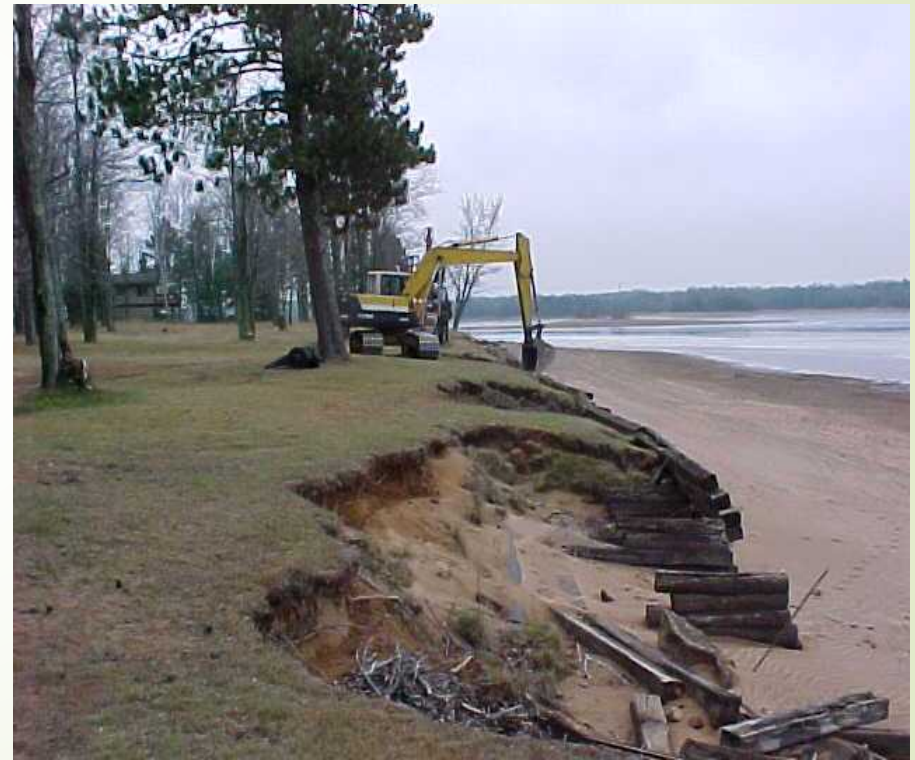
Seawall Removal Replace with Riprap

Seawall Removal

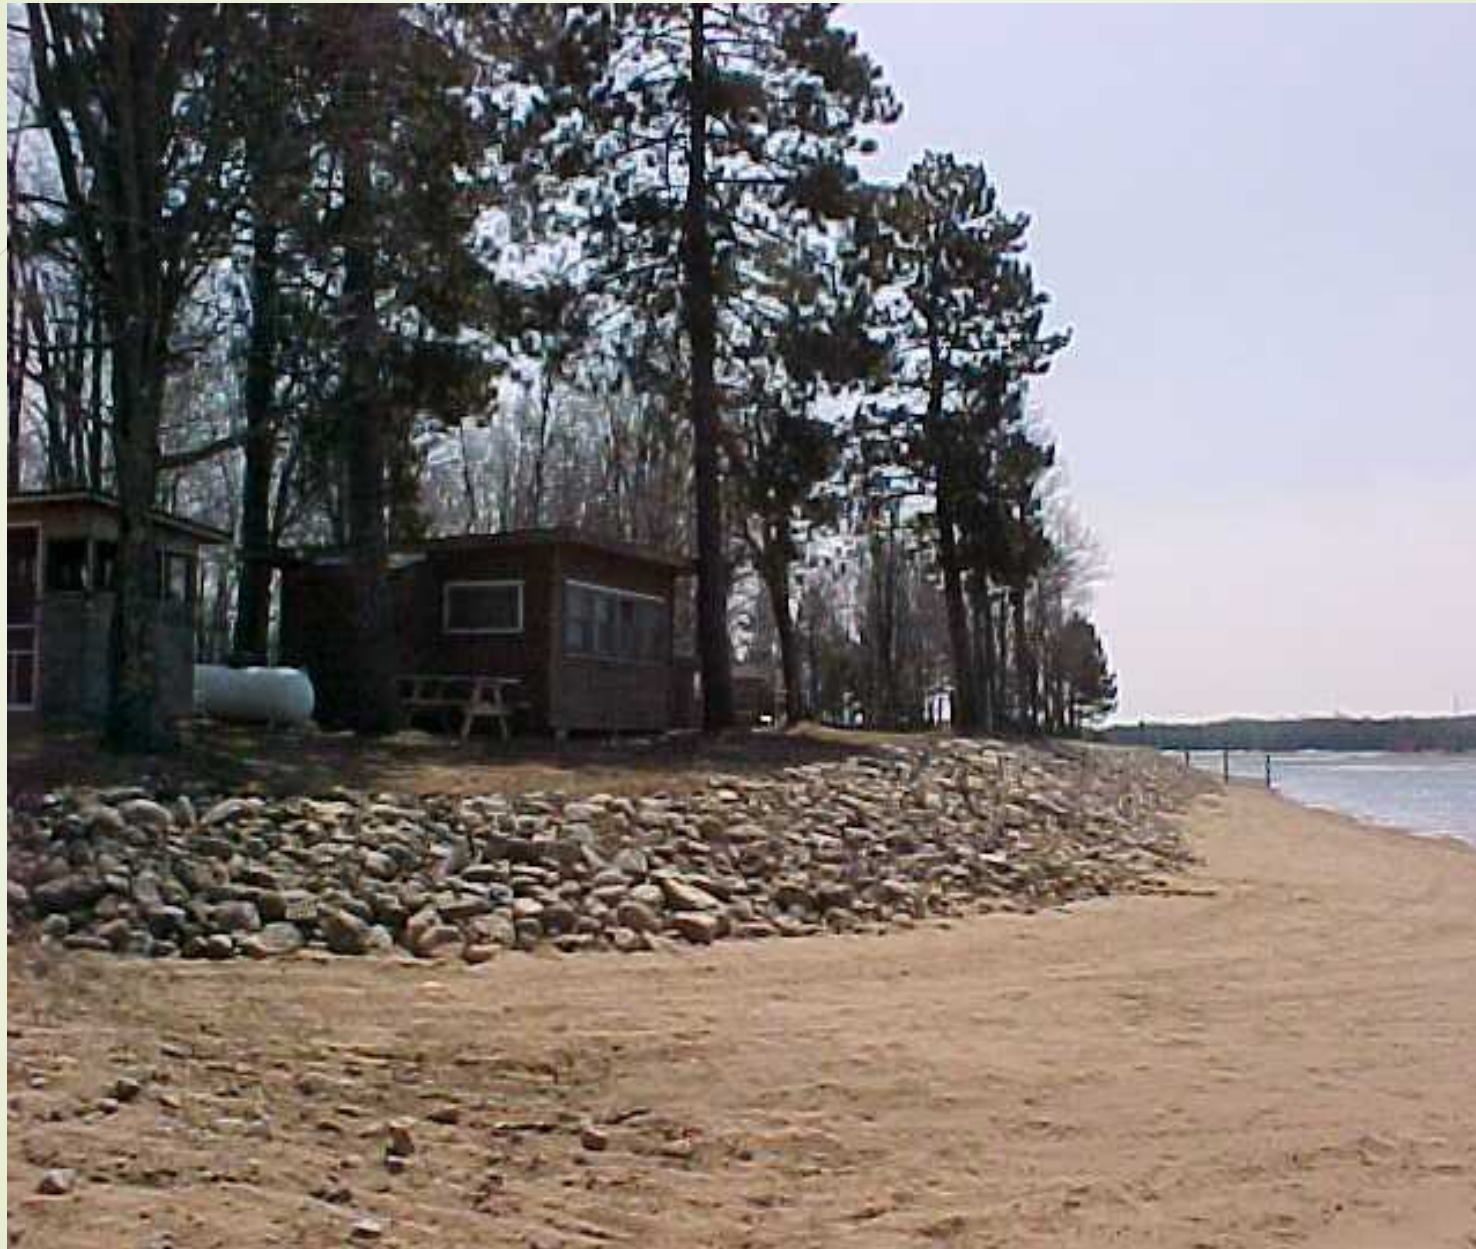
Rock Riprap
AFTER

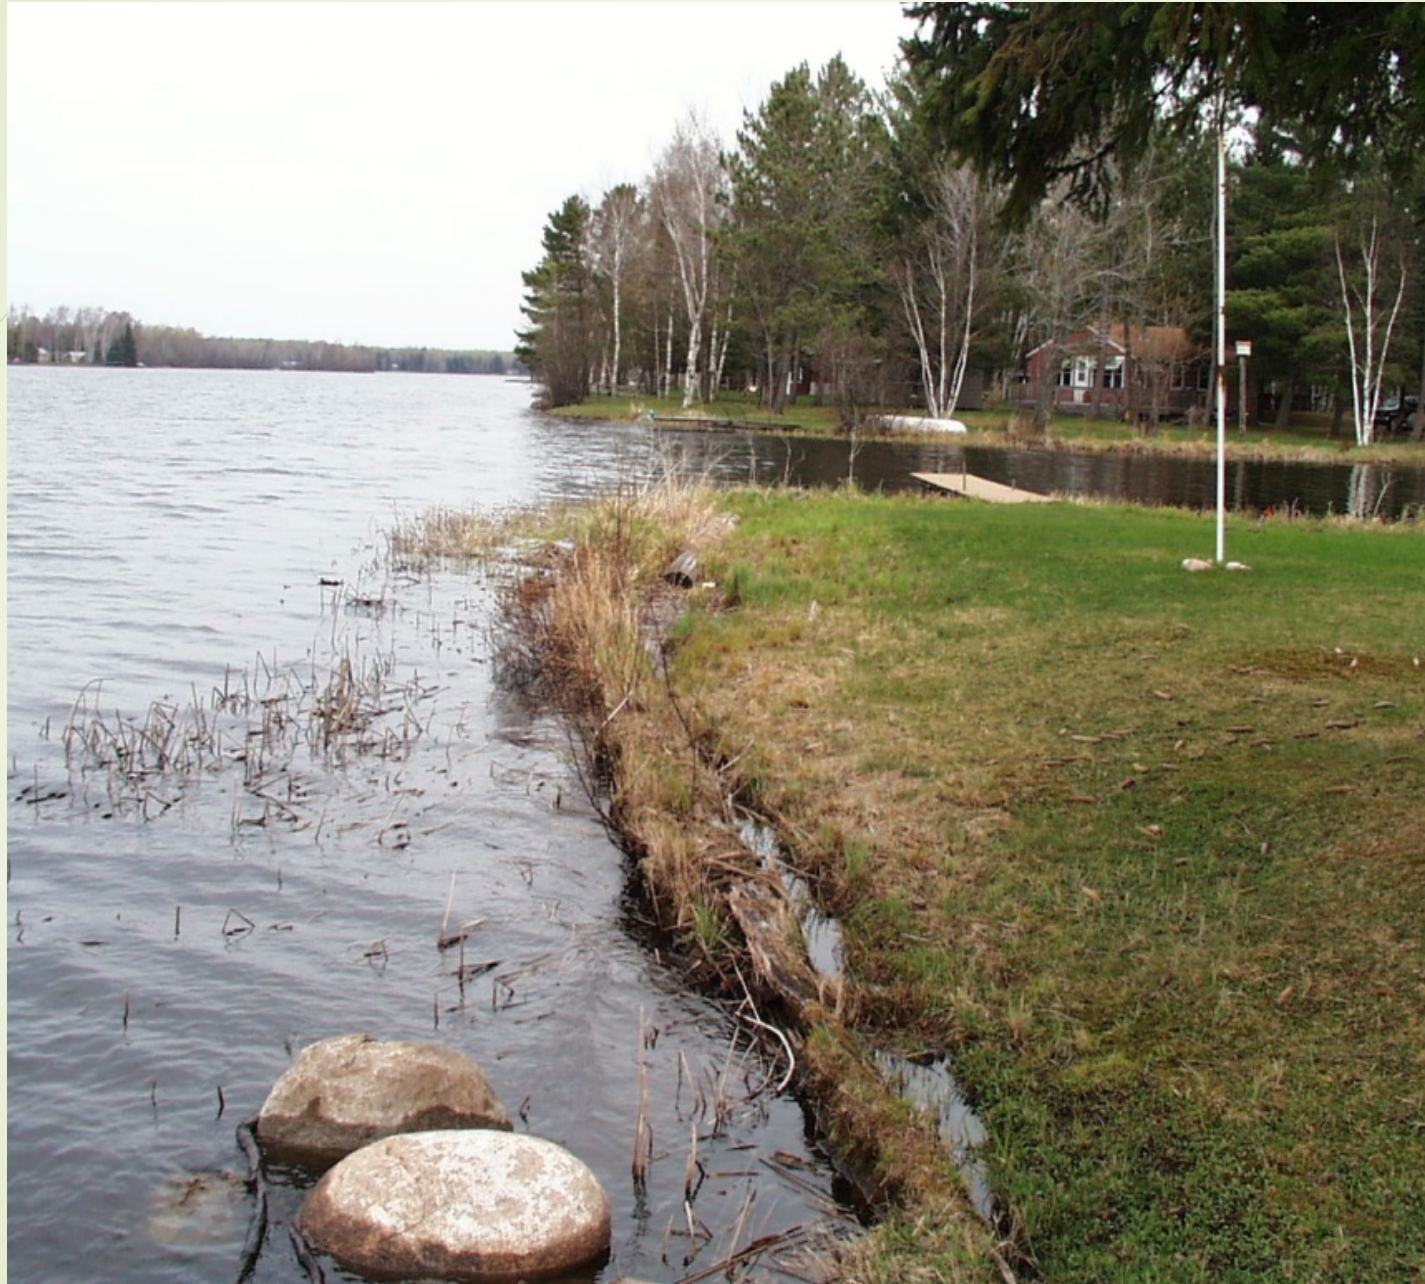
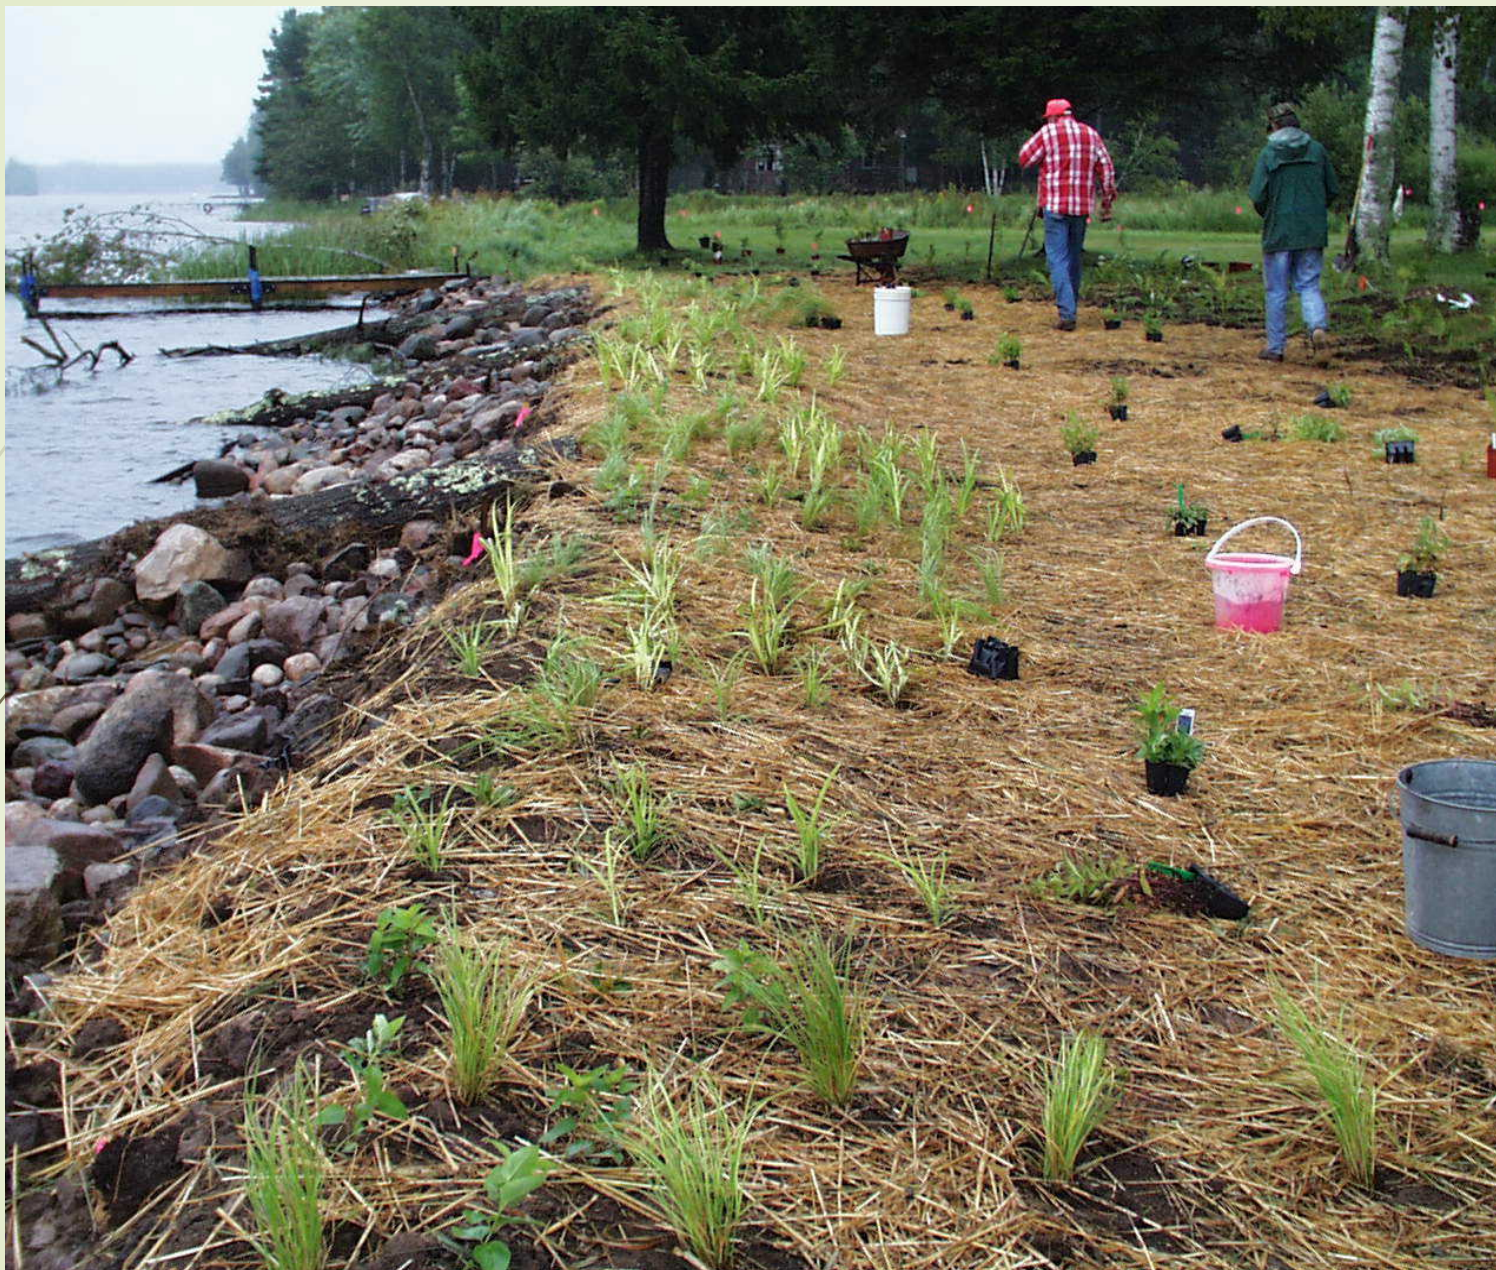
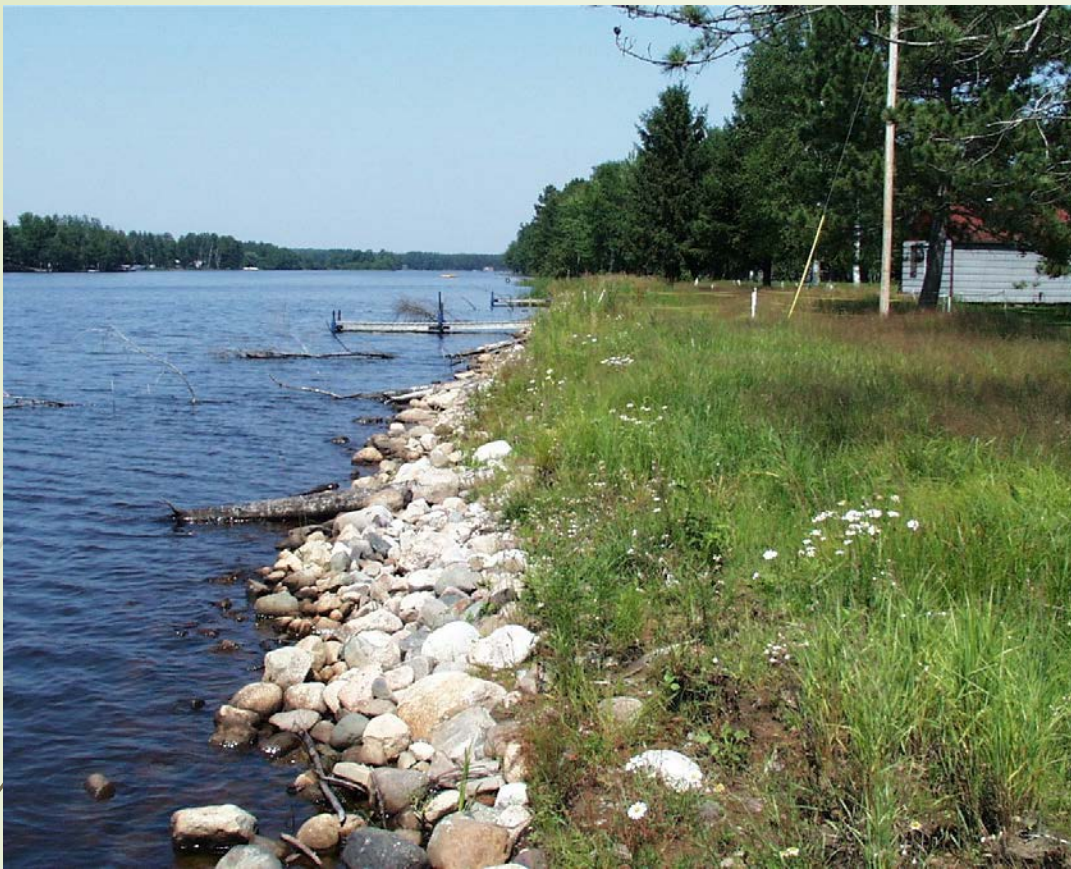
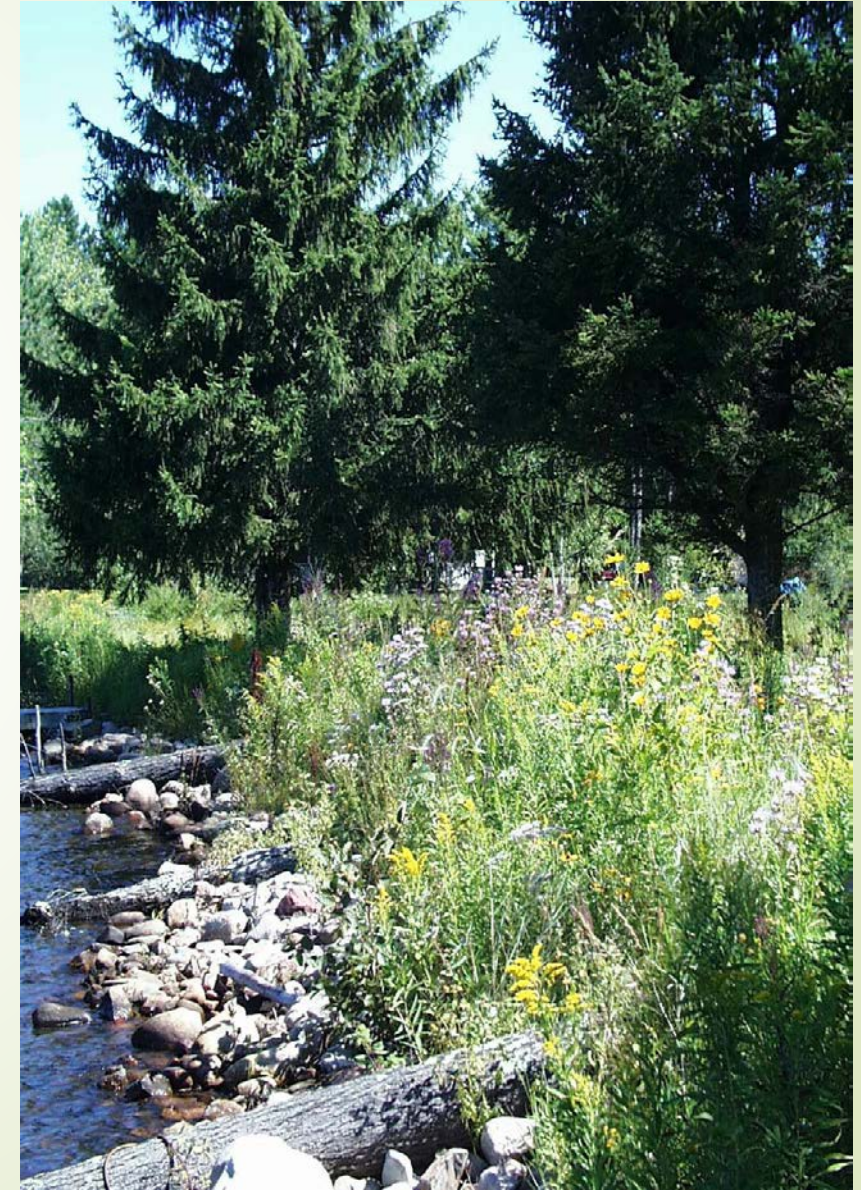
Riprap and Tree Drops with Plantings

BEFORE

DURING

AFTER
