Case Studies - Photos

Lakeshore Protection Options

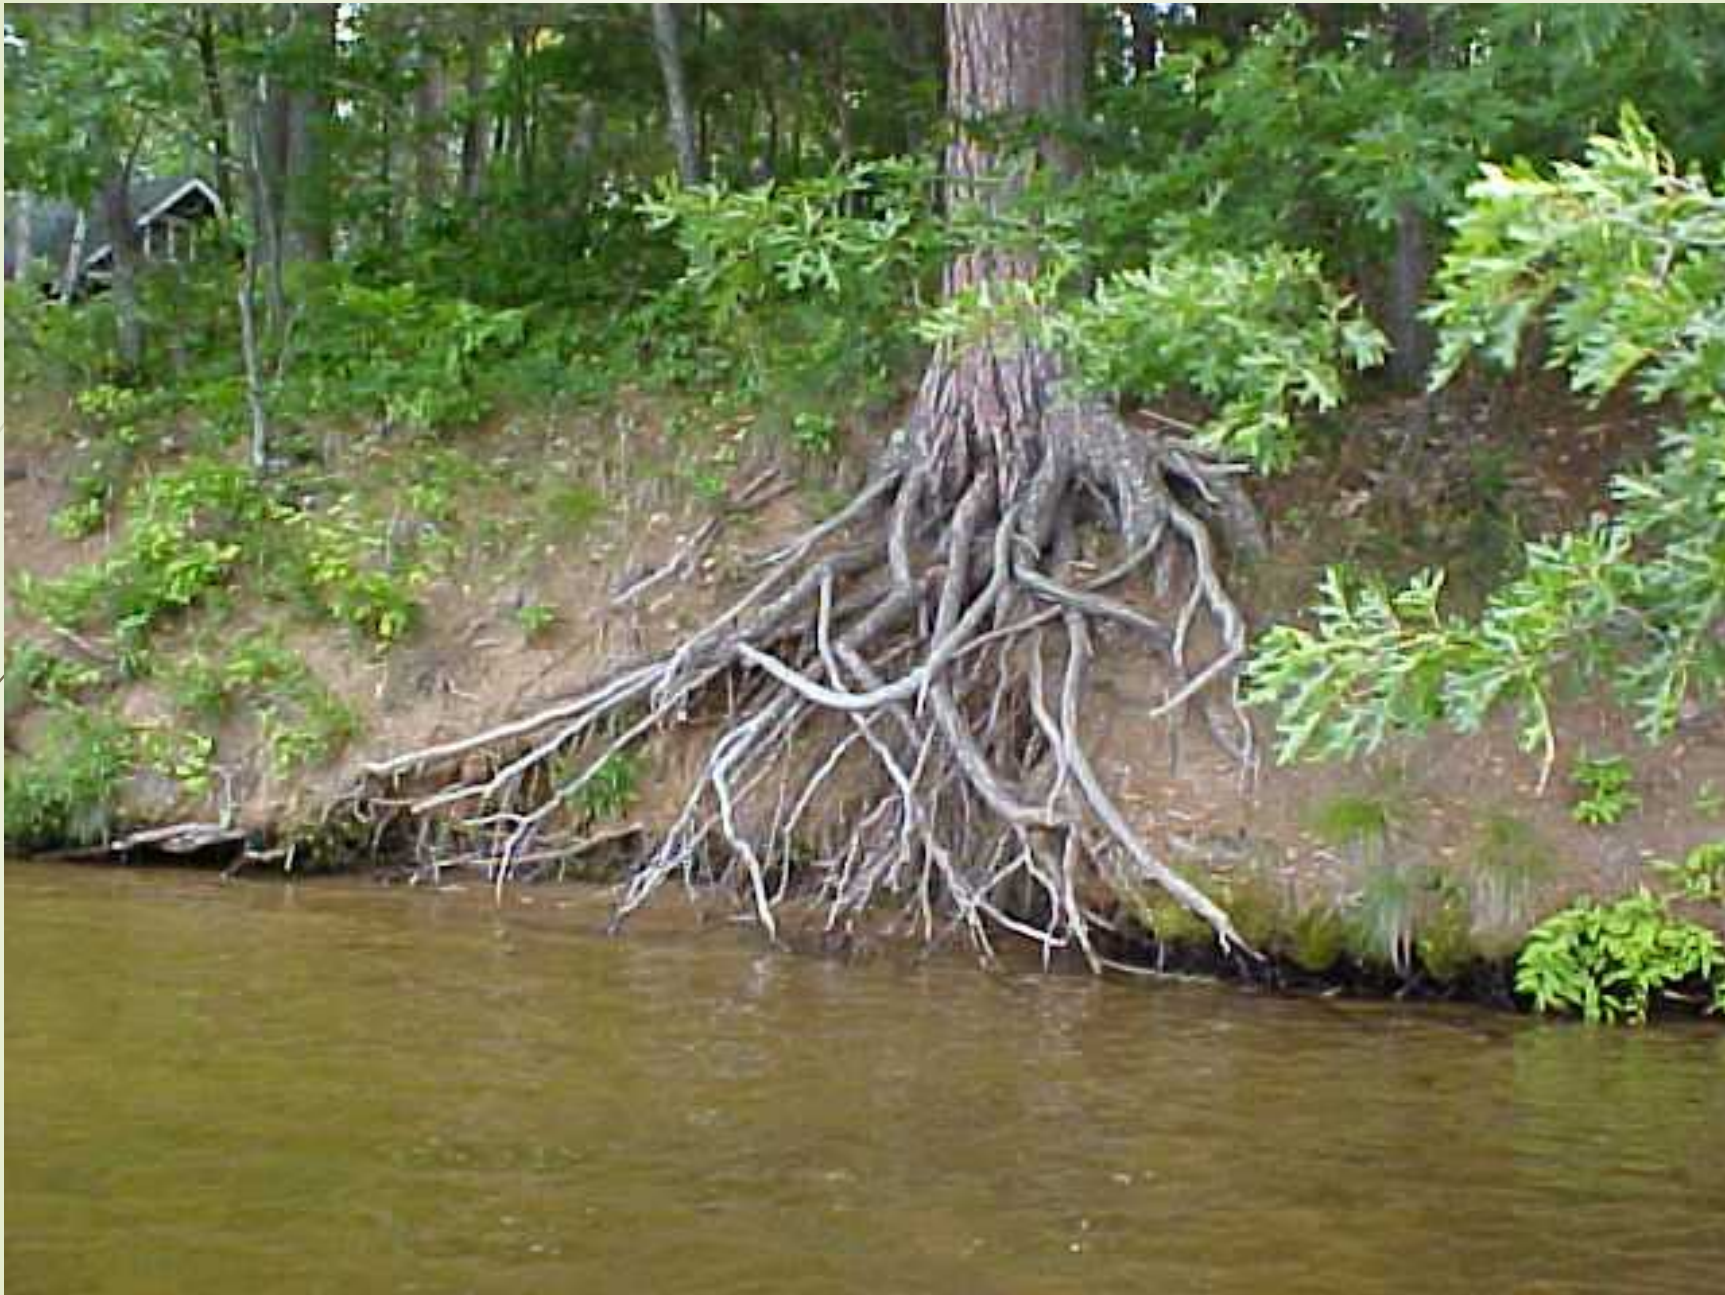
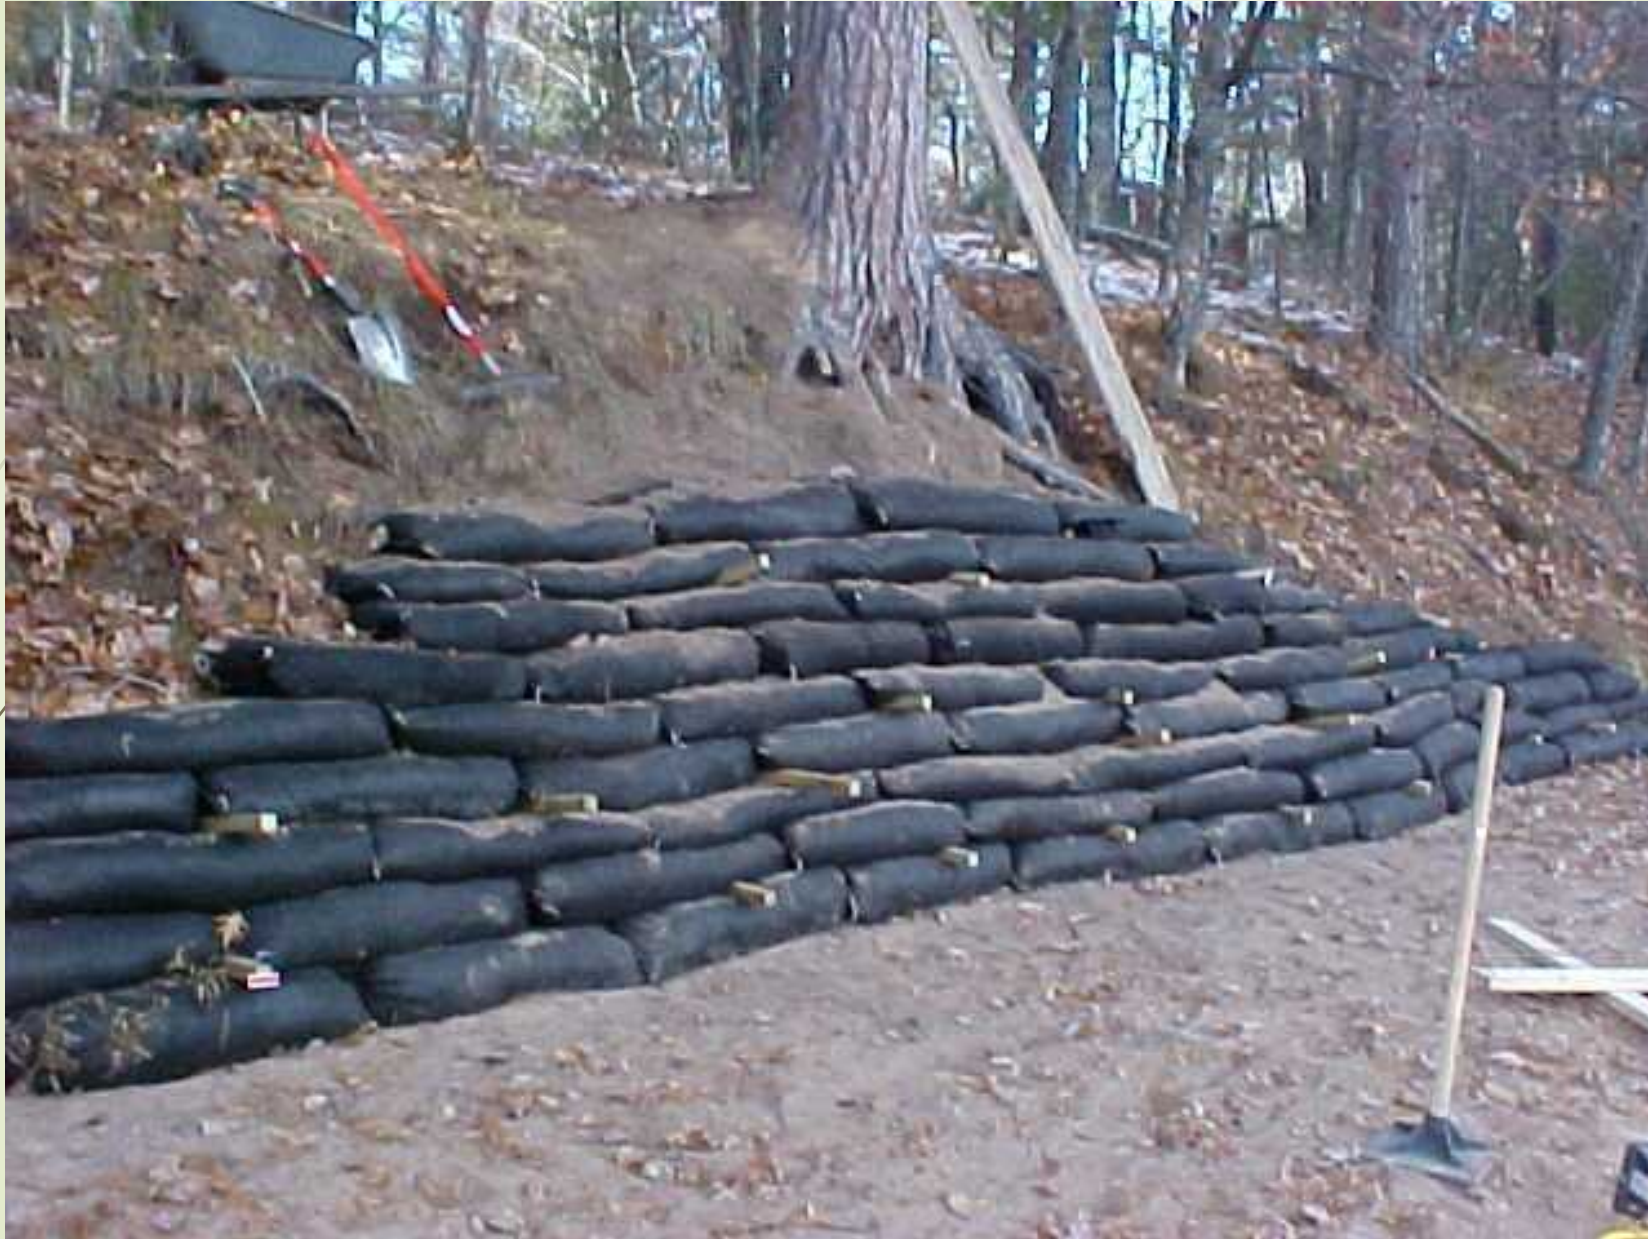
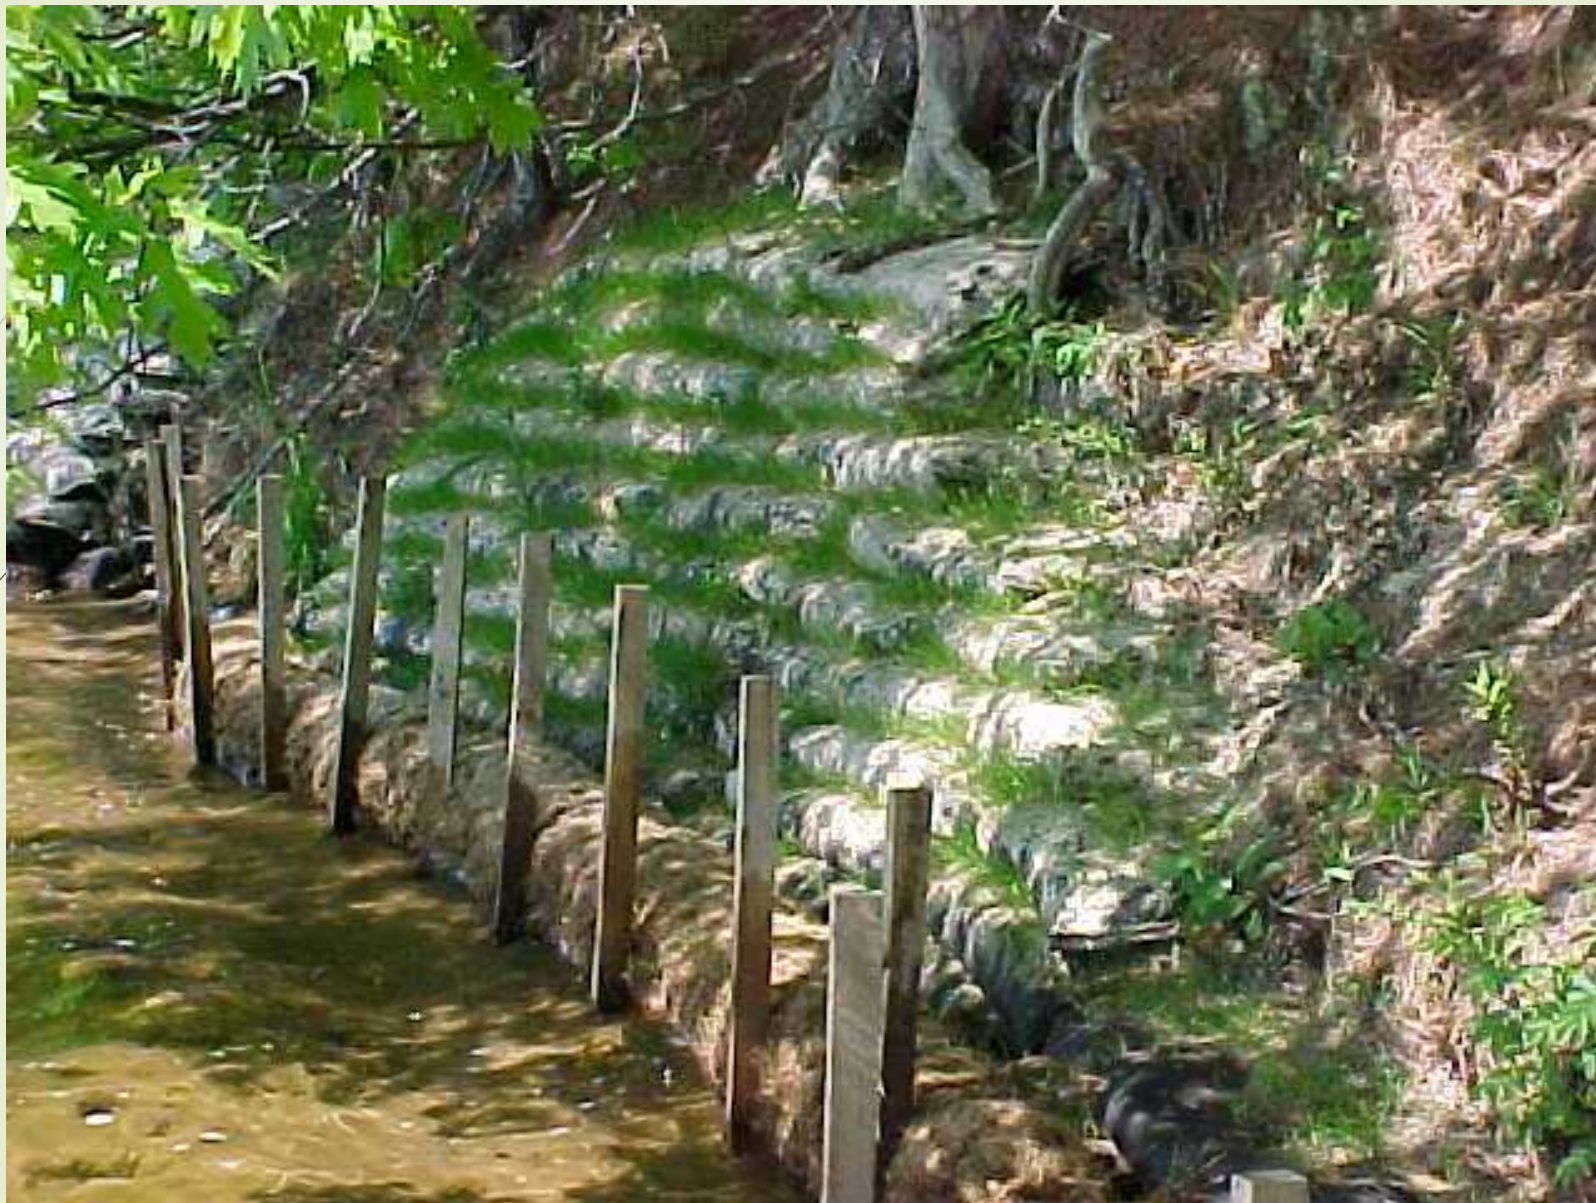
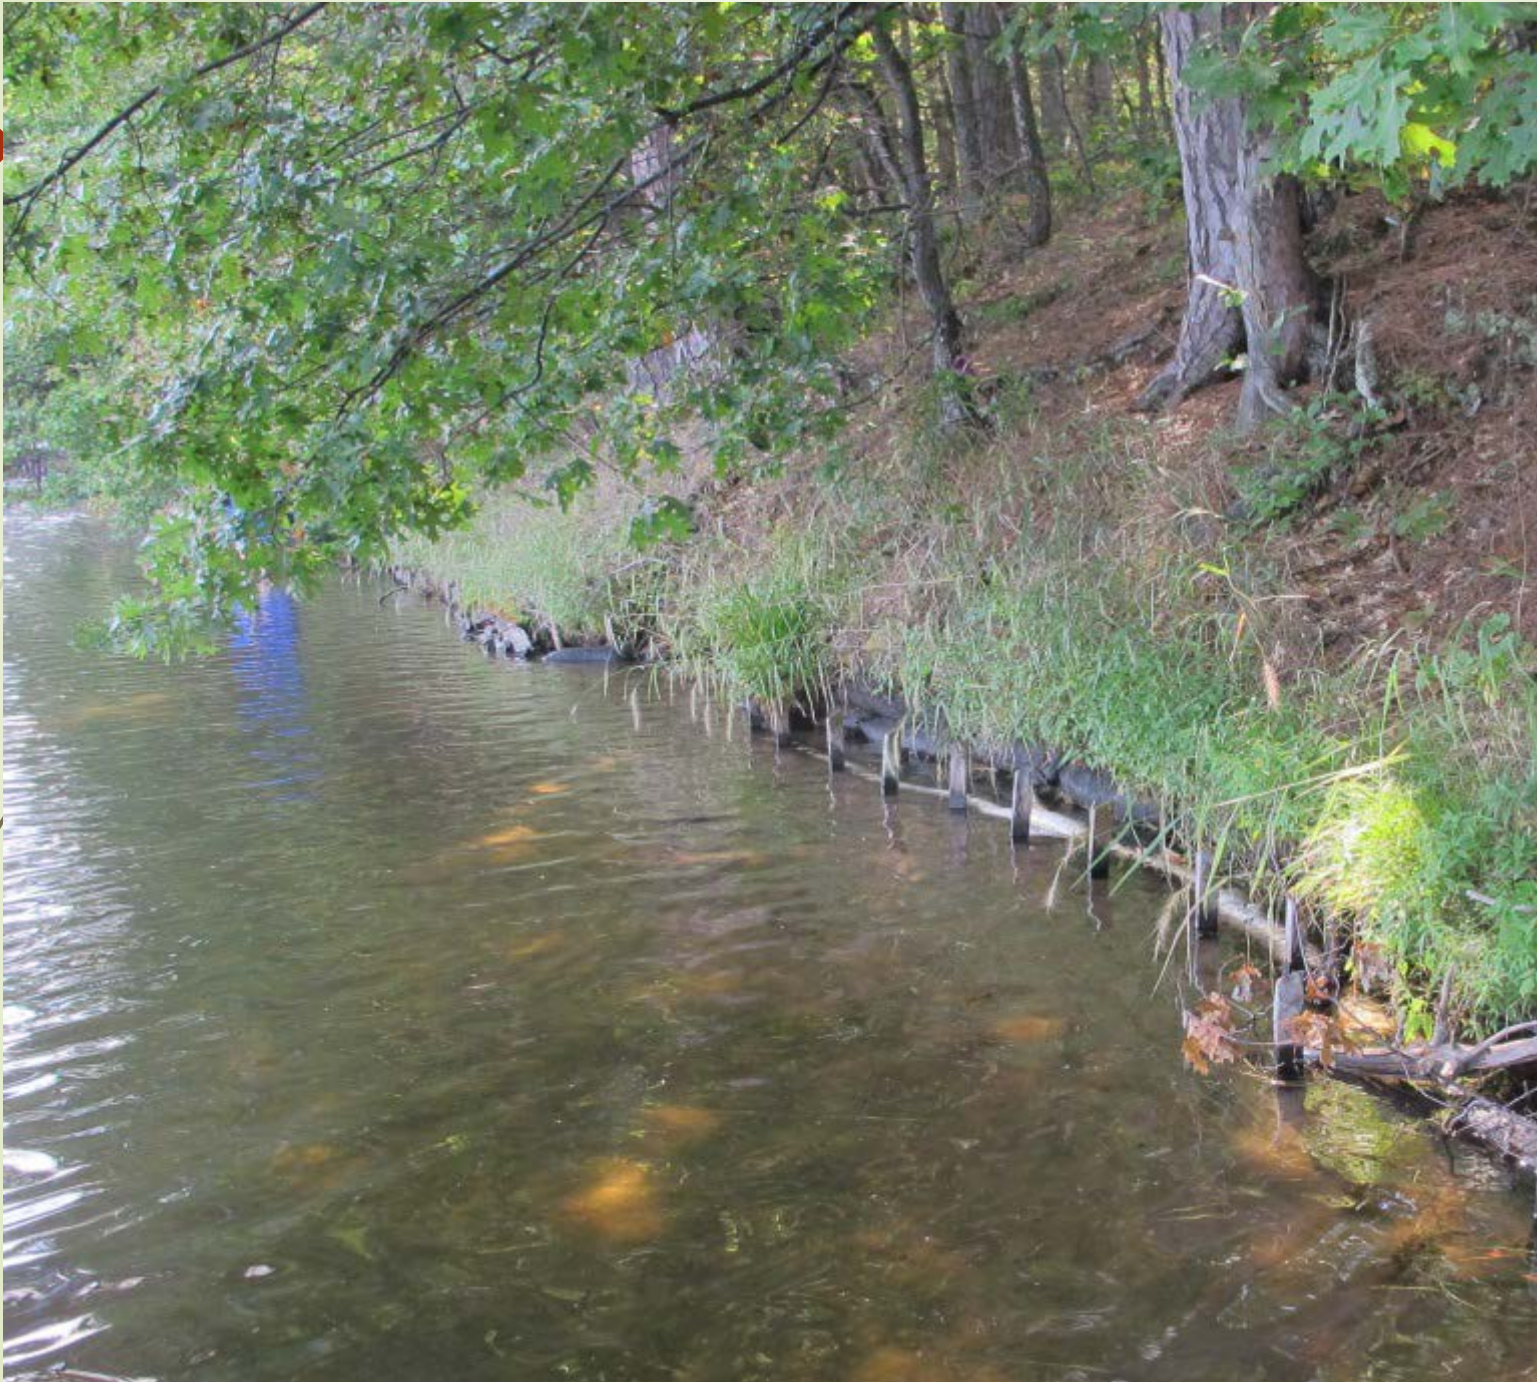
Geotextile Bags to Protect Tree and Re-establish Bank Soils

BEFORE

DURING

AFTER

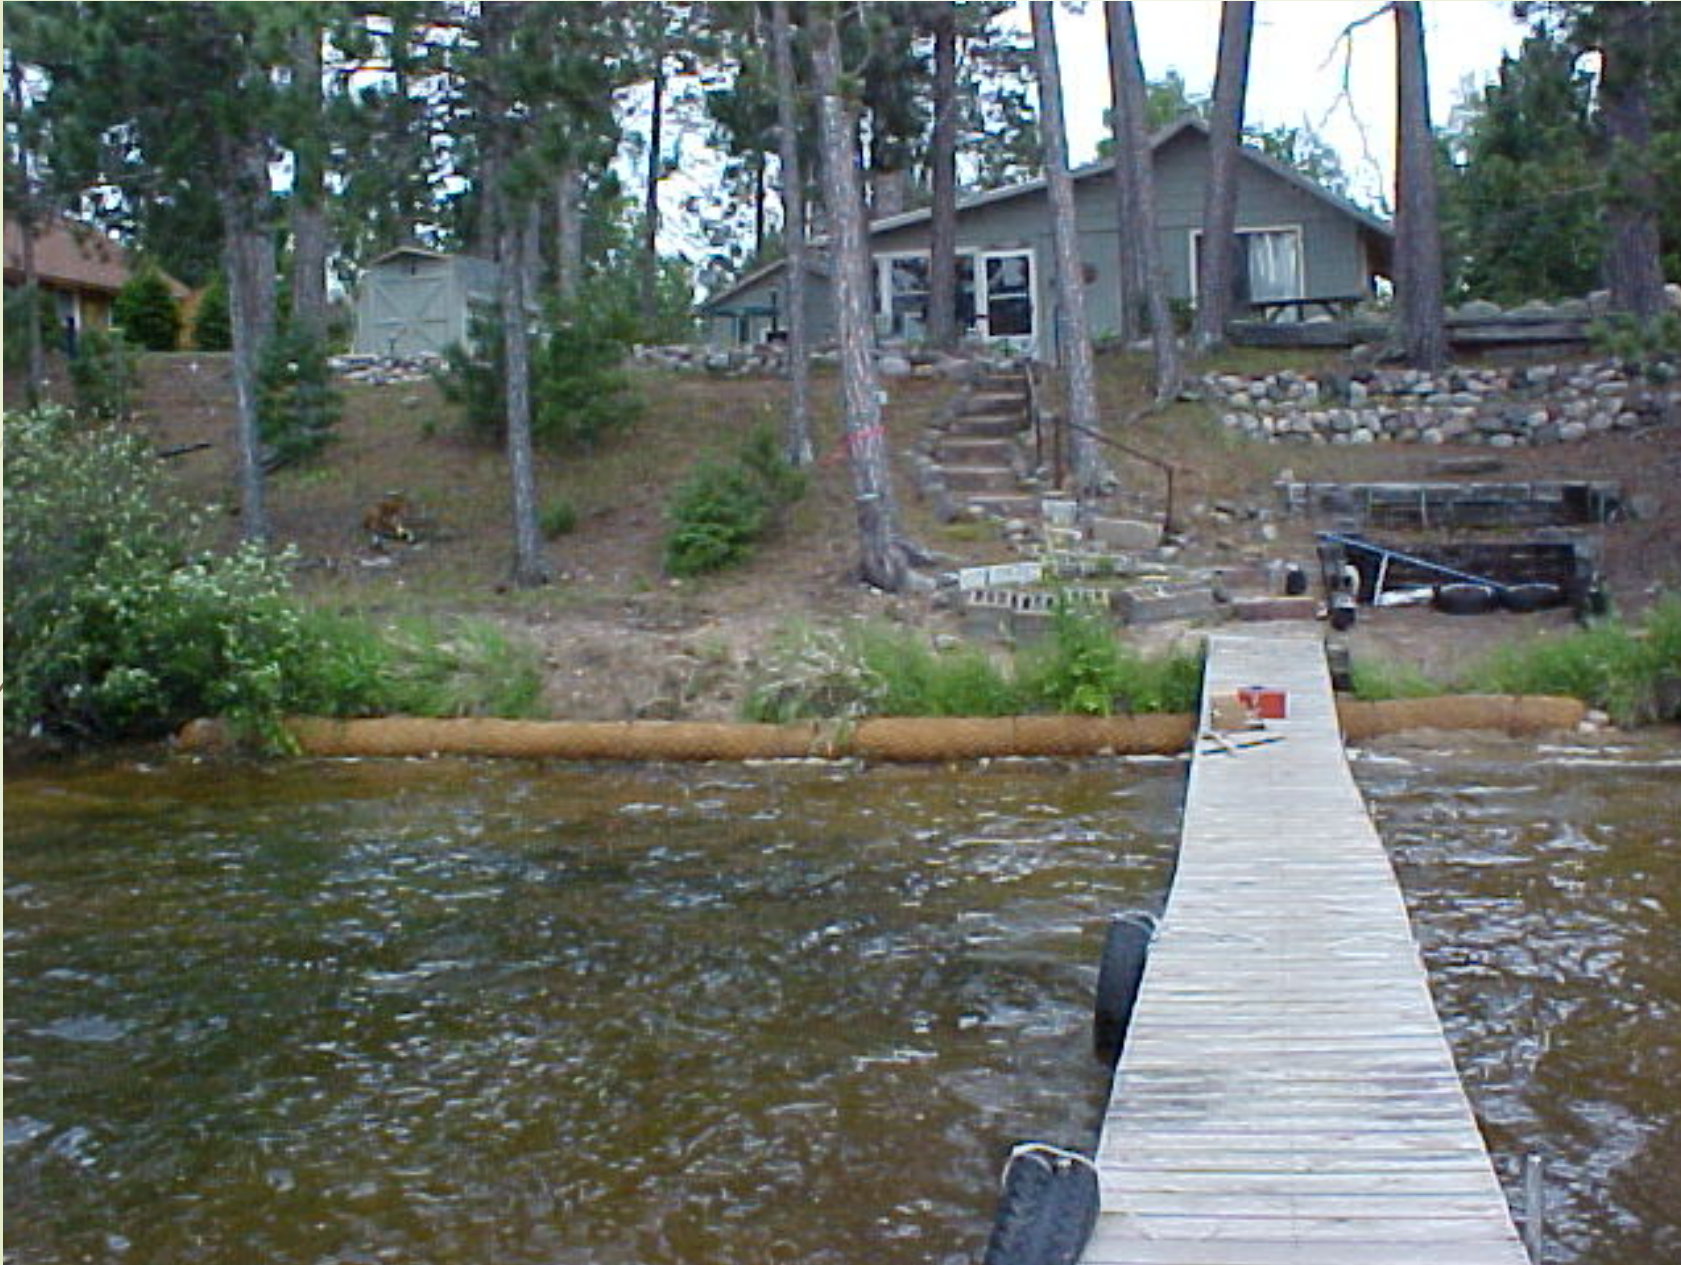
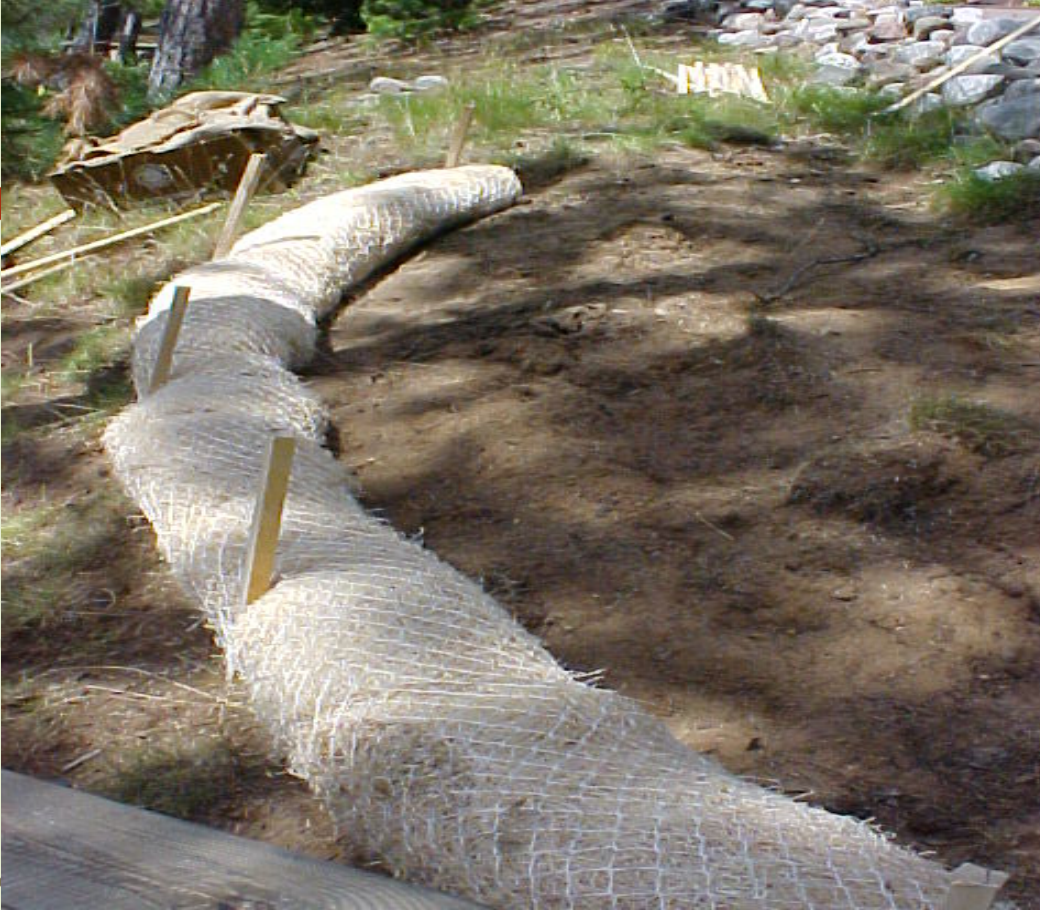
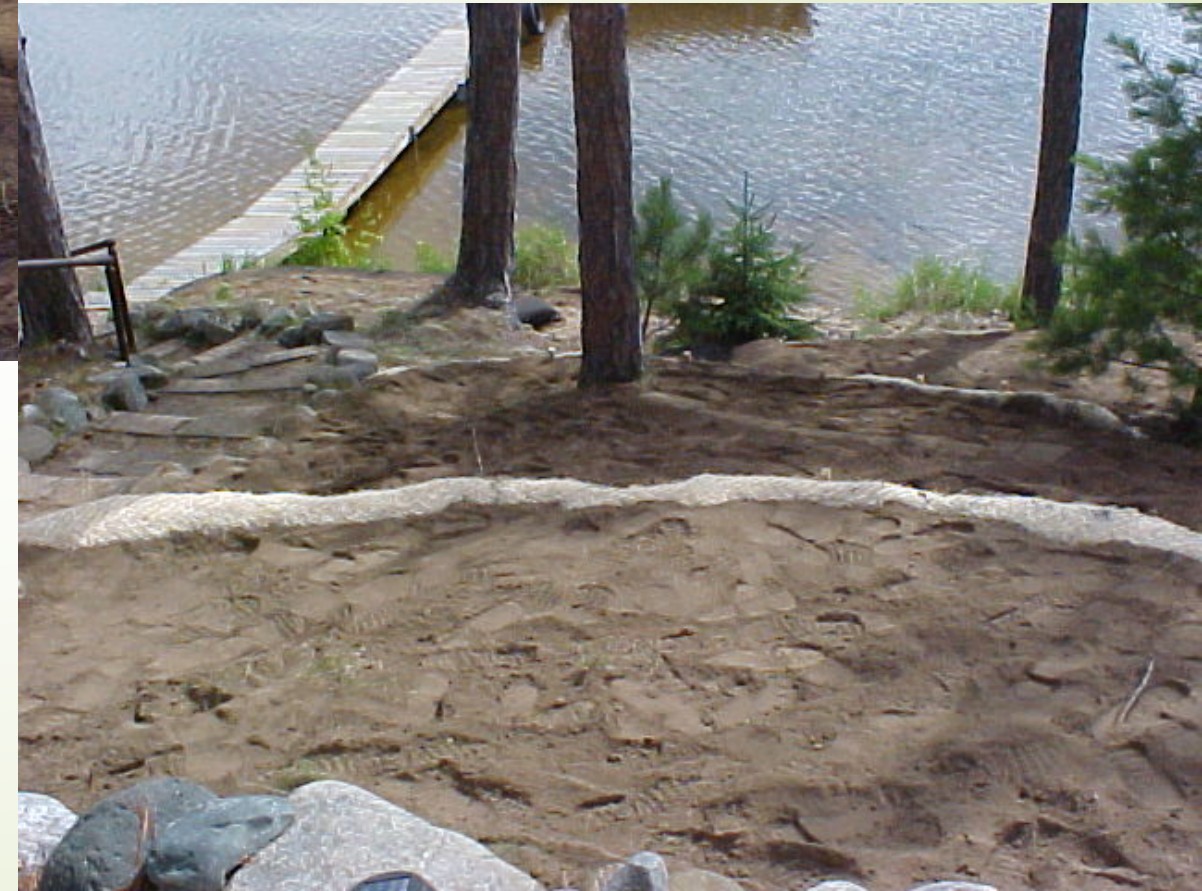
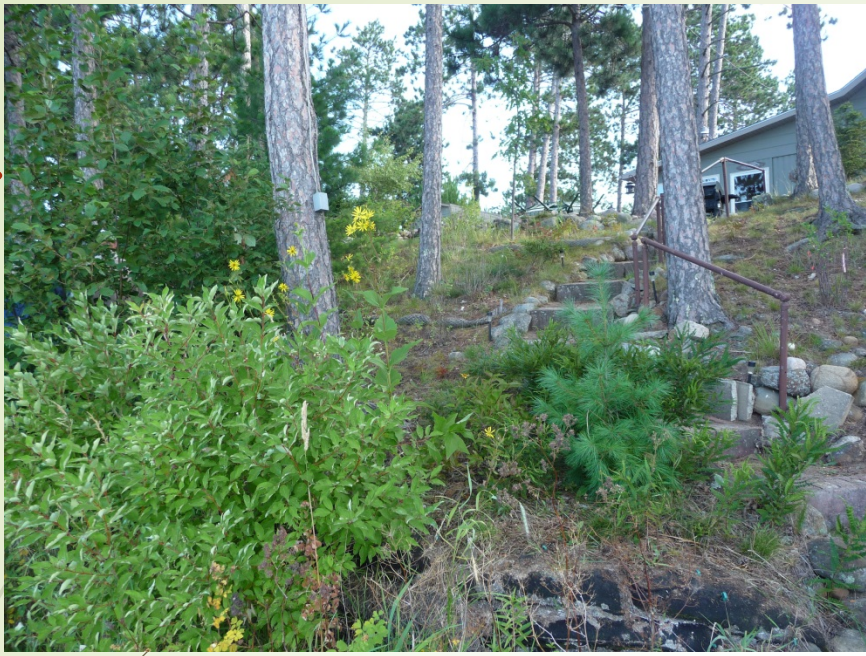
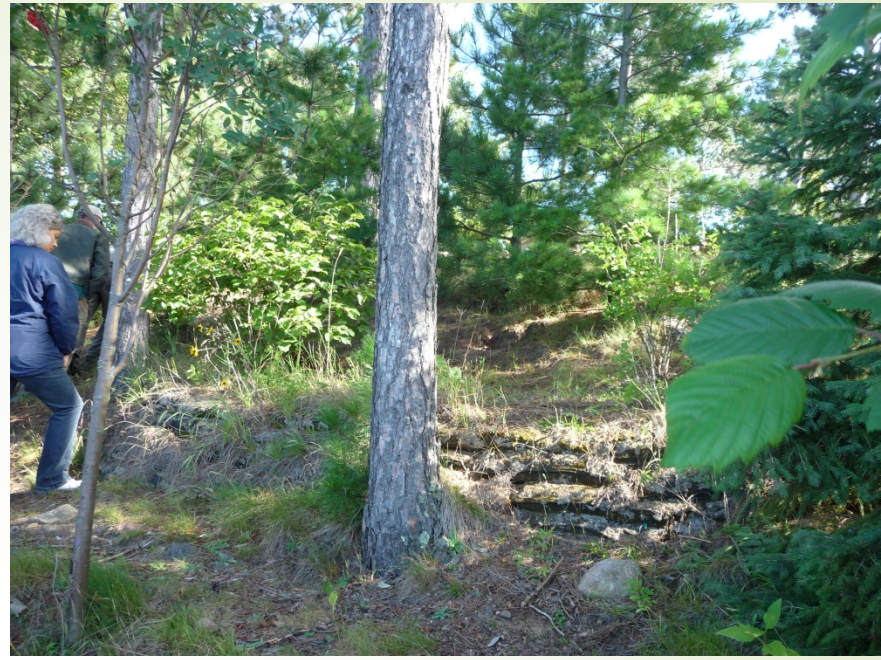
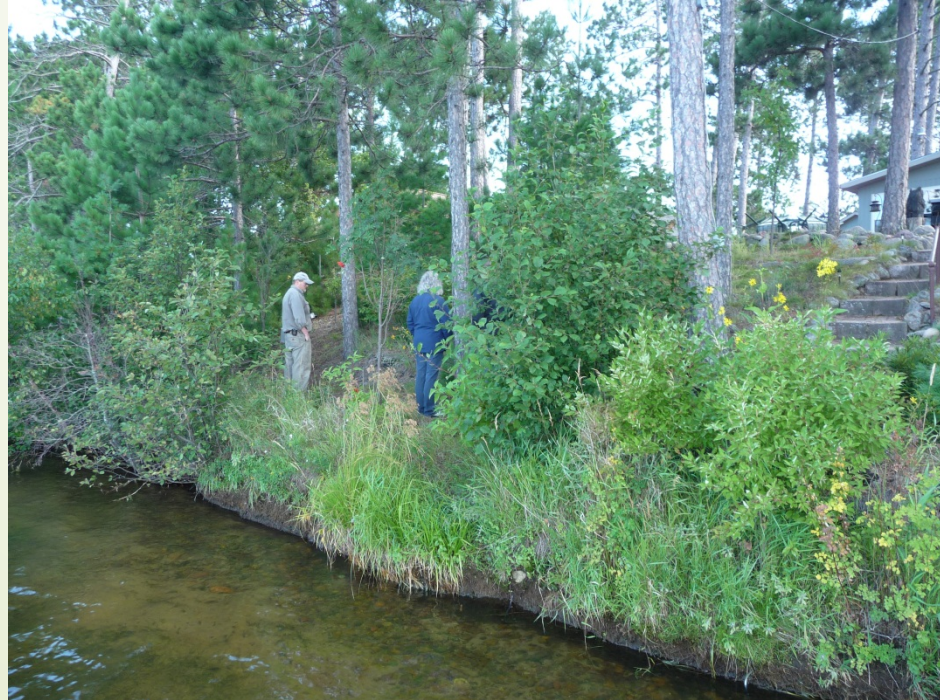
Biolog at Toe and Sediment Logs on
Slope to slow water flows from patio

BEFORE

DURING

AFTER

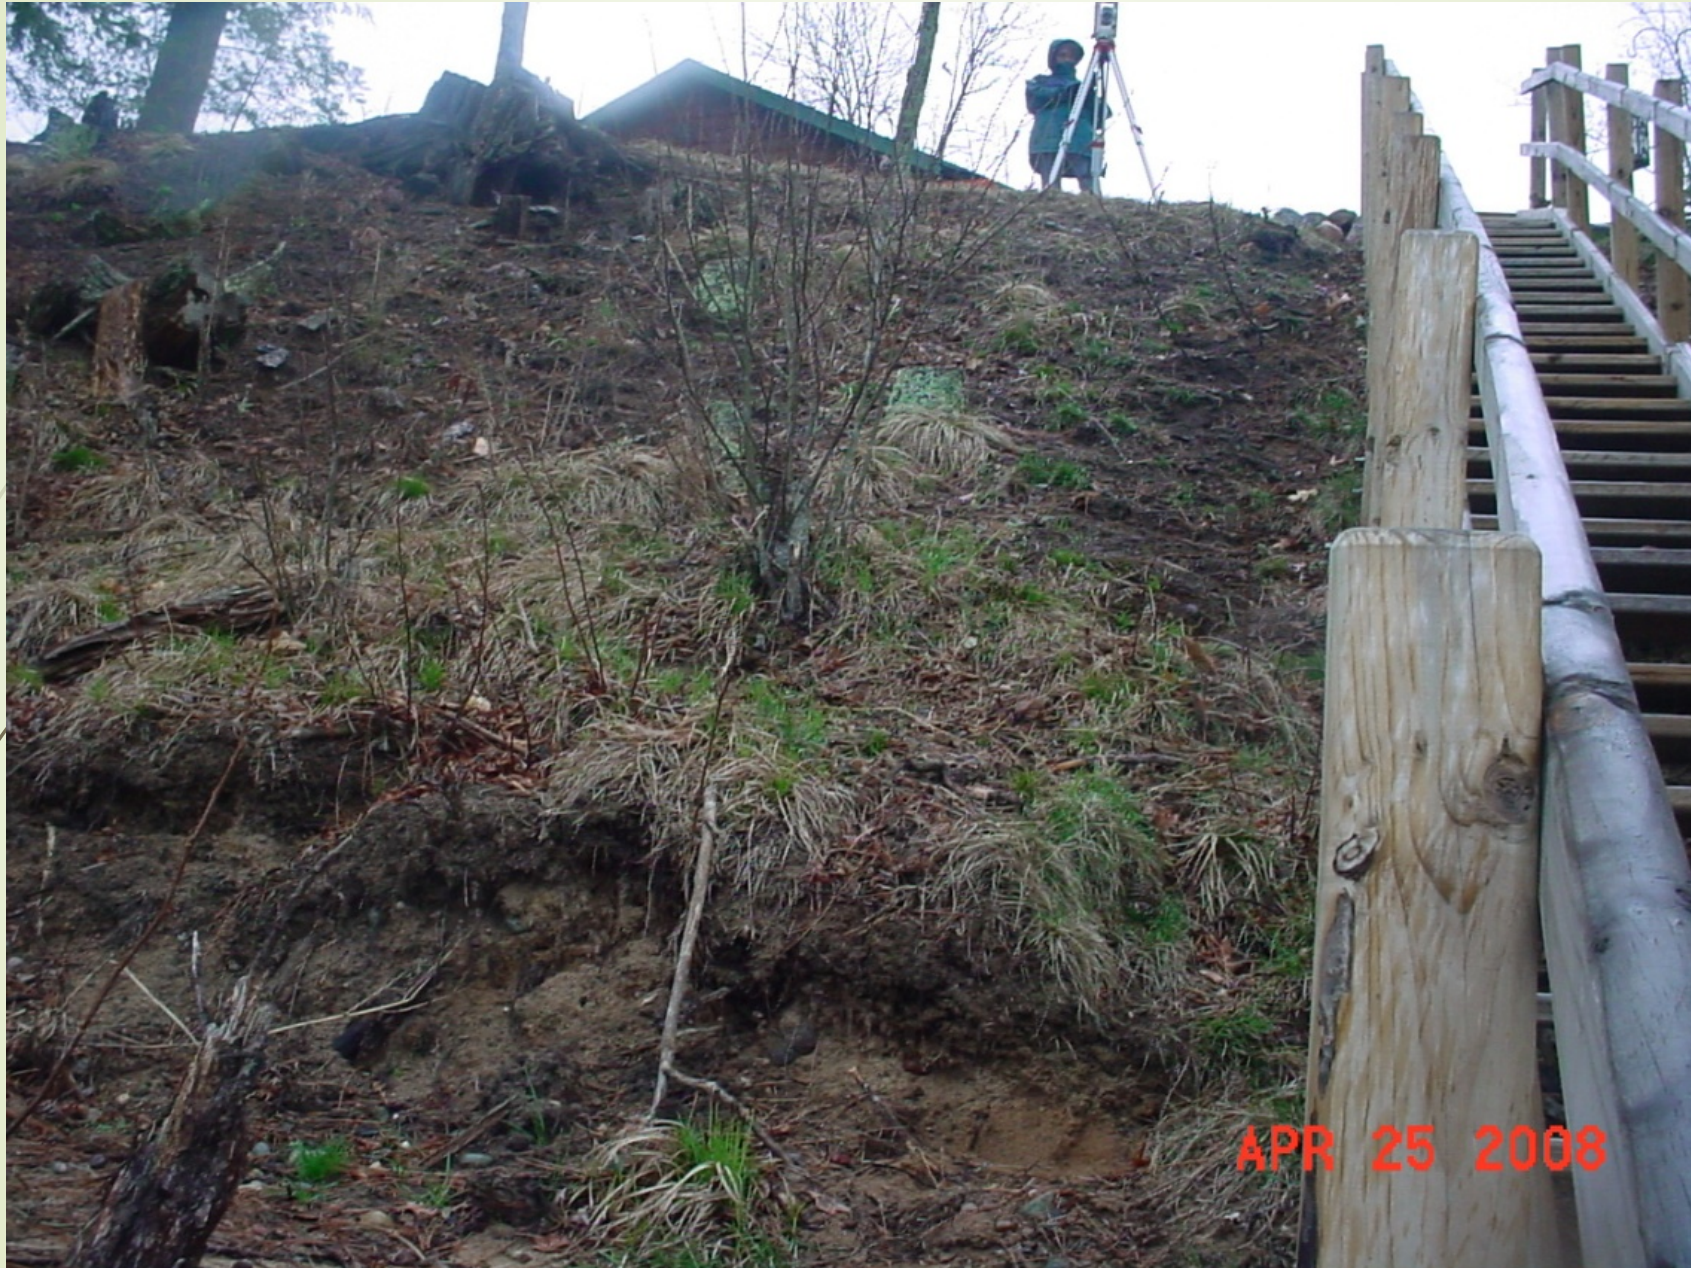
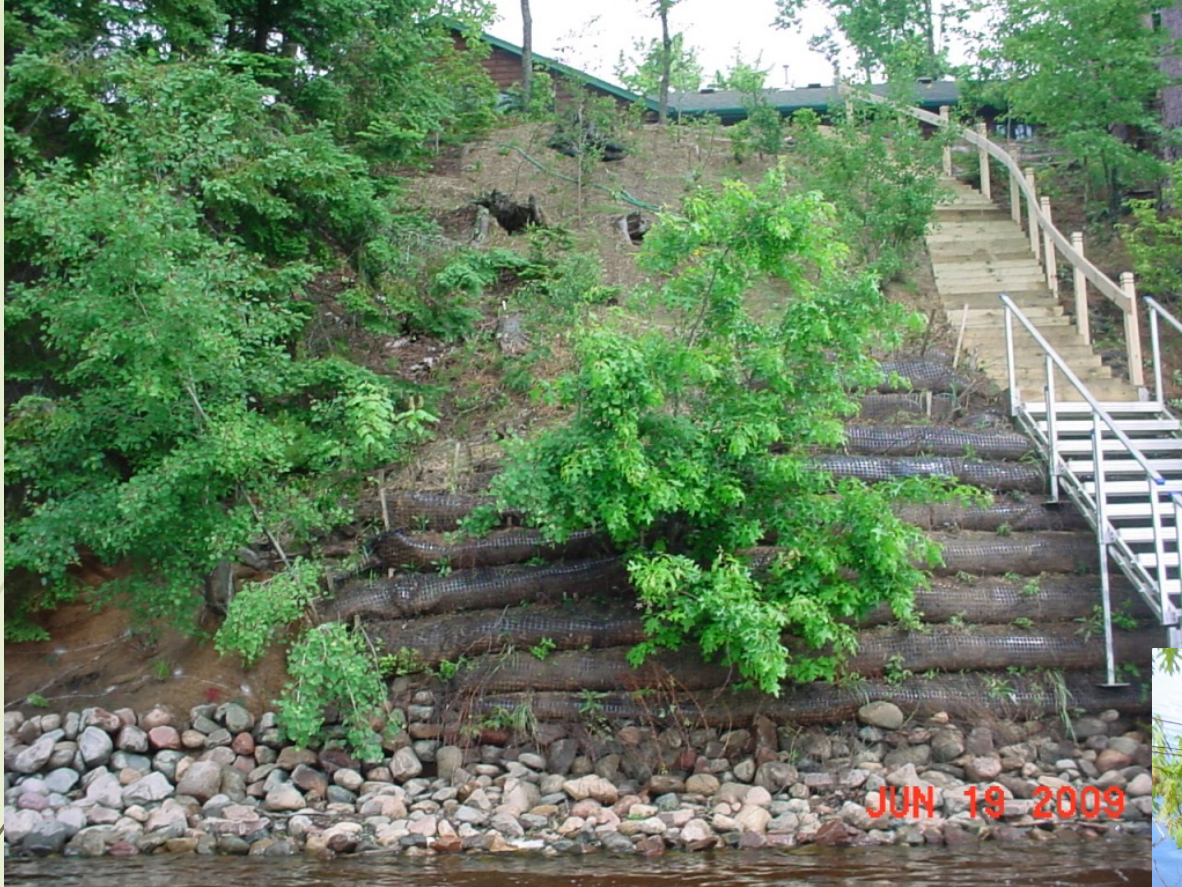
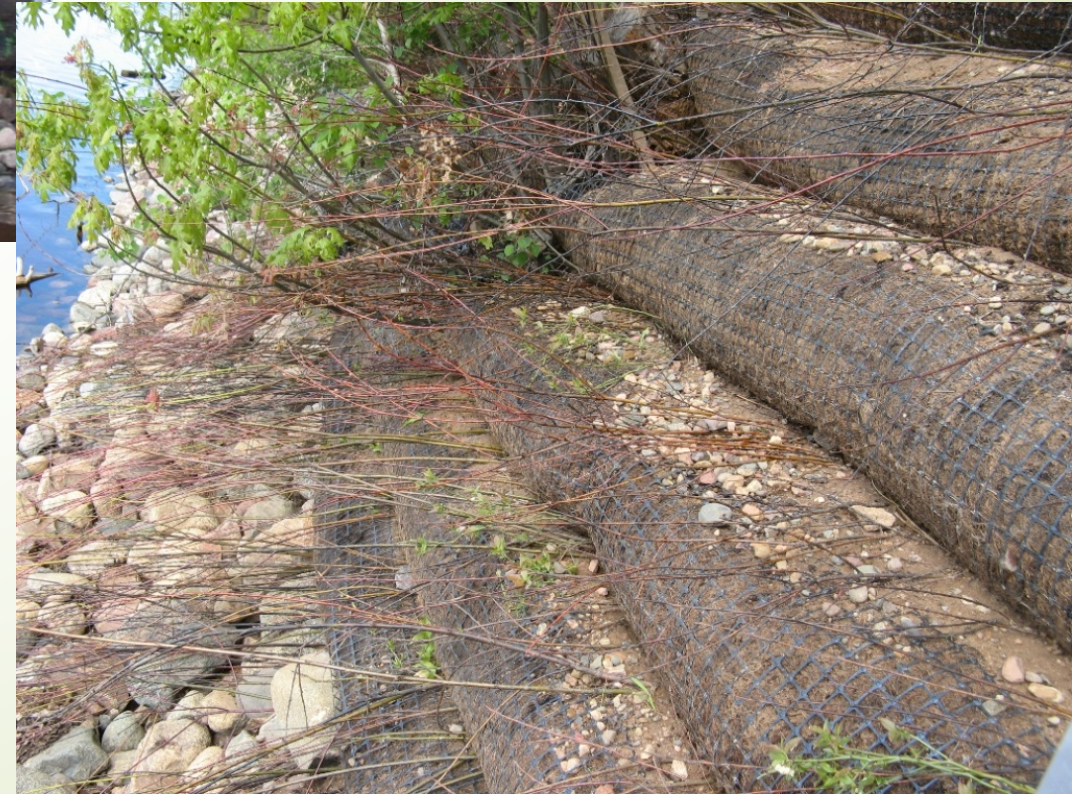
Rock Riprap Toe and Vegetated Geogrid Lifts

BEFORE

AFTER

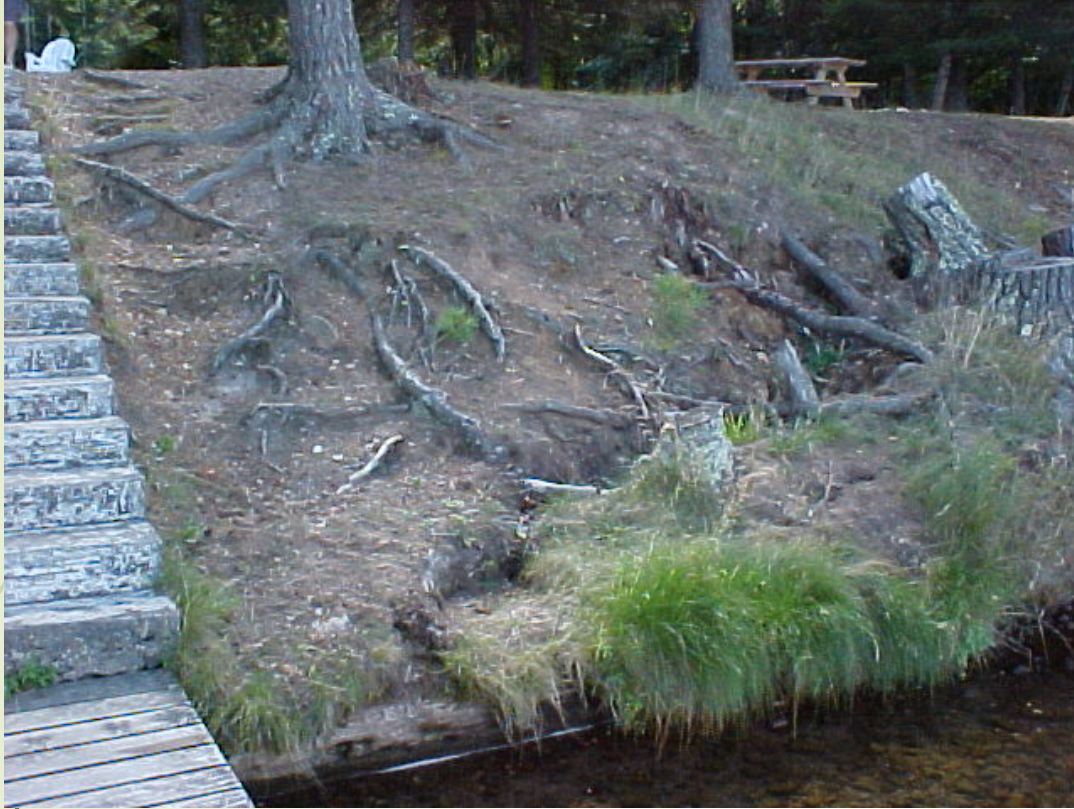
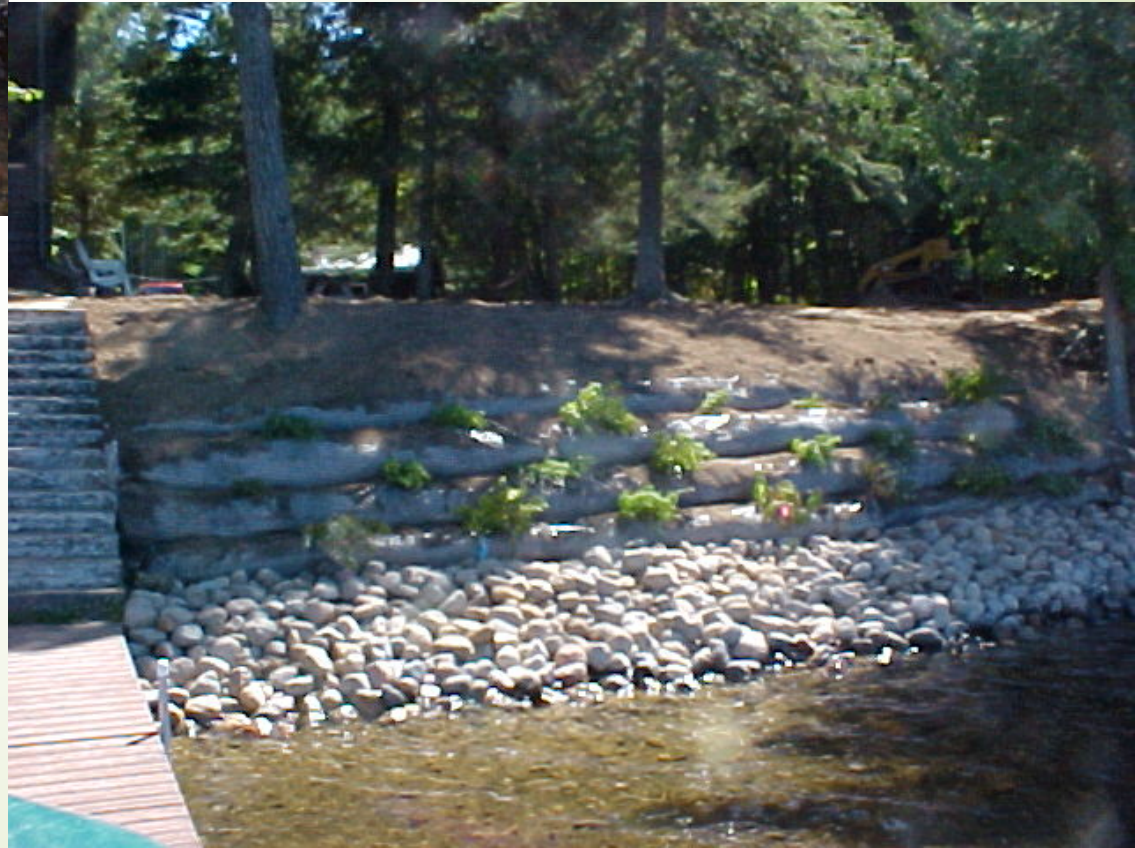
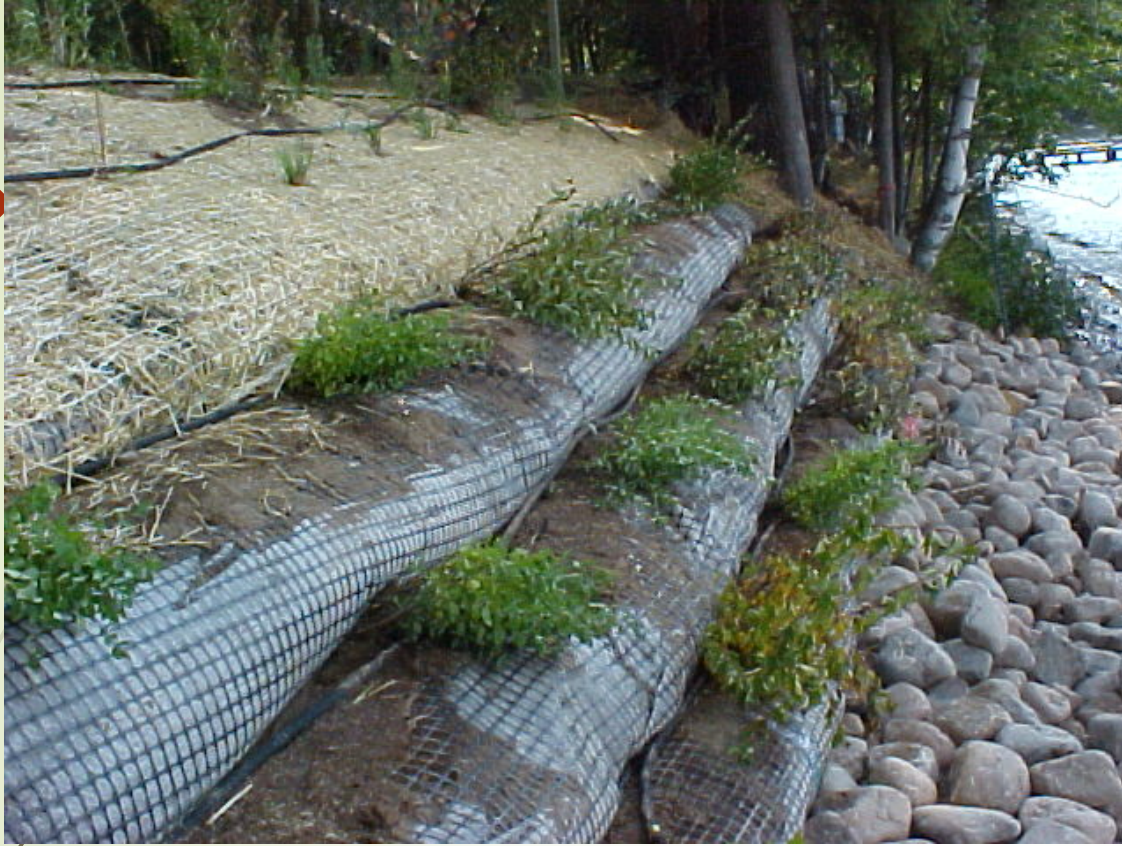
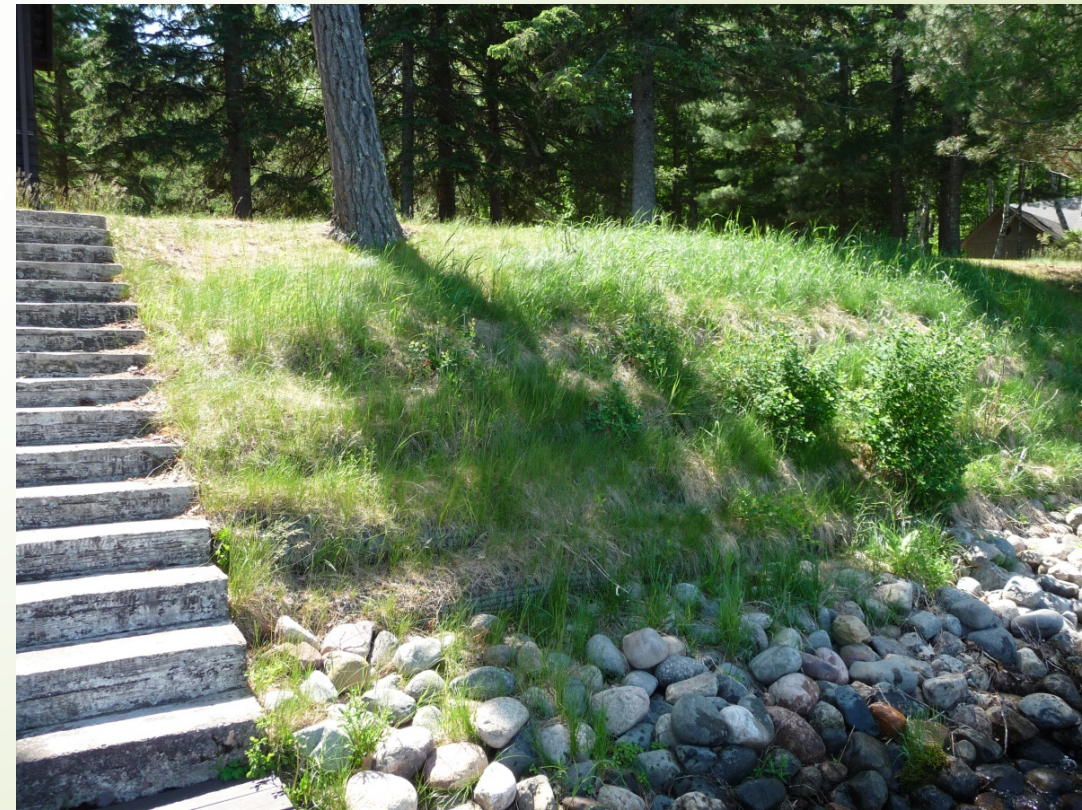
Rock Riprap Toe and Vegetated Geogrid Lifts

BEFORE

AFTER
