Case Studies - Photos

Lakeshore Protection Options

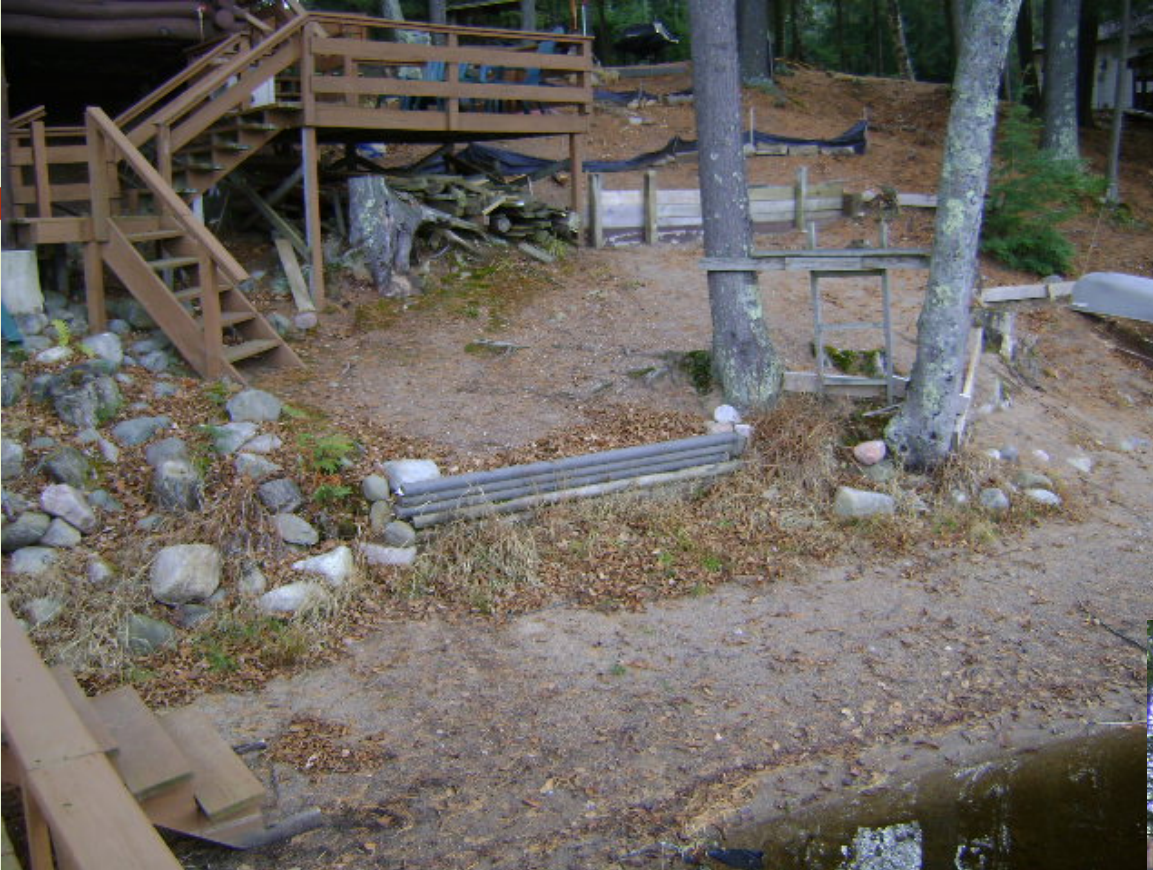
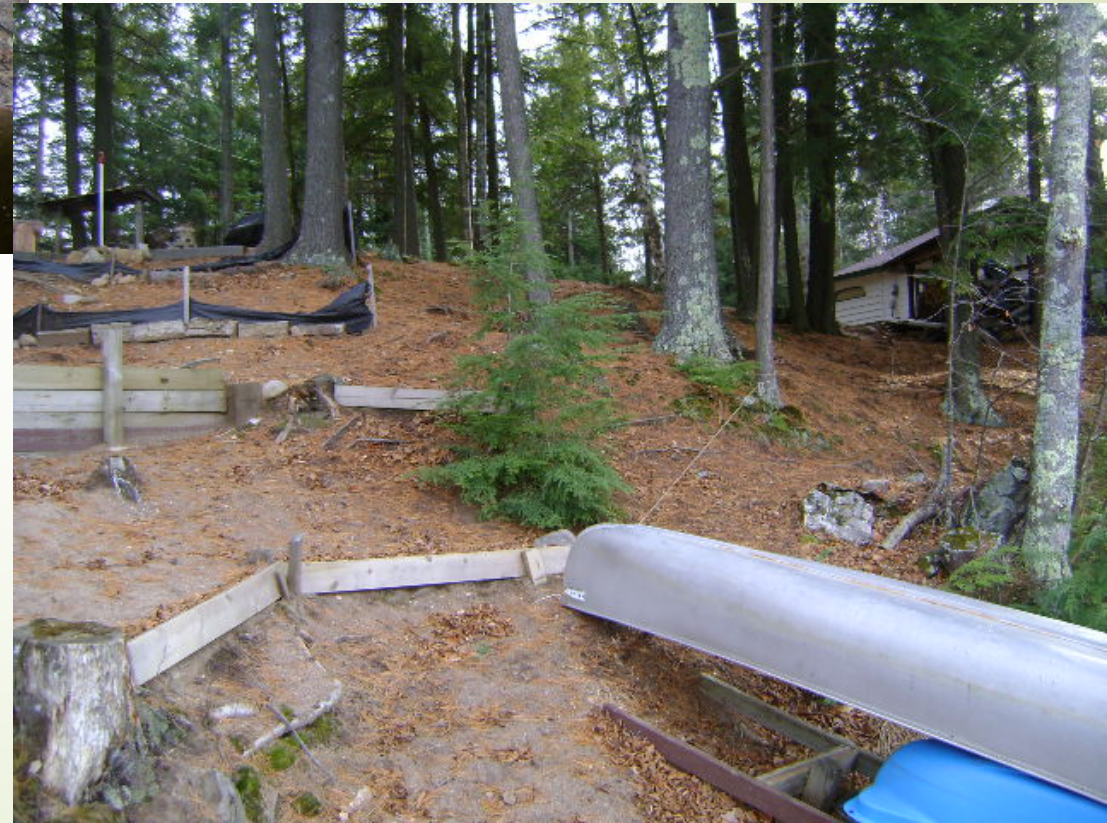
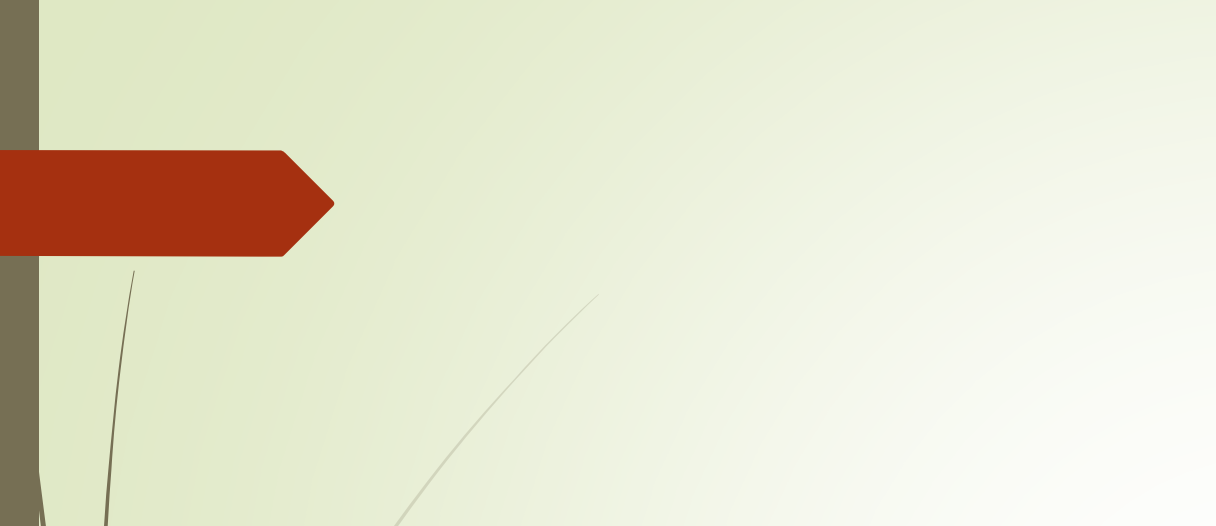
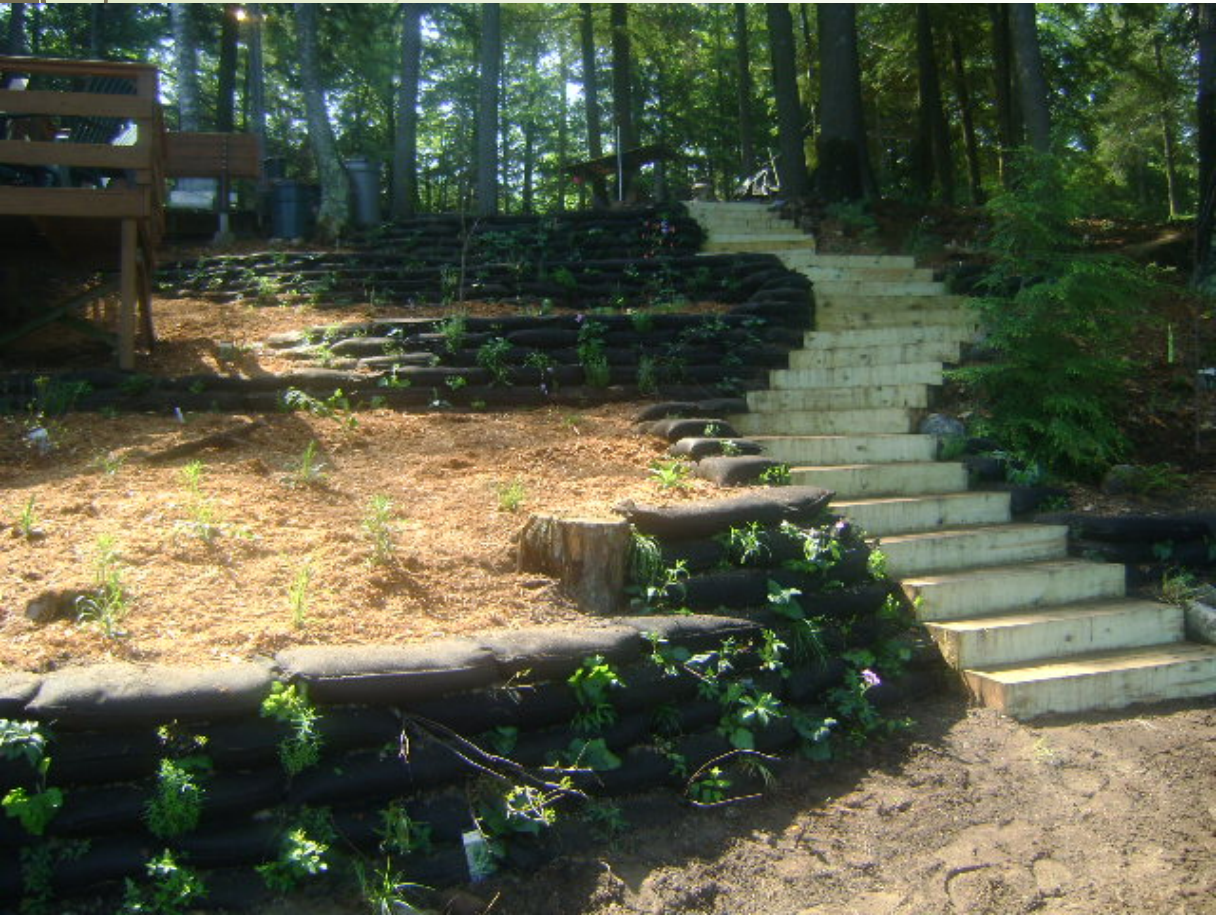
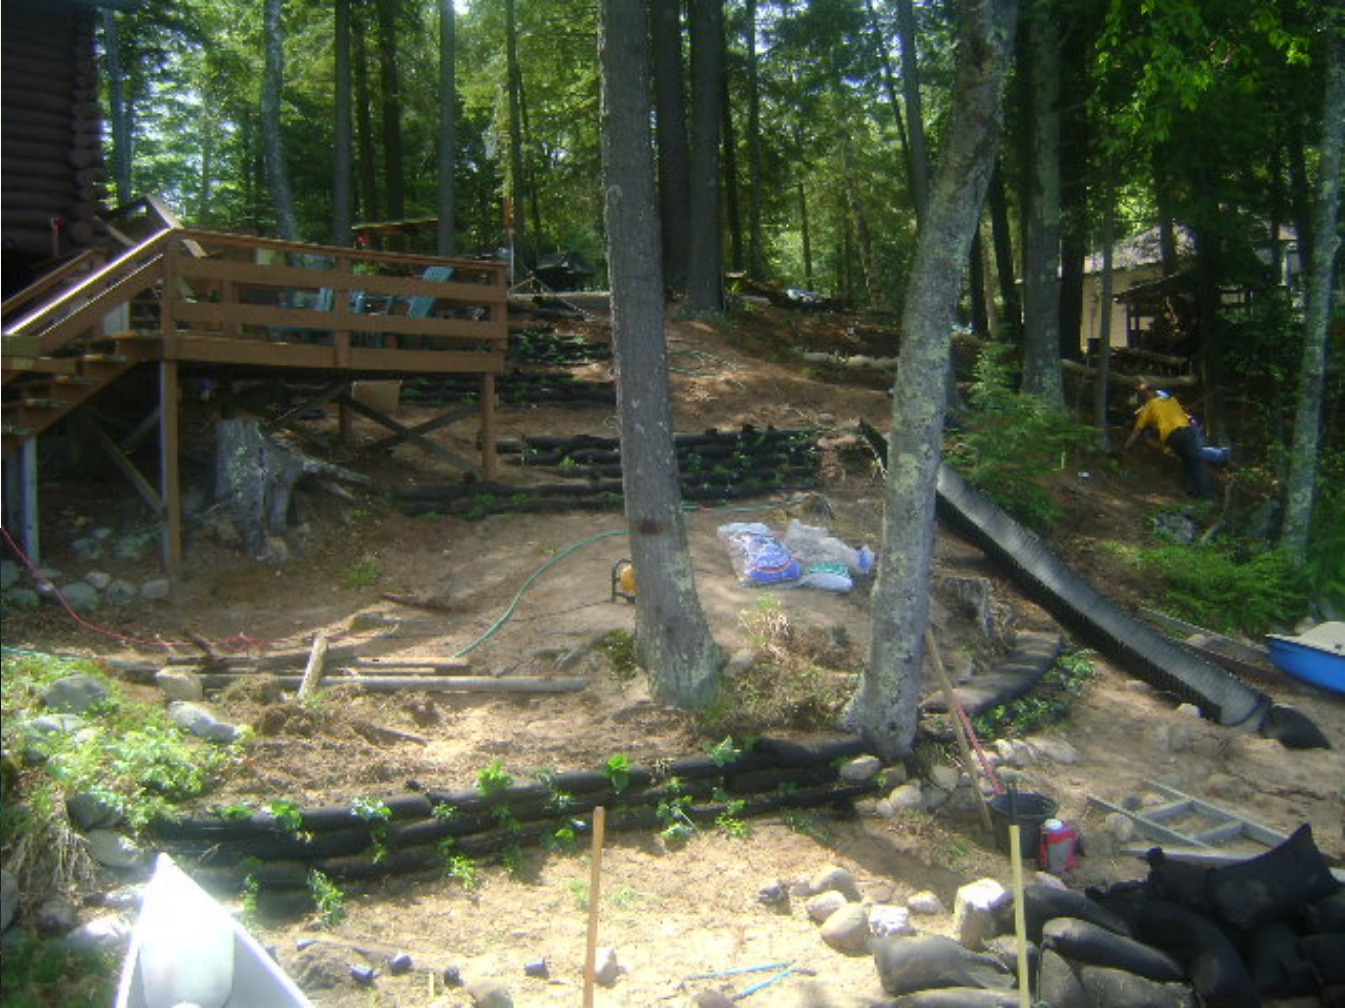
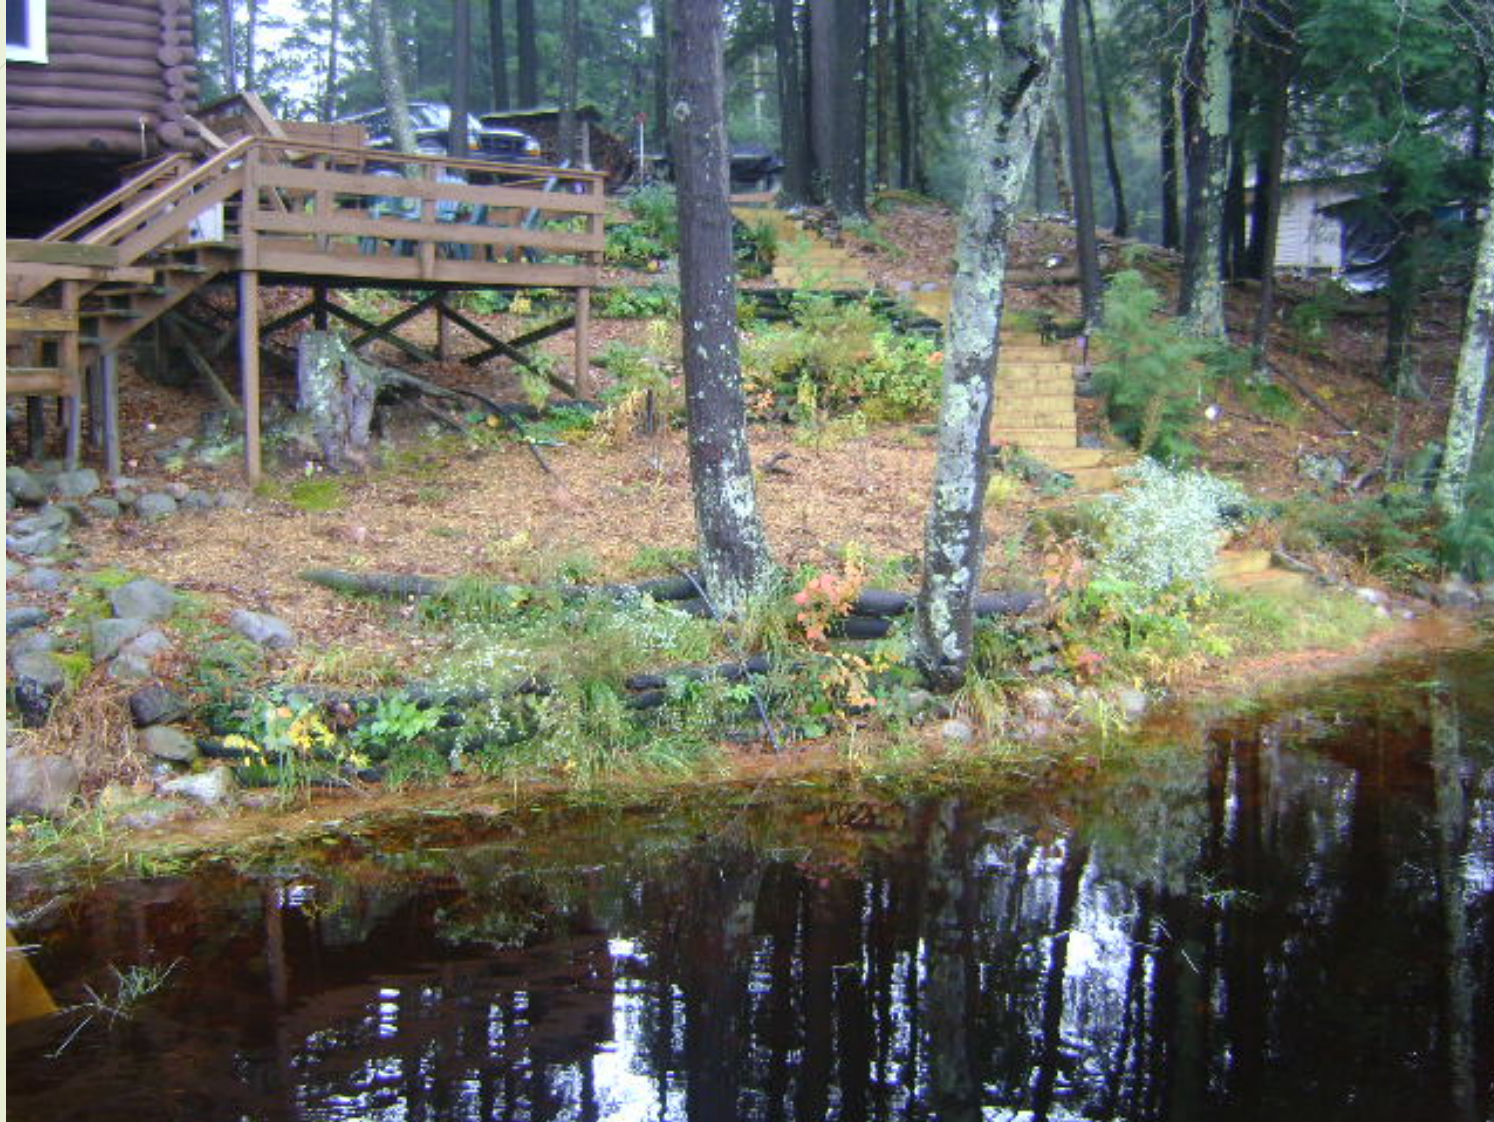
Geotextile Bag Walls on Upland Slopes
to prevent runoff to lake

BEFORE

AFTER

After 5 months of growth (May 2010 to Oct 2010)

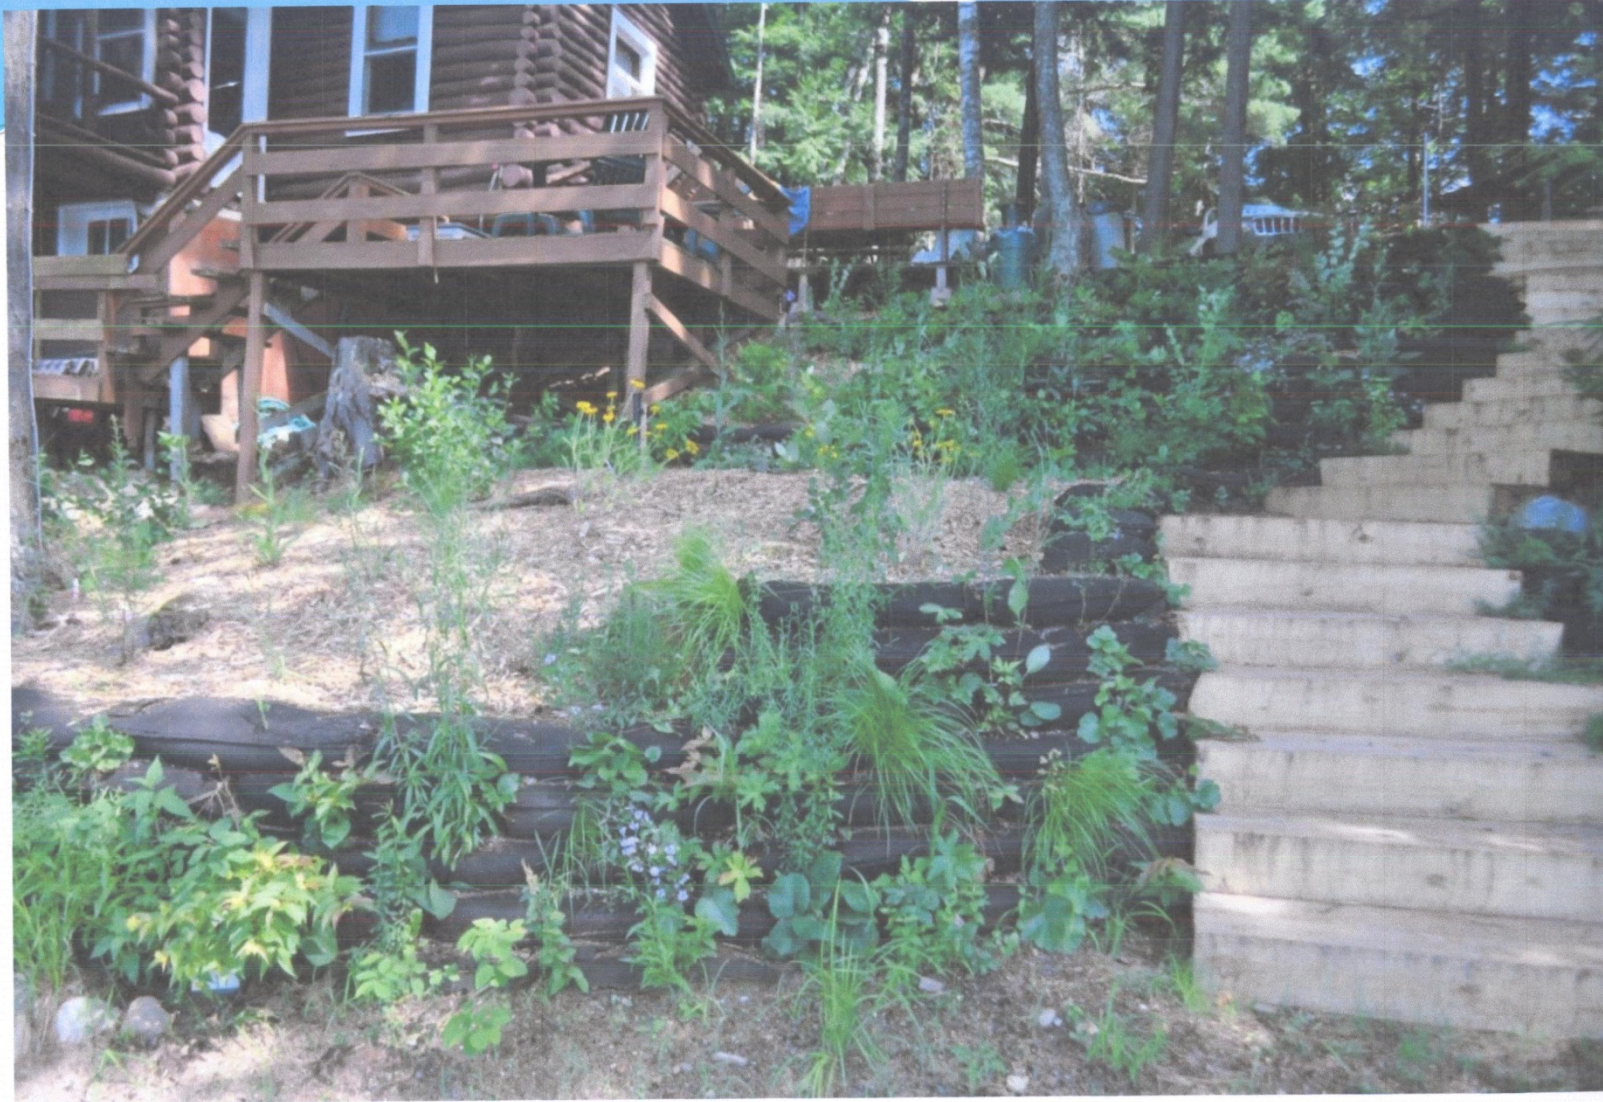
Vegetated Retaining Walls - Geotextile Bags (Install)

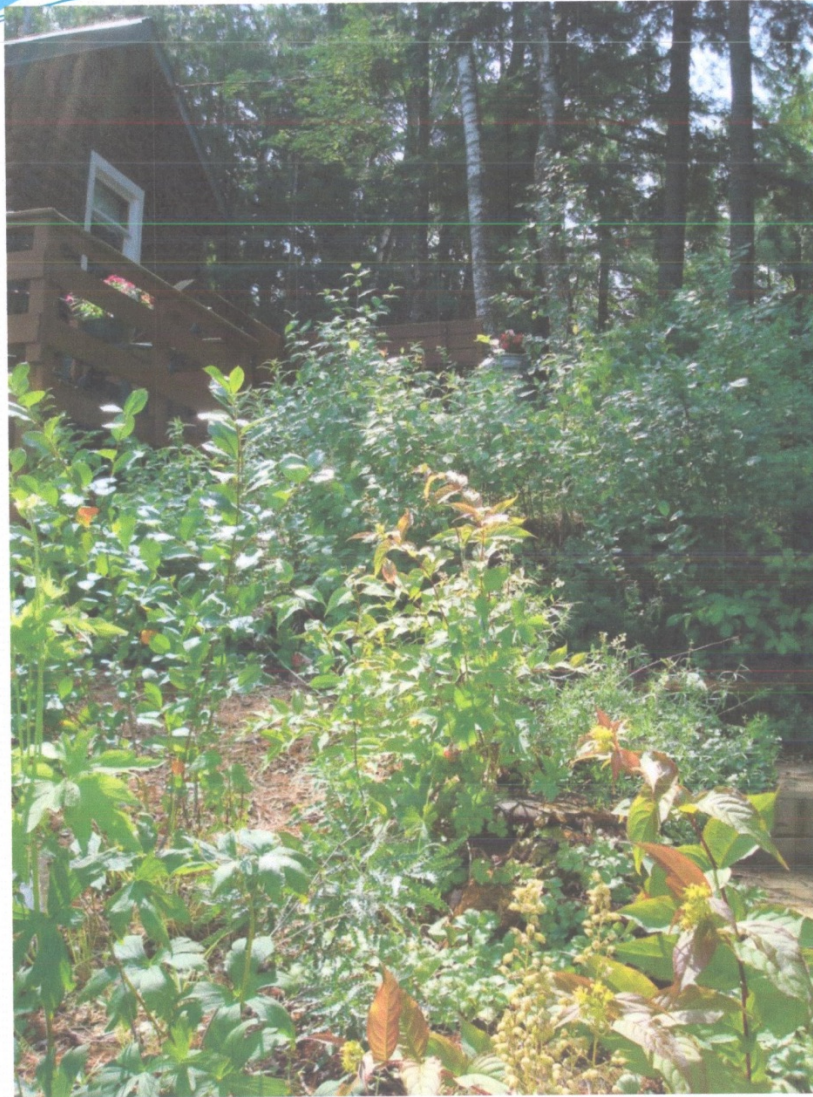
Vegetated Retaining Walls - Geotextile Bags (After)

**One growing season
later – Summer 2012**

(left side of stairs)

- Native plants are growing successfully
- Bags are camouflaged and will break down in time (biodegradable)

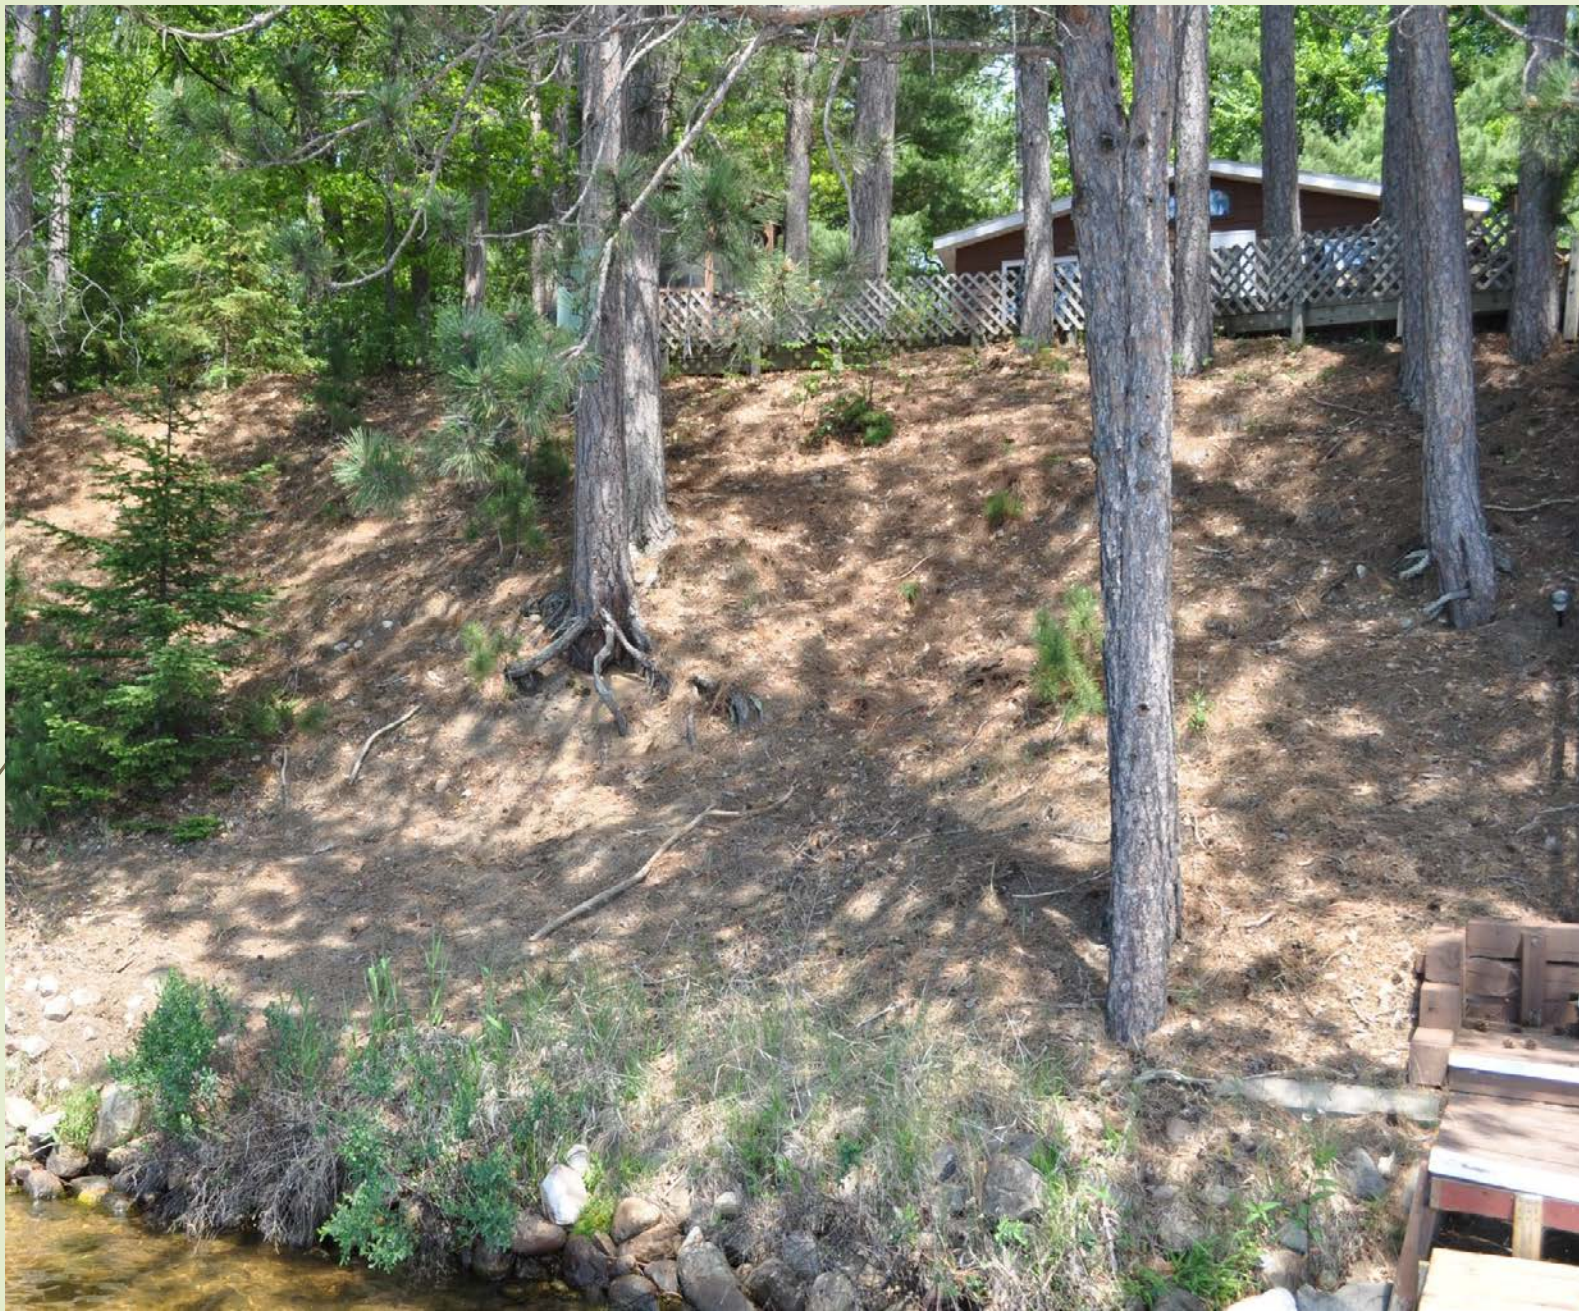
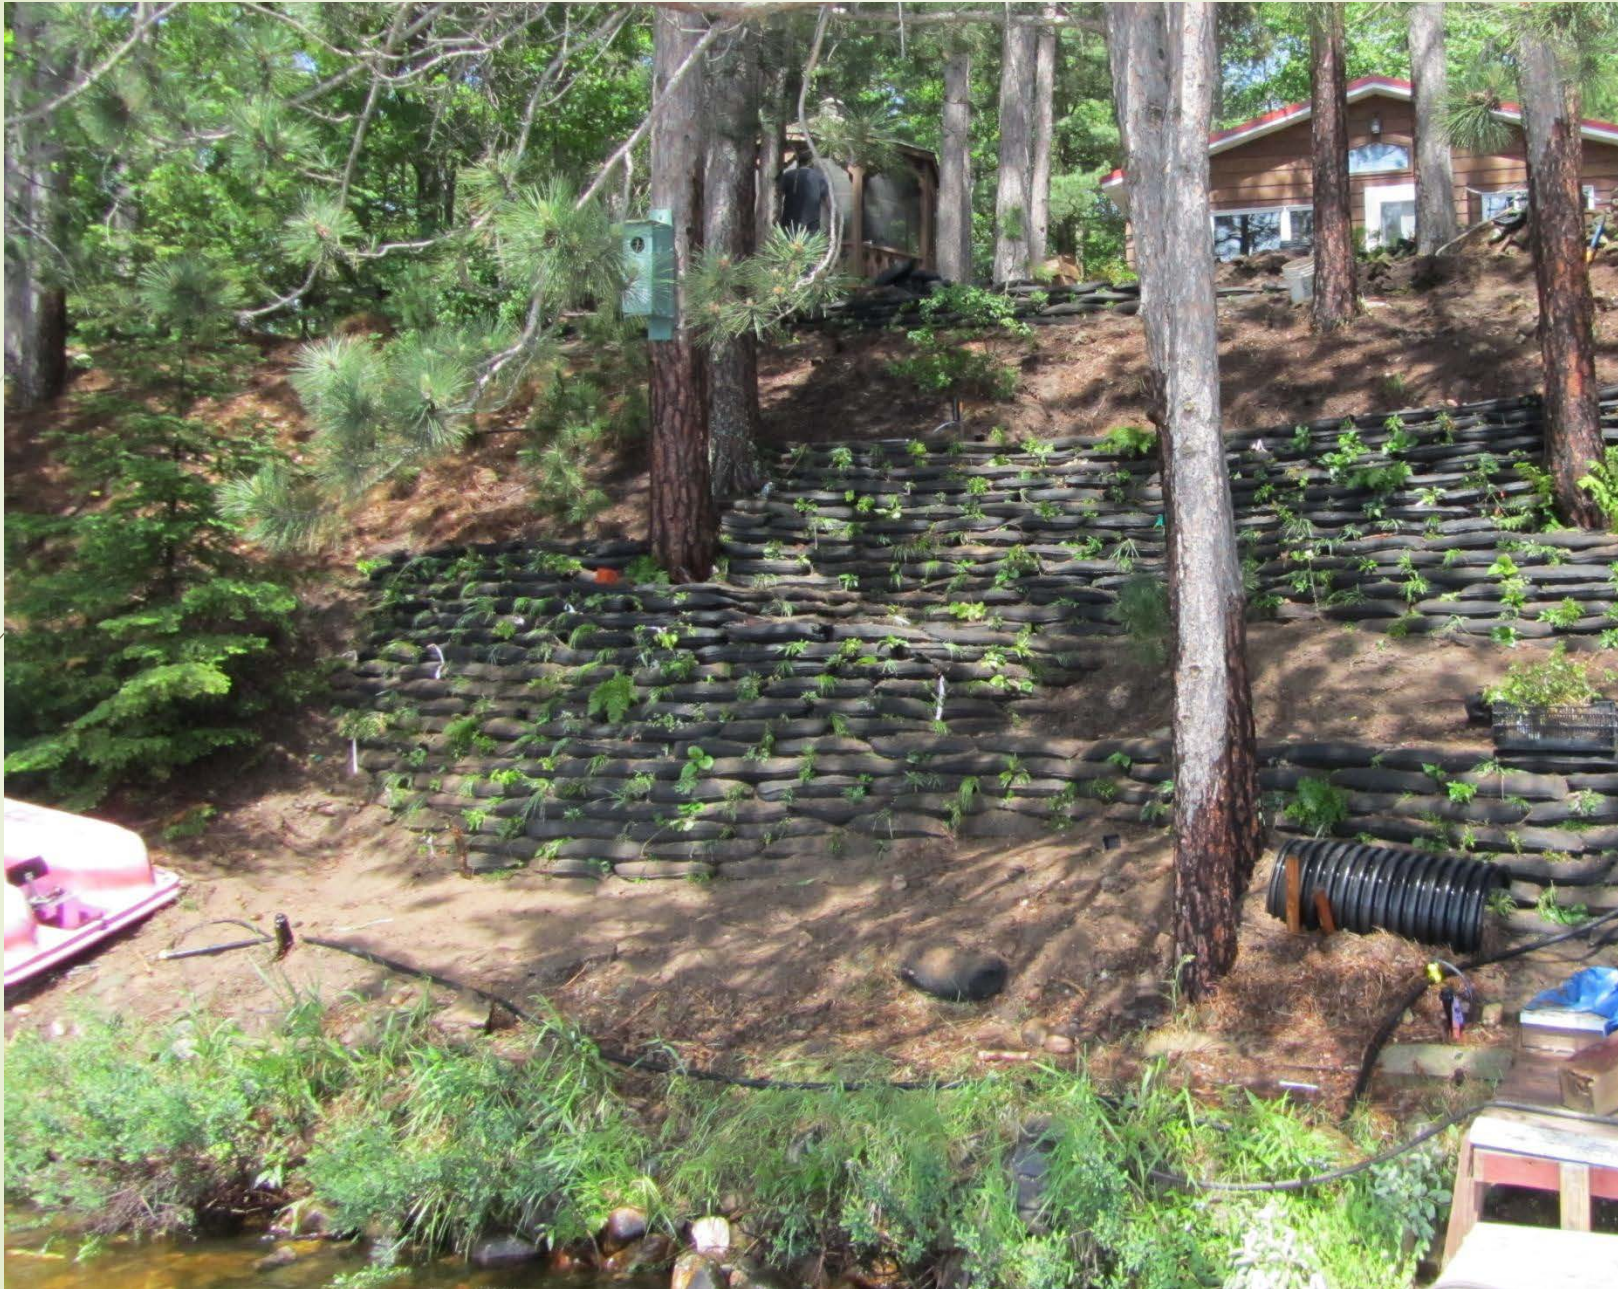
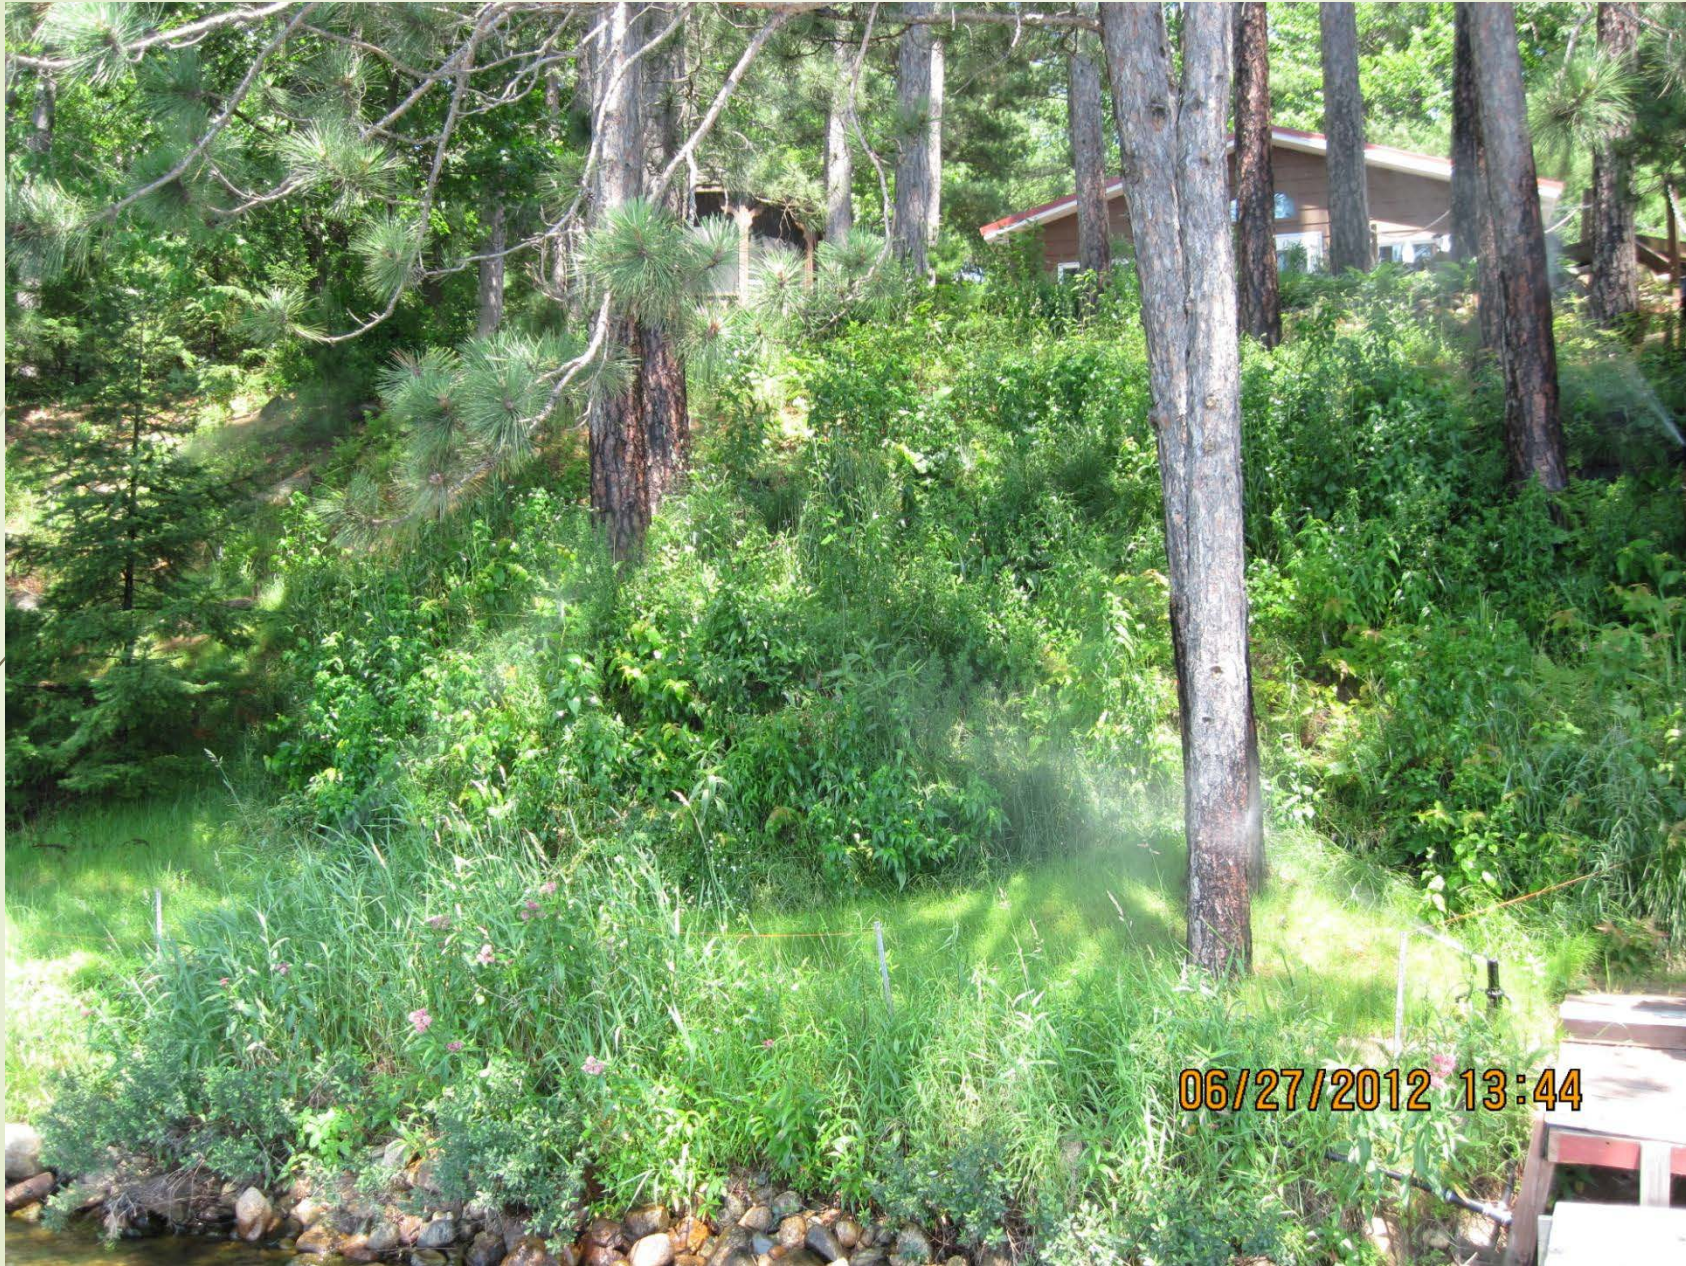
Geotextile Bag Walls Upland

June 2010 Before

June 2011

June 2012

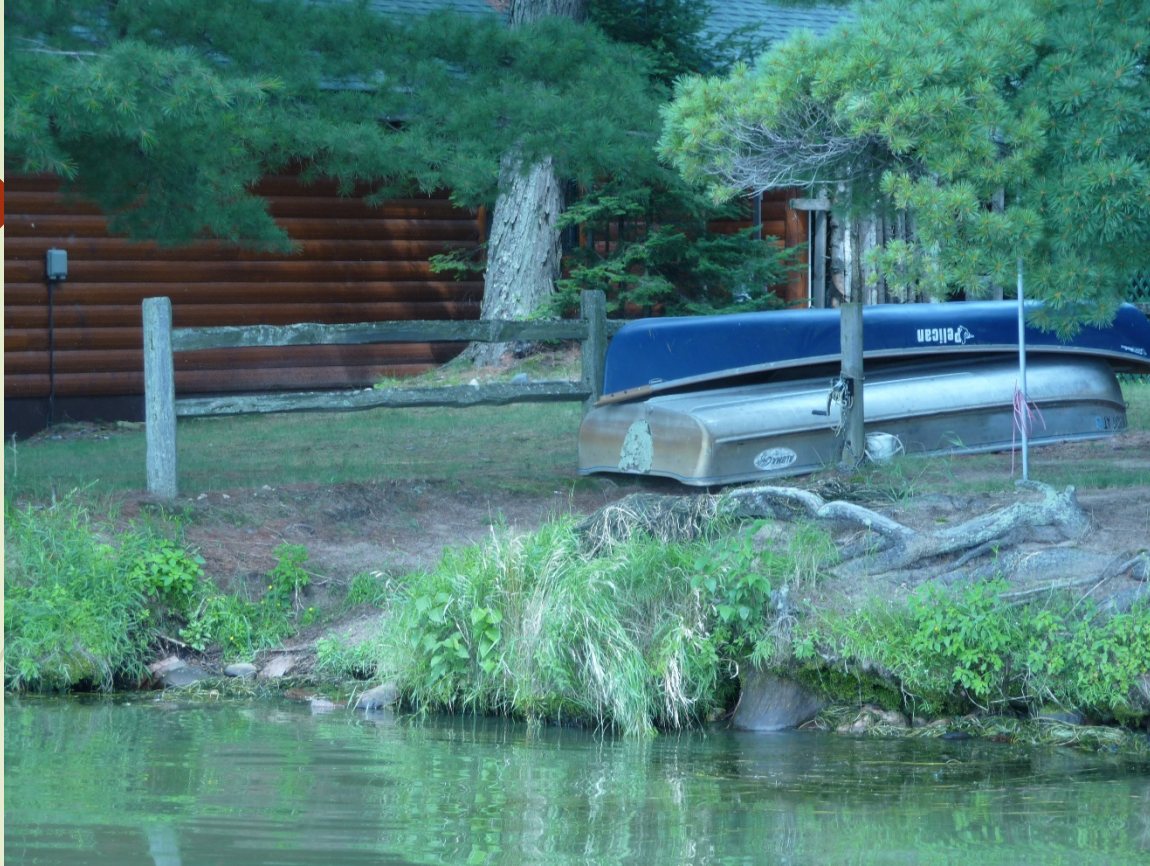
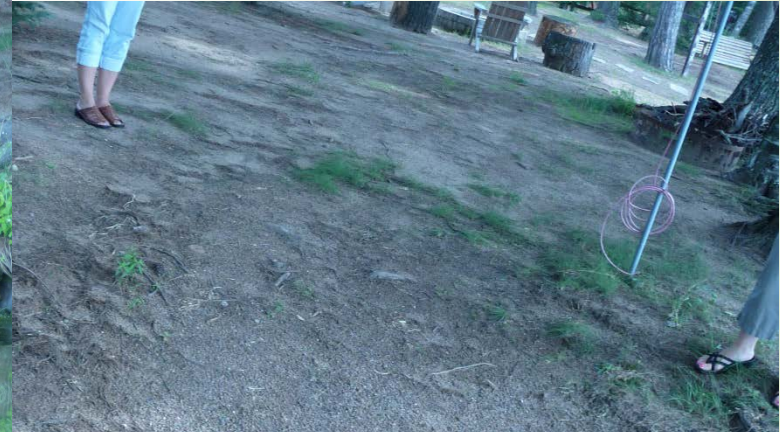
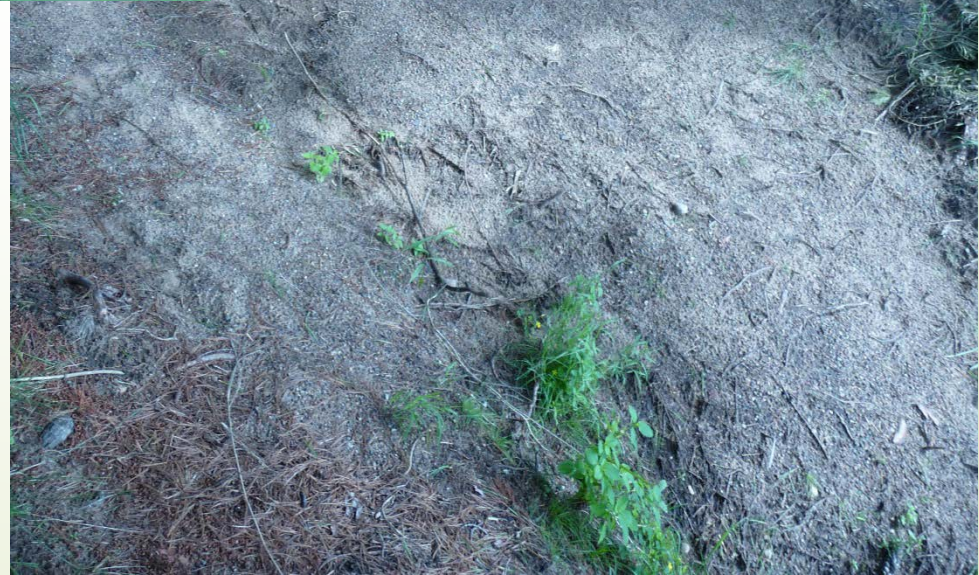
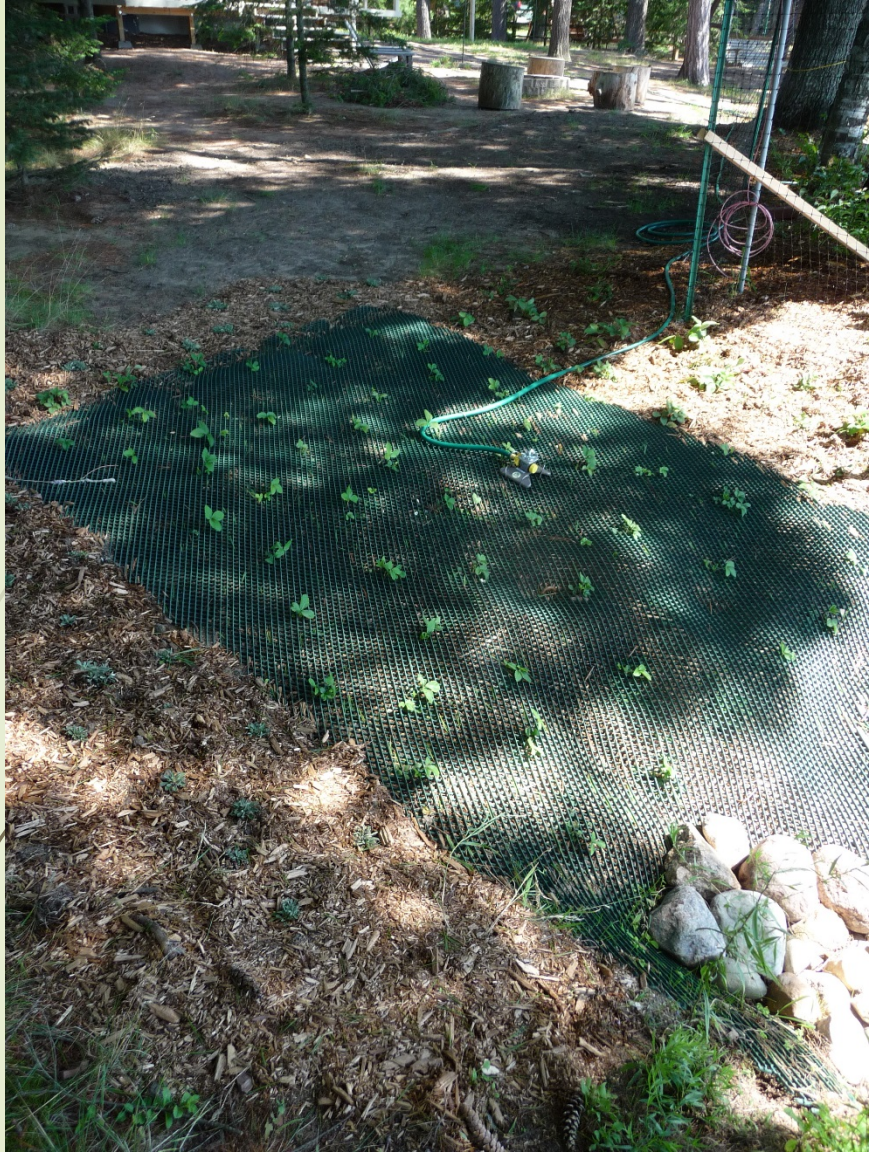
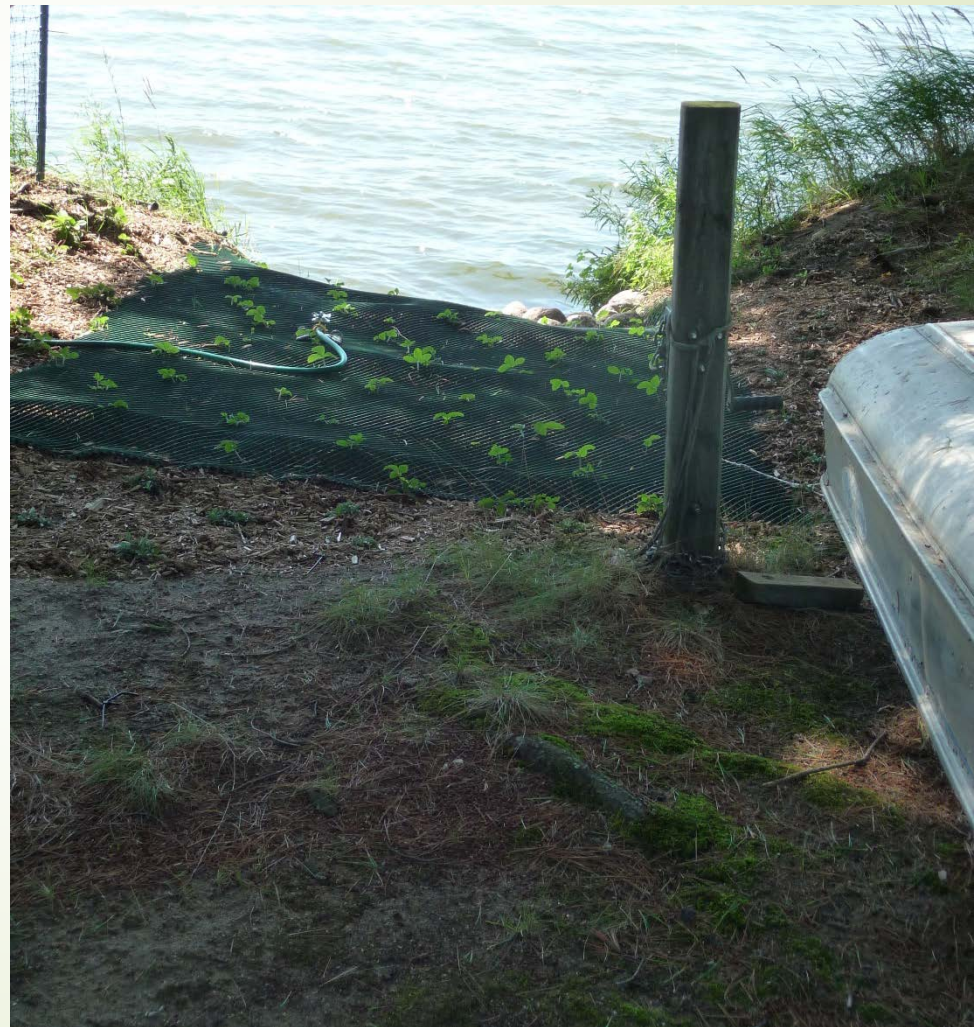
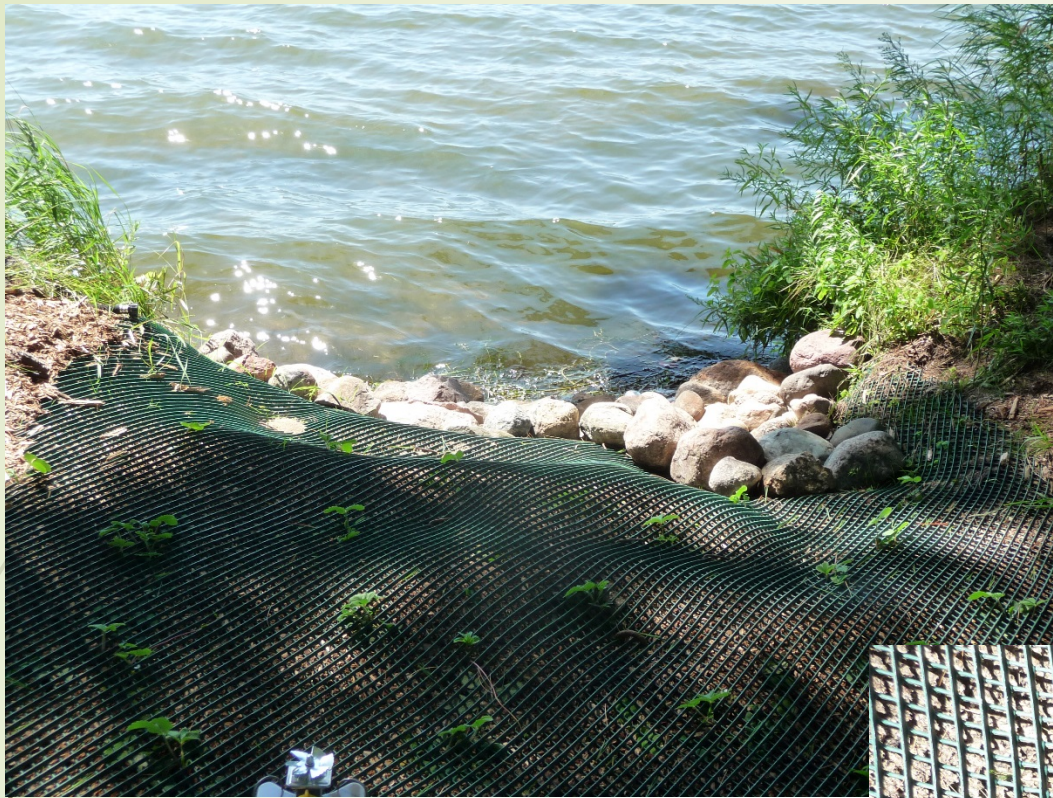
Grass Protect Matting for a walk-in access/boat landing
