Case Studies - Photos

Lakeshore Protection Options

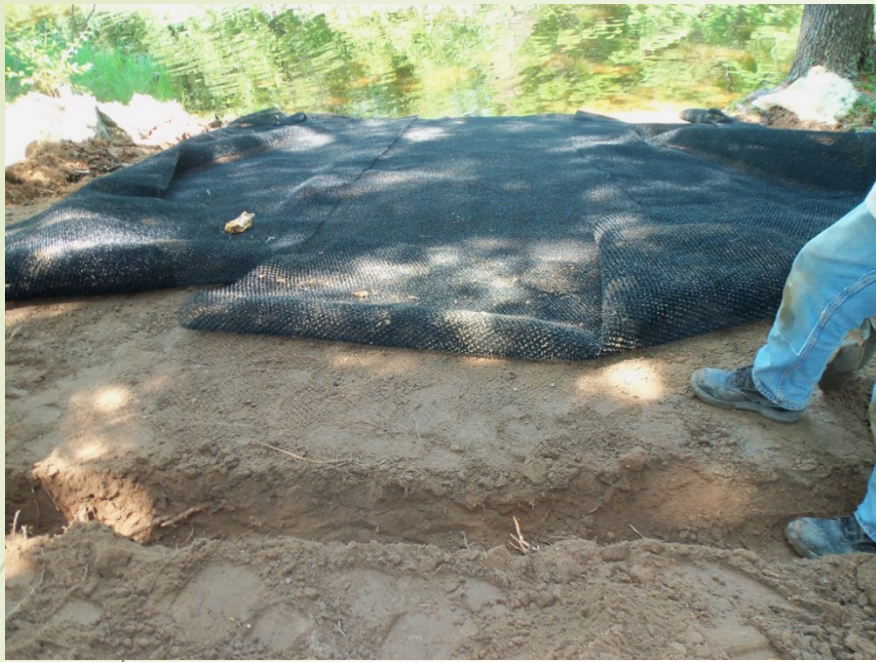
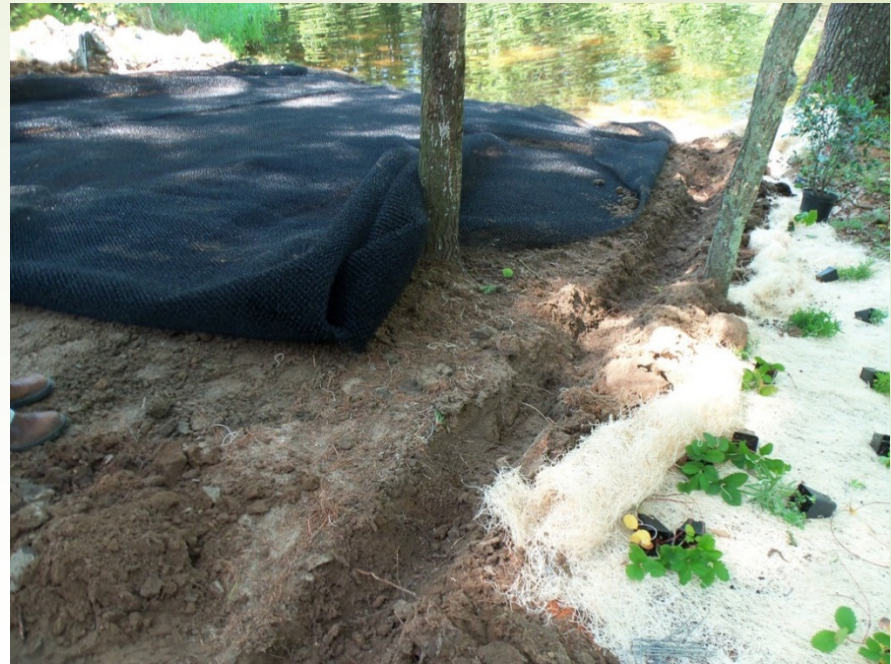
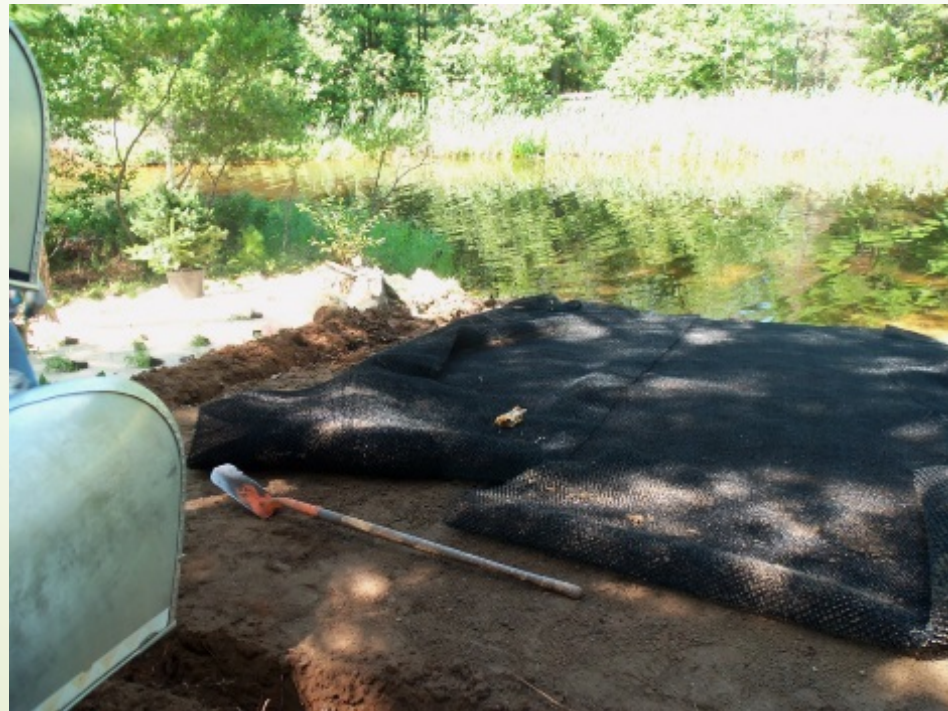
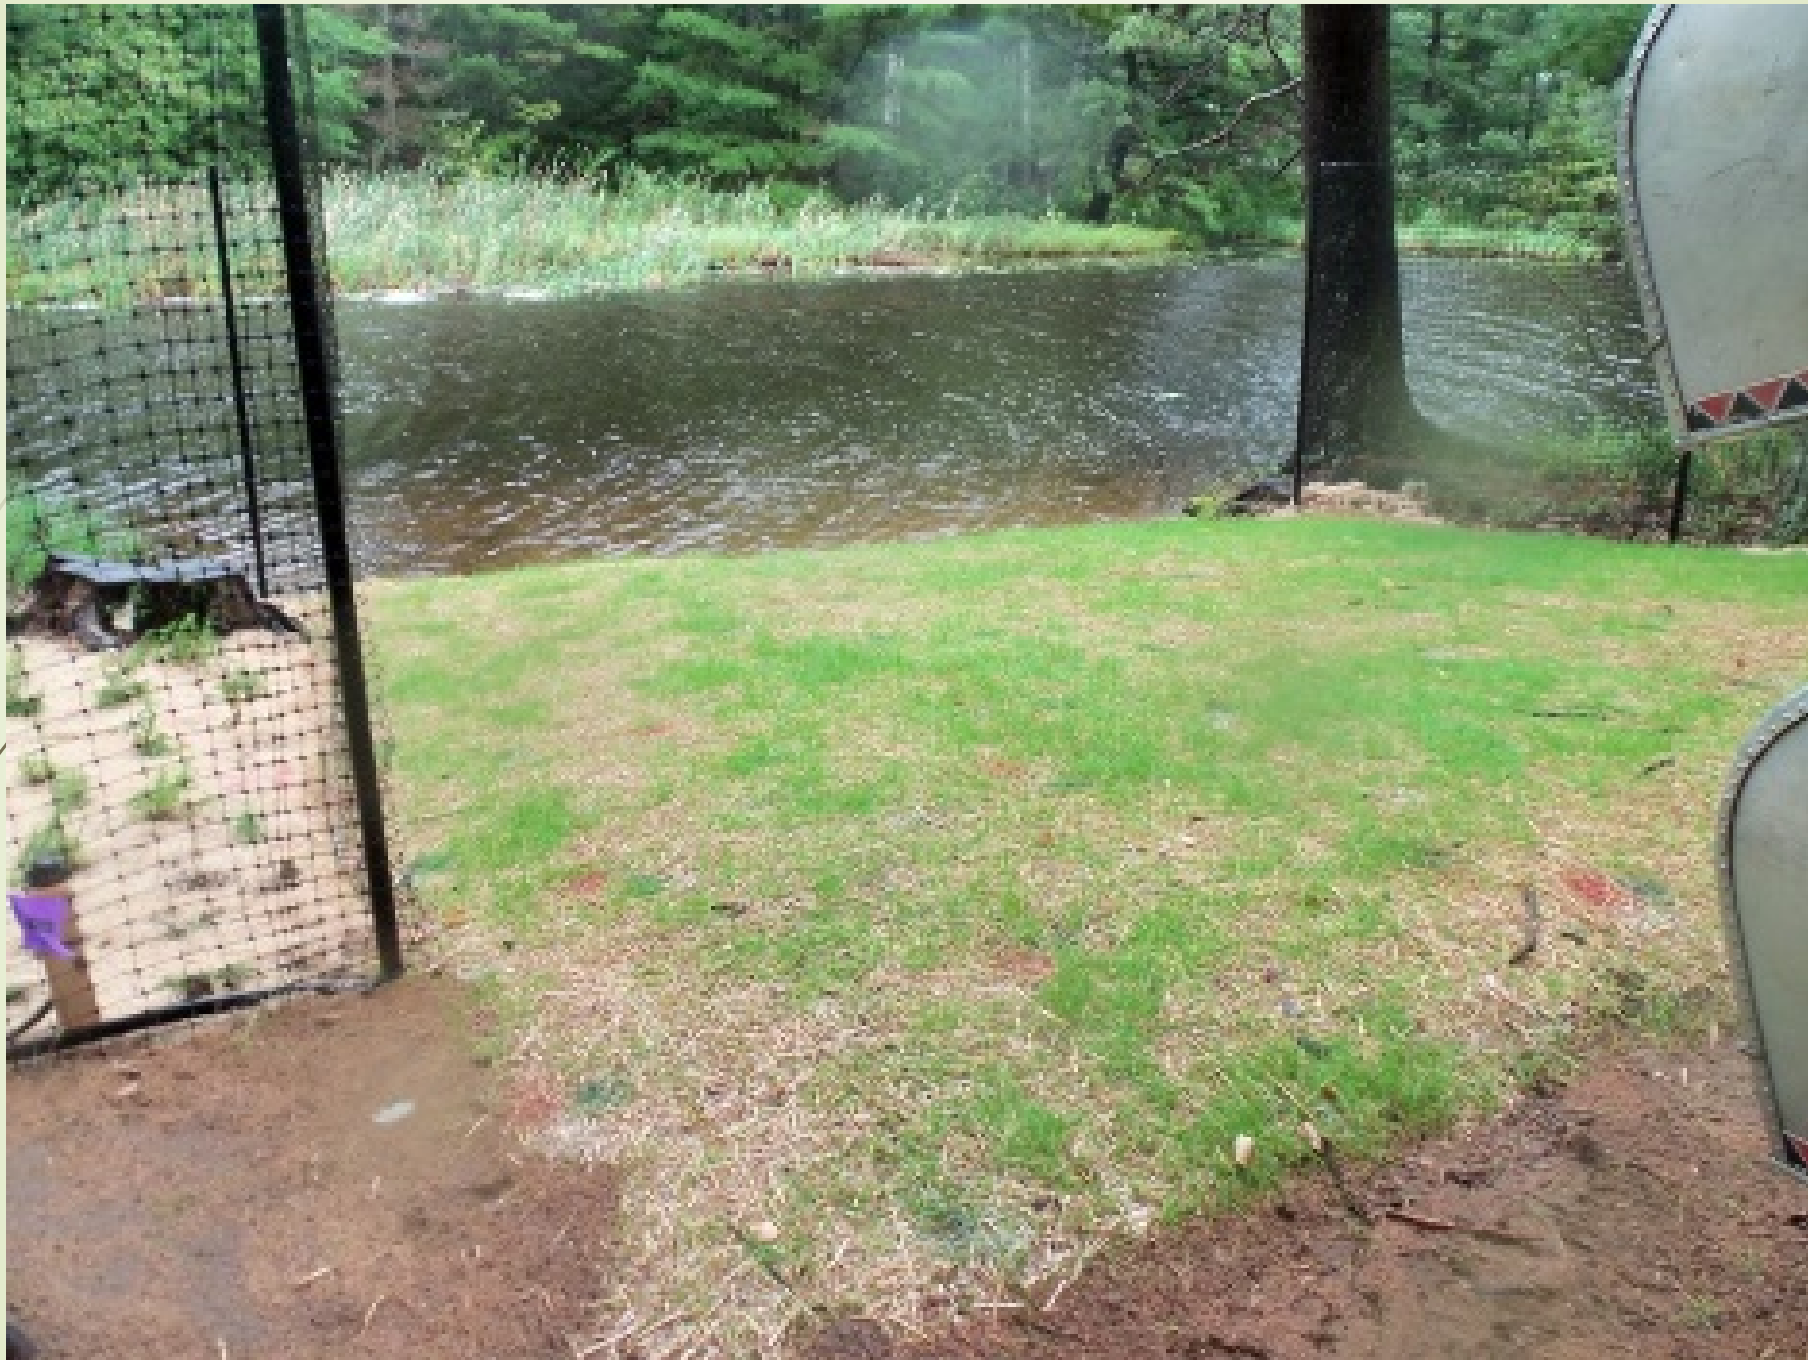
Enkamat Turf Reinforcement Matting for a Canoe Landing at a Camp
