We installed a total of 376 feet along the two tips of the island. The Legend Lake Protection and Rehabilitation District helped immensely to complete this project as they paid half the cost and supplied the boats and most personnel. We completed the install in about 10 hours with 7 people. There was a little time spent on land as well getting all the supplies loaded and live stakes gathered (I cut them myself from some wet ditches).

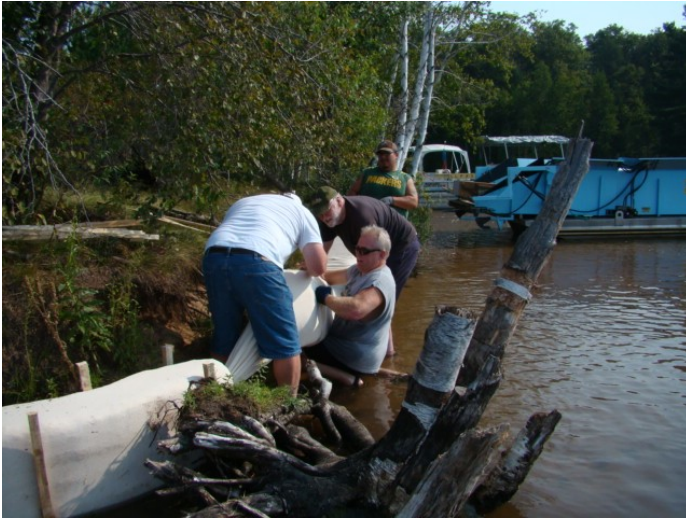
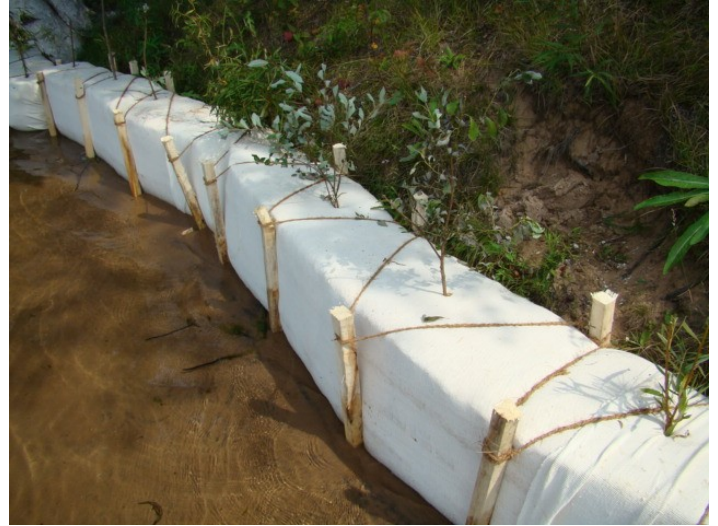
It's definitely quite labor intensive for a few reasons. Like I mentioned to you, fitting one inside the extra fabric of the next one is pretty tough (one action photo for you).

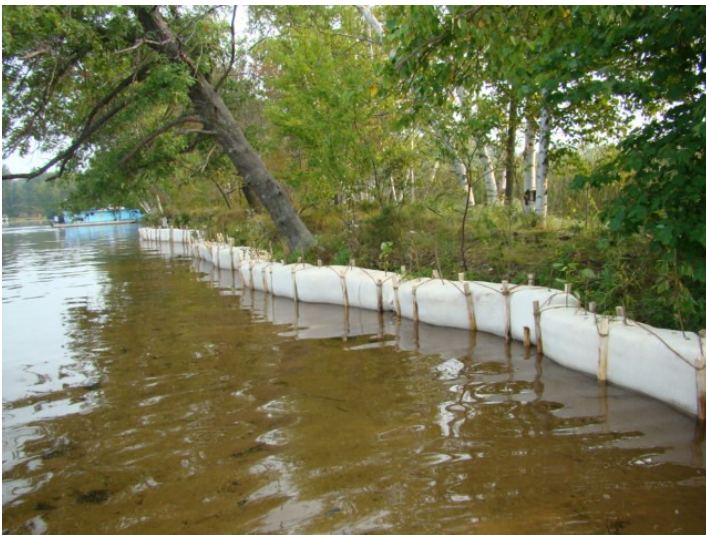
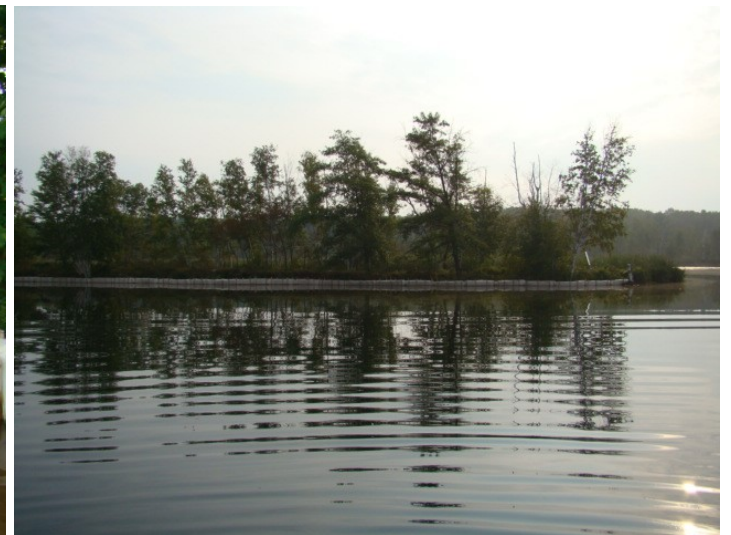
Pounding in the wooden stakes is not the easiest job either. As you can see, we have a hard sand substrate that resists the stakes after about 6" deep. The design specs calls for them, but you may want to consider cables and duck-bills. Not sure how tight you can do that though without harming the integrity of the curlex. May be worth a try on a

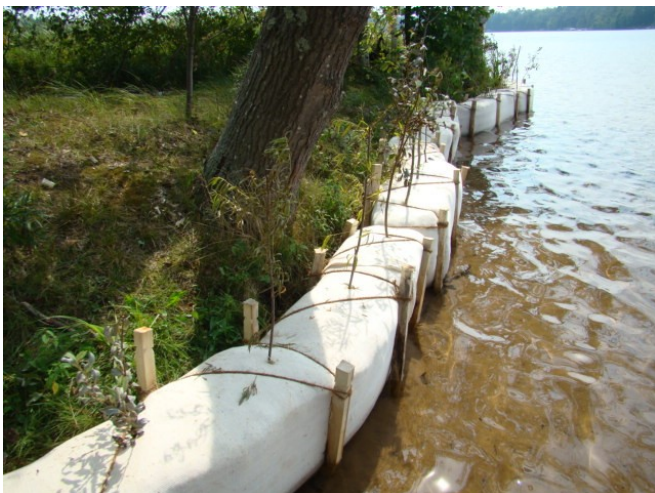
smaller site. Also, getting holes punched through the curlex to install livestakes isn't easy. We obtained a 6 foot length of rebar that we grinded to a point to hammer through with a post pounder. Then the livestakes slipped in pretty easy.
